Inquiry 10-010:
Bombardier DHC-8-311, ZK-NEB, landing without nose landing gear extended,
Woodbourne (Blenheim) Aerodrome, 30 September 2010

Final Report

Aviation inquiry 10-010
Bombardier DHC-8-311, ZK-NEB
Landing without nose landing gear extended
Woodbourne (Blenheim) Aerodrome
30 September 2010

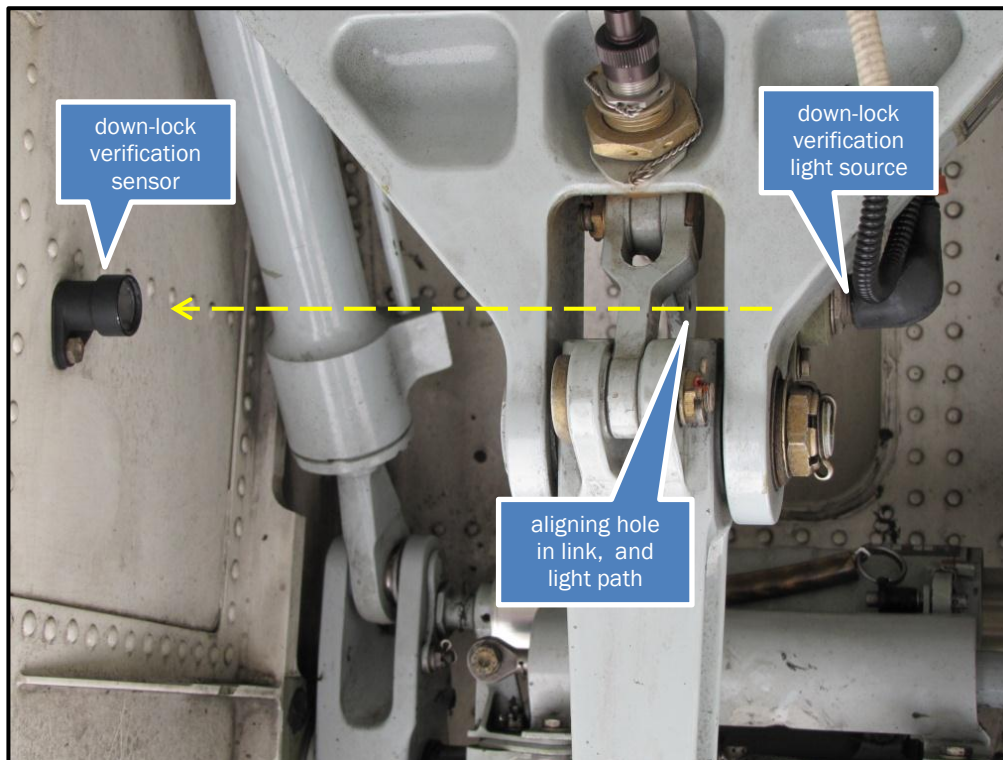
Figure 5
Down-lock verification system

- 3.4.1. The complete verification system from ZK-NEB was tested for the Commission by the Transportation Safety Board of Canada. The general condition and proper construction of the assembly were found to be satisfactory. All tests, including the circuit performance with the sensor immersed in water, were satisfactory. The Transportation Safety Board reported that:

the most likely cause of the [false down and locked indication] was a light source producing sufficient ambient light to activate the circuit. Tests conducted by Bombardier seem to indicate that the most likely source of light was the taxi light which is located on the nose [landing] gear.

- 3.4.5. On 14 November 2010 the operator added daily in-flight checks of the verification system to supplement the daily ground checks it already performed. During 2011 the operator had 7 reports of false landing gear position indications in flight. None involved the nose landing gear, but in one case the indications for both main landing gear legs were false. Flight in moist conditions was a common factor. In each case the defect was rectified by cleaning the sensors and connectors and applying a water repellent. The aeroplane maintenance manual already contained advice on this issue.

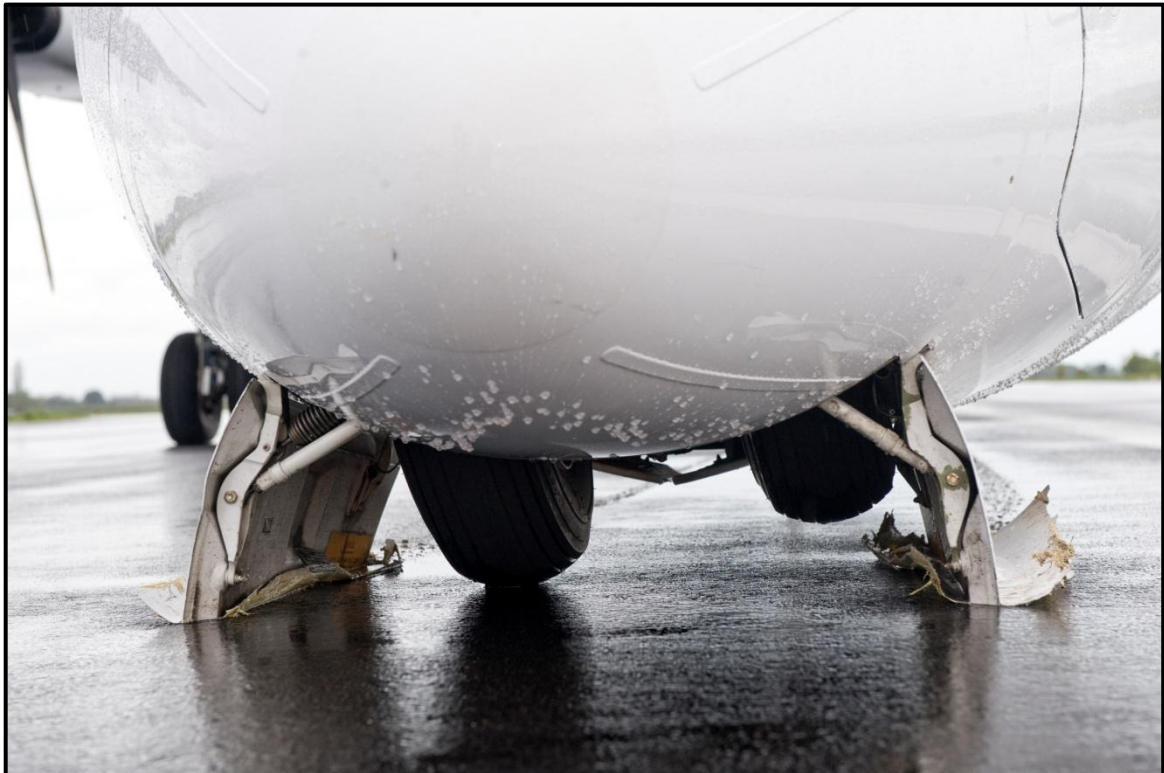
Figure 6
Damage to ZK-NEB

- 1.6. When the aircraft touched down and the pilot lowered the nose, the nose landing gear was pushed into the wheel well and the aeroplane completed the landing roll skidding on the nose landing gear doors. Damage to the aeroplane was minimal and no-one was injured.

- 3.3.2. After the aeroplane nose was lifted by crane, the nose landing gear extended under its own weight and was pushed rearwards into the locked down position. The wheels were at a slight angle, but there was no sign that mechanical binding or an obstruction had prevented normal extension. The damage was confined to the forward nose landing gear doors and the surrounding skin, and a radio antenna on the lower fuselage (see Figure 6). The aeroplane was towed to the apron about 5 hours after landing.

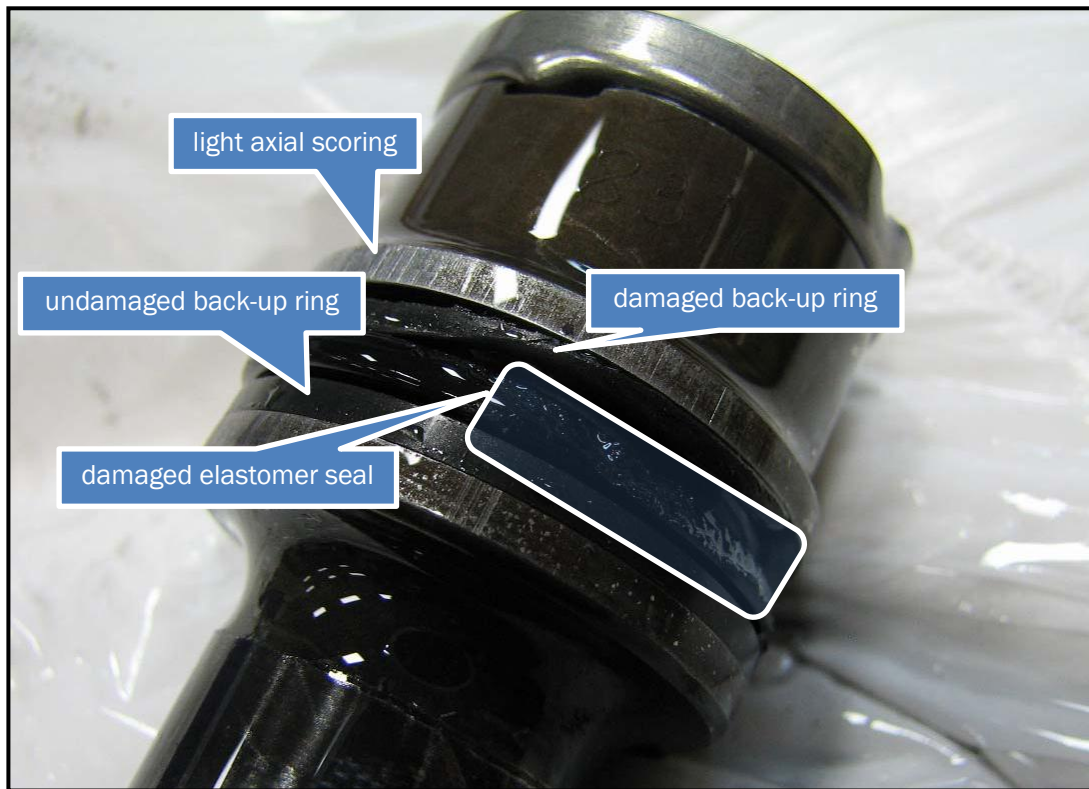
Figure 7
Nose landing gear actuator piston removed from ZK-NEB

- 3.4.10. The nose landing gear actuator could be fully extended and retracted by hand without excessive force or binding. However, on disassembly fluid contamination was noted and minor wear marks were seen on the piston head. Black debris was found on the inside of the UP restrictor. The dimensions of the actuator met production specifications. An analysis of residual fluid and debris determined that the hydraulic fluid was of the correct type and that the contaminants were a range of metals, predominantly aluminium, and a black, organic material with characteristics consistent with those of Teflon.

- 3.4.11. The piston seal and one of the seal back-up rings had damage that the manufacturer considered rare (see Figure 7). An analysis indicated that the seals and back-up rings were genuine parts and had been fitted in the correct order. Messier-Dowty stated that nose landing gear actuators had seldom leaked fluid or sustained seal damage like that found in this actuator, and their specifications had not been changed.

- 3.4.12. The Messier-Dowty report concluded that the seal deterioration and contamination were the result of hydraulic system contamination. It did not specifically address the cause of the actuator failing to extend the nose landing gear, but implied that a particle of contaminant had blocked an integral port and prevented proper actuator operation.

3.4.14. The Transportation Safety Board of Canada laboratory identified the presence of particles of a “7xxx-series aluminium alloy” on the seal.²⁵ The report noted that the nose landing gear actuator cylinder was 7075 alloy and that “the composition of most metal particles found on the back-up ring ... is consistent with the major elements specified for this alloy”.²⁶ The report concluded that:

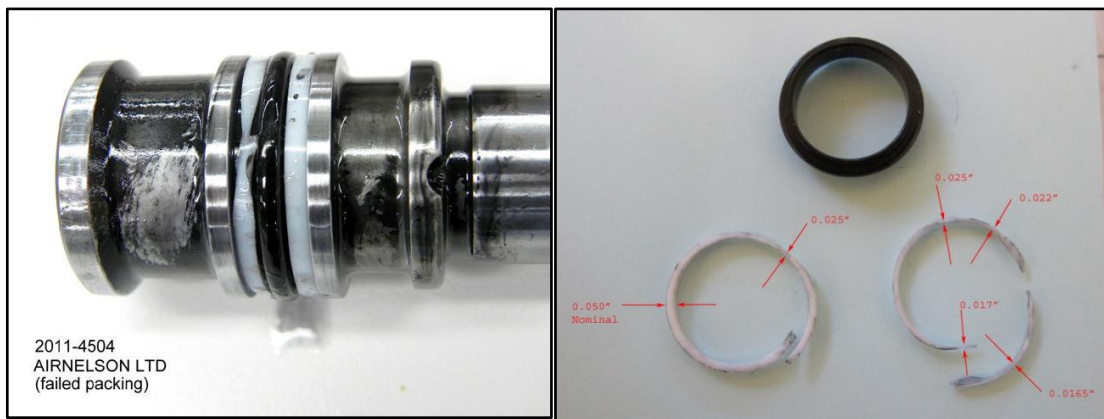
Figure 8
Nose landing gear door actuator from ZK-NEB:
damaged seals in place (left) and removed (right)

- 3.4.20. The nose landing gear door actuator was examined by its manufacturer, which found that the aluminium cylinder was worn beyond limits and the white Teflon piston seal back-up rings were excessively worn (see Figure 8). The door actuator had been installed as a new item when ZK-NEB was manufactured. Bombardier advised that between August 2005 and February 2011 the world Q300 fleet mean time between unscheduled removals of the door actuator was 49 134 flight hours.

- 3.4.21. The operator removed the door actuators from 5 aeroplanes, based on their hours in service and higher, although acceptable, levels of hydraulic fluid contamination. Four actuators had cylinder wear that was outside limits and the seals of 2 had major damage. The aeroplane manufacturer and operator continue to examine causes of the high wear rate. In the interim, the operator has instituted a finite life for the nose landing gear door actuators.
