Report 10-101: wrong route setting, high-speed transit through turnout,
near miss and SPAD (signal passed at danger), Tamaki, 13 August 2010

Final Report

Rail inquiry 10-101
wrong route setting, high-speed transit through turnout, near miss
and SPAD (signal passed at danger),
Tamaki, 13 August 2010

Transport Accident Investigation Commission

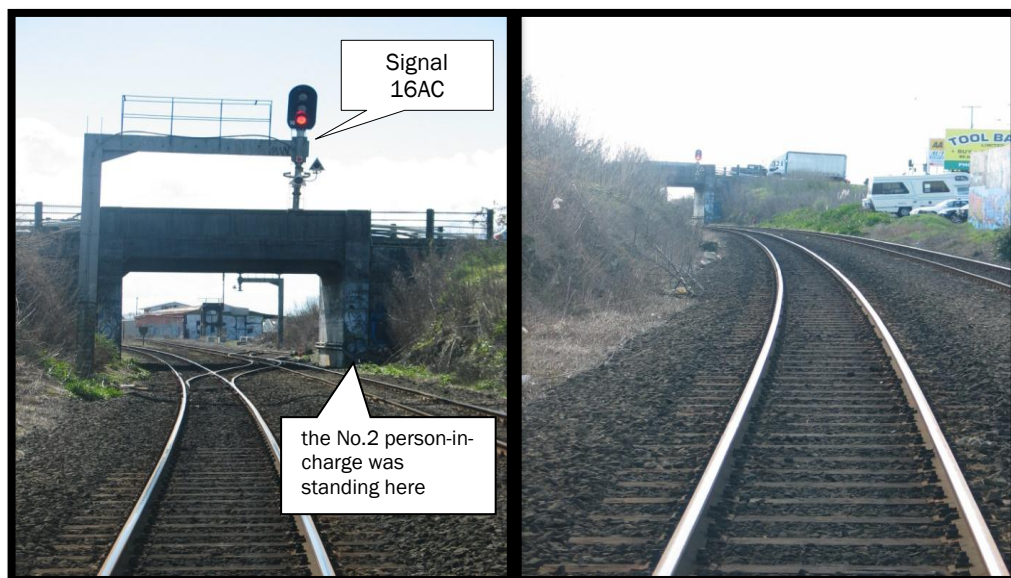
Figure 2
Signal 16AC close and at a distance

- 3.2.15. At about the same time, the Auckland signal box controller handed over his panel to the Newmarket controller and left the signal box to catch a train to Otahuhu, where he was to complete his shift relieving in the Otahuhu signal box. The handover between signal box controllers was completed just as a train was seen on their mimic displays going through Points No.15 at Tamaki. They both thought that it was the shunt, when in fact it was the passenger train.

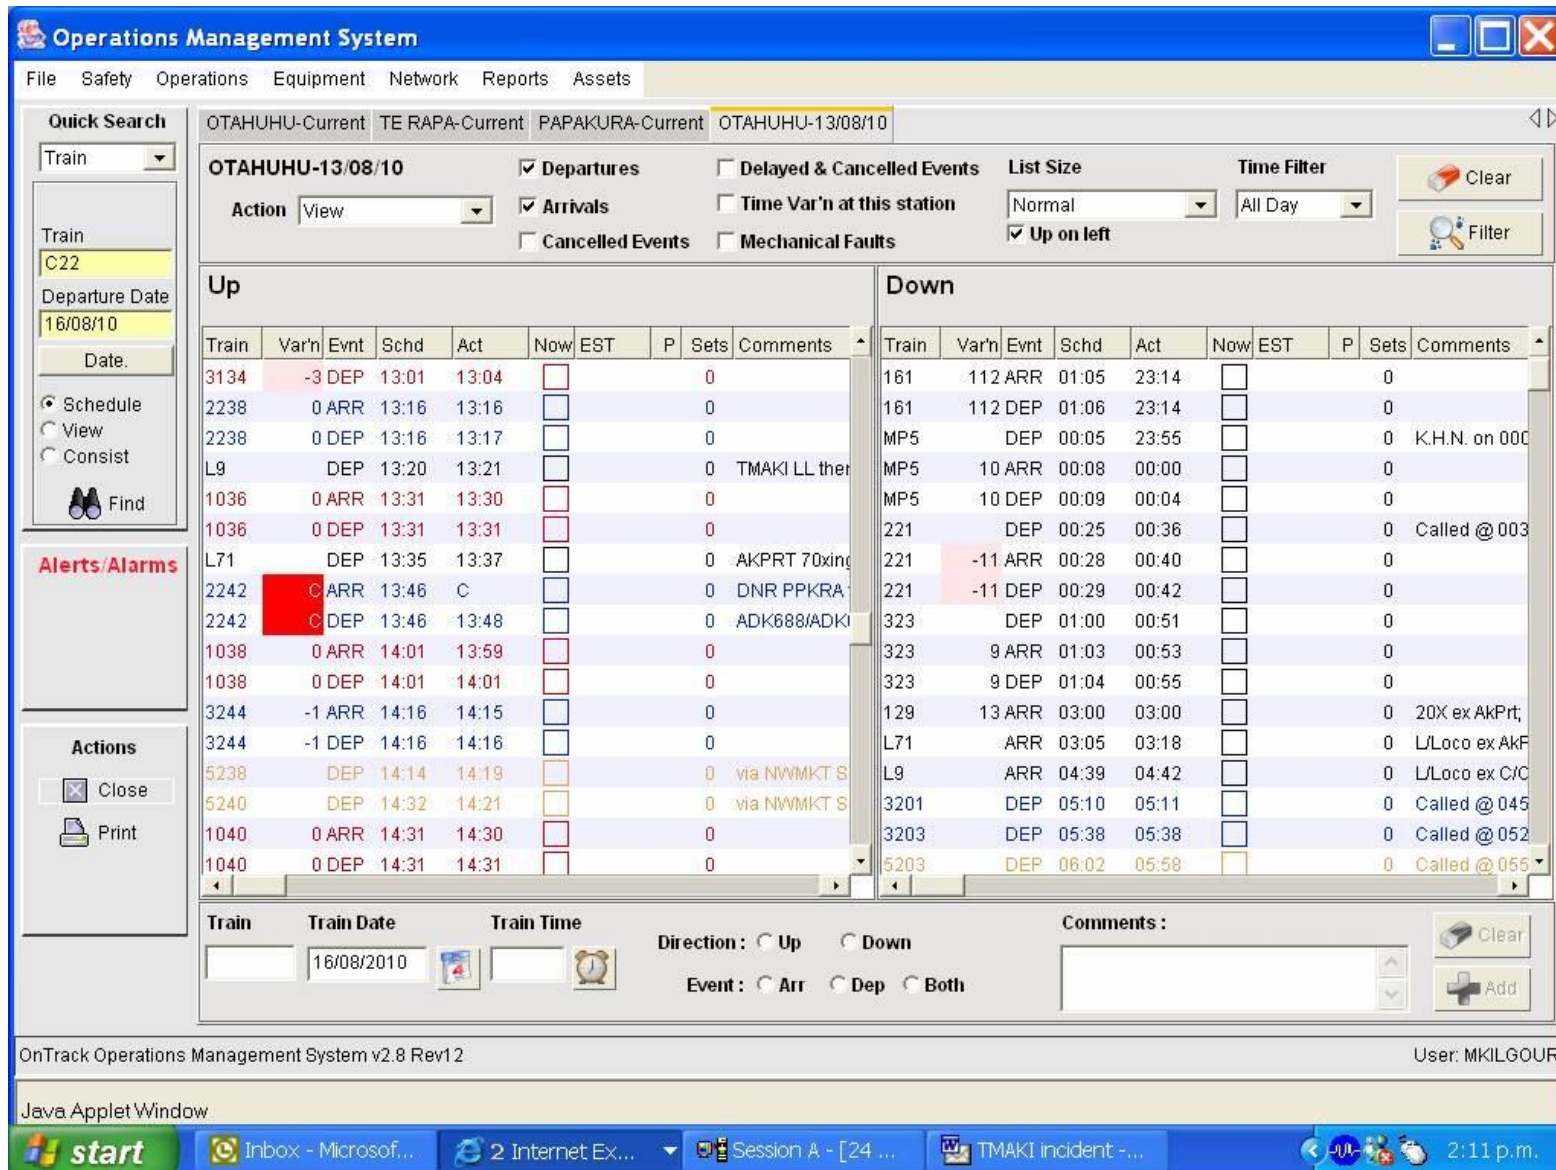
Figure 5
Signal box controller's train register display (example from Otahuhu)

- 3.4.5. The train register was pre-programmed with the published train timetable, but unscheduled services had to be entered manually at the time by the respective signal box controllers. Any person with access to the networked system could look at displays for other locations, but company policy was that signal box controllers were only able to enter data for their own locations. Train movements were automatically sorted on the train register display by the time for an event at the location. The user display was usually scrolled to display a window, with the current time near the top of the page and future times towards the bottom.

- 3.4.6. Tamaki was not set up with its own location display page, so standard practice was for the Auckland signal box controller to use the single Auckland display to log movements at both Tamaki and Britomart Stations. Tamaki movements would be separated from Britomart events by about 12 minutes' running time, and the signal box controller would add notes in the comments column of the Tamaki movements to note that they were not travelling the full line distance to Britomart.

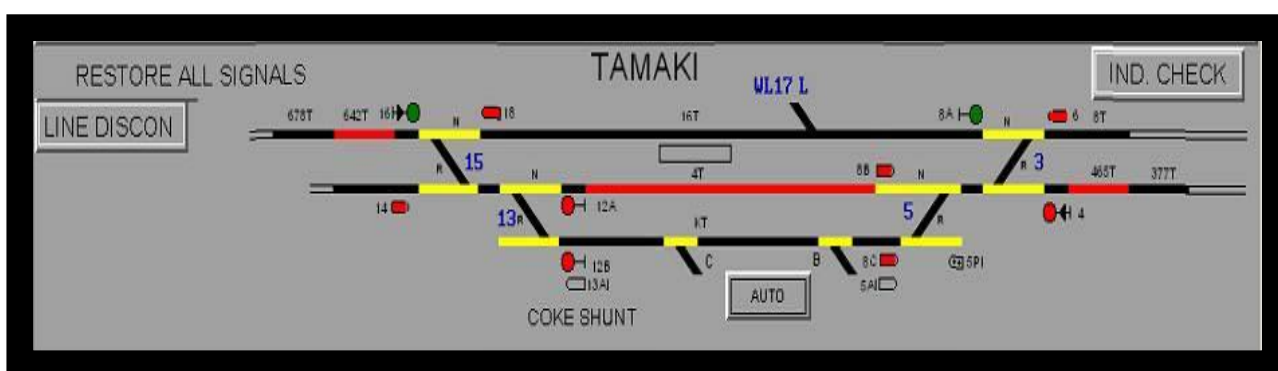
Figure 6
Tamaki mimic display

- 3.4.8. The mimic display showed the real-life status of points and signals and approximate train locations. The top horizontal line of the Tamaki mimic display (Figure 6) represents the Up Main line going from Westfield (left) to Britomart (right). The Down Main line going away from Britomart is the centre line and the Tamaki siding is the bottom line. The status of all points within station limits is shown by the yellow directional status lines, with the identifying numbers adjacent and letters identifying the normal (N) and reverse (R) positions. Signals are represented by the signal identification numbers and coloured symbols for the current status. The track segment is red when it is occupied by a train, but the length of the red segment is not relative to train length.

- 3.4.9. The status of the Tamaki mimic display shown in Figure 6 was the actual display after the passenger train had set back to clear Points No.3 on the day of this incident and after the SPAD. The shunt is the red line before Signal 16AC (labelled as 16) and the passenger train is within station limits on the Down Main line but clear of Signal 8B. A passenger train that was travelling from right to left is shown stopped before Signal 4 on the Down Main line. The points were in the normal position of straight through on the up and Down Main lines. The button at the bottom is the controller's Tamaki Station manual/automatic cursor control button shown in the manual control state (if the button was pressed the station would switch to auto).
