Inquiry 11-001: Bell Helicopter Textron 206L-3, ZK-ISF  
Ditching after engine power decrease, Bream Bay, Northland  
20 January 2011

Aviation inquiry 11-001  
Bell Helicopter Textron 206L-3, ZK-ISF  
Ditching after engine power decrease  
Bream Bay, Northland  
20 January 2011

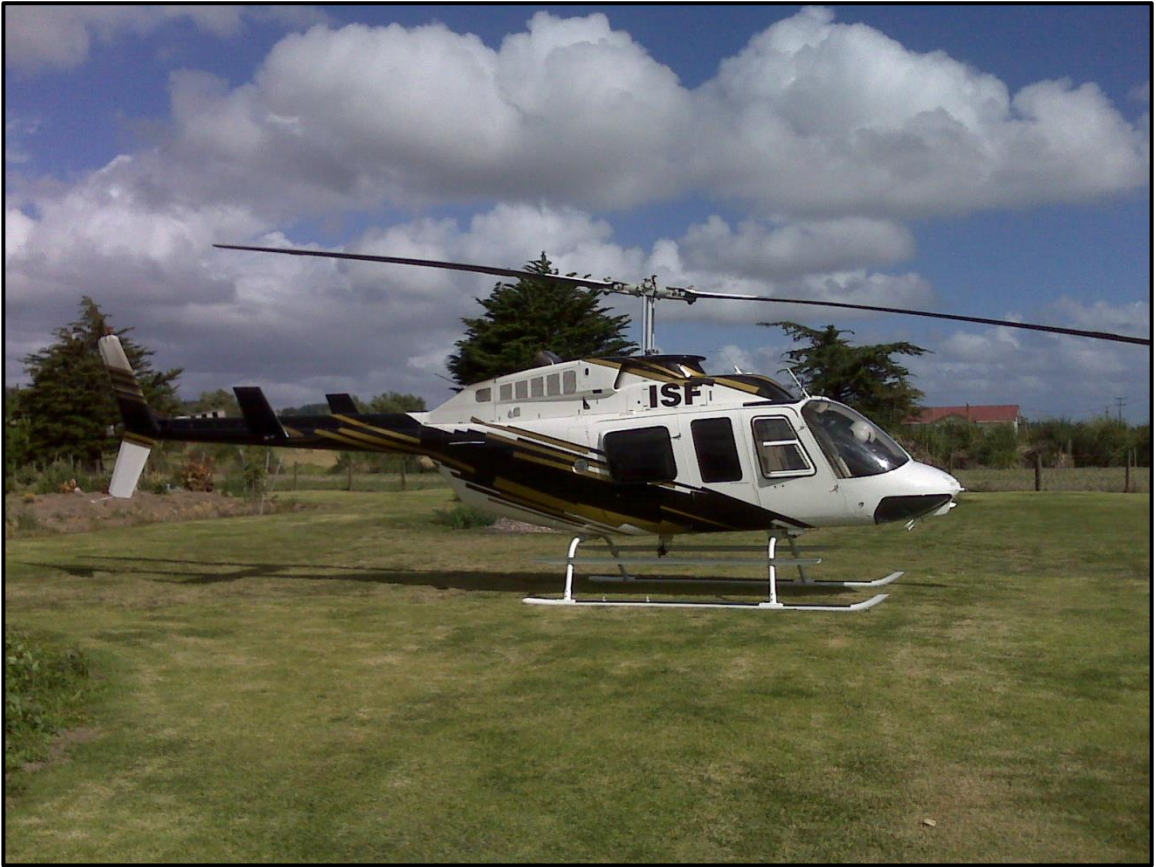
Bell 206L-3, ZK-ISF

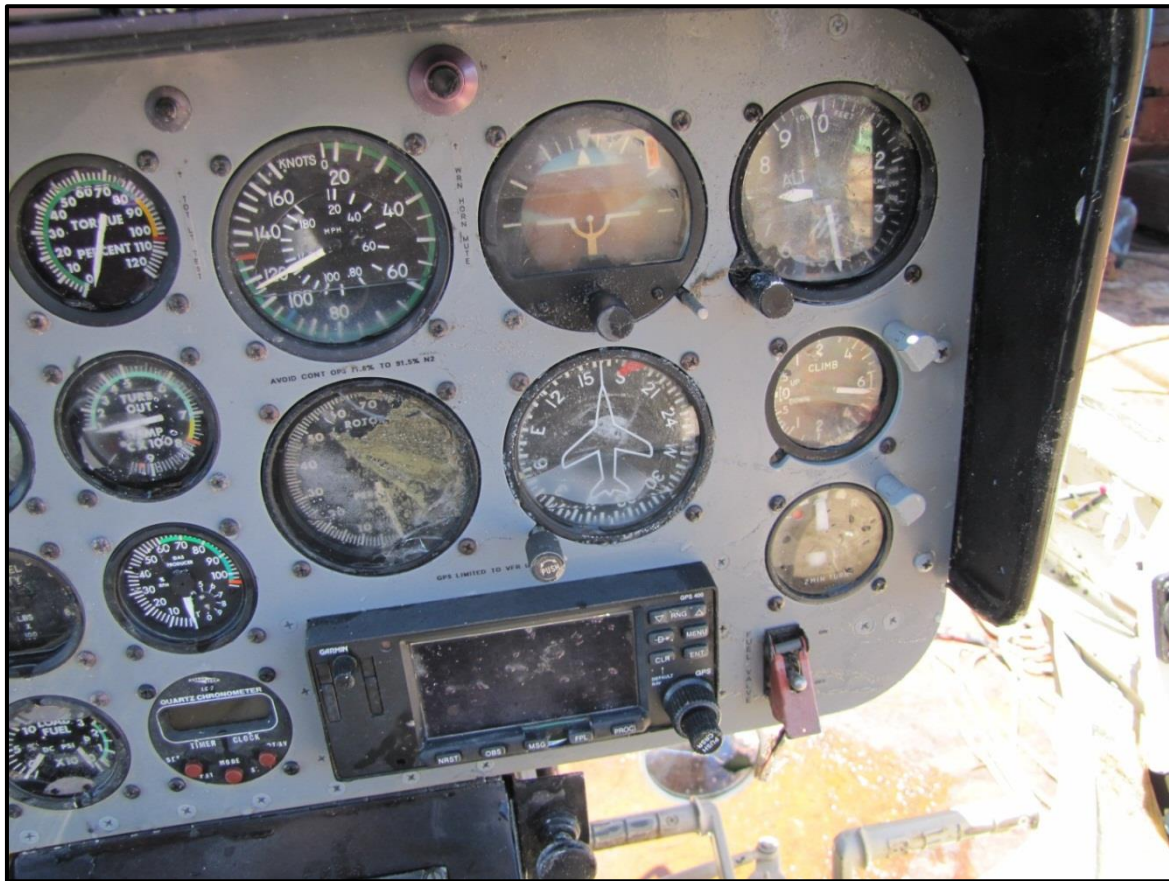
Figure 1  
Instrument panel in ZK-ISF

- 4.2.6 The pilot said that the ENG OUT and ROTOR LOW RPM warning lights did not illuminate, nor were there any aural warnings. The CAUTION circuit breaker, which protects these 2 systems, was found open after the accident, which could explain that. However, it is also common to find that circuit breakers have opened after an aircraft has sustained a substantial impact, and the main rotor striking the sea might have been of sufficient force to open circuit breakers. Although the pilot did not recall the N1, he did say that the engine had kept operating. If the N1 had remained above 55% the ENG OUT warning would not have been triggered. Similarly, the pilot had likely kept the  $N_R$  within the autorotation range, which would have avoided a ROTOR LOW RPM warning.

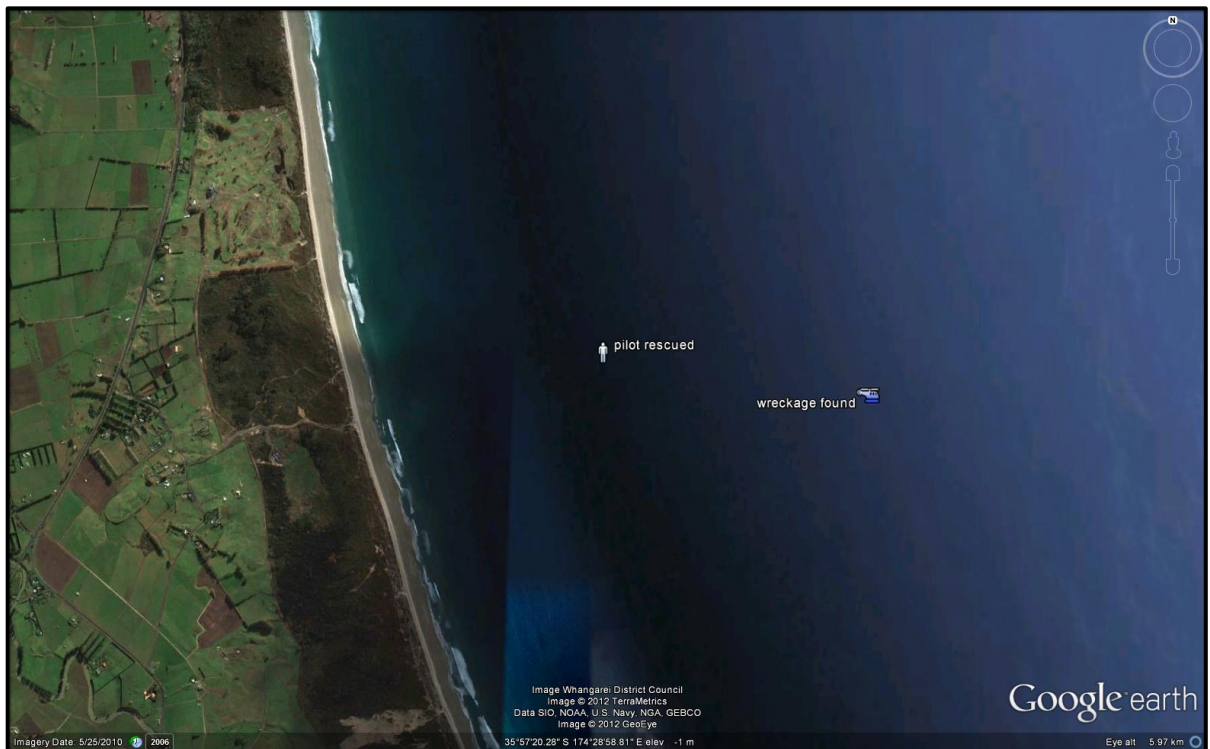
**Figure 2**  
Locations of accident and pilot's rescue

- 3.1.12. The accident happened on 20 January 2011 at, according to the pilot, about 1210. On 26 January a Navy dive team found the main wreckage at a depth of 19.5 m in position 35 degrees 57.42 minutes south, 174 degrees 29.98 minutes east. This position is almost 3 kilometres offshore and approximately 1600 m east of where the pilot was rescued (see Figure 4).

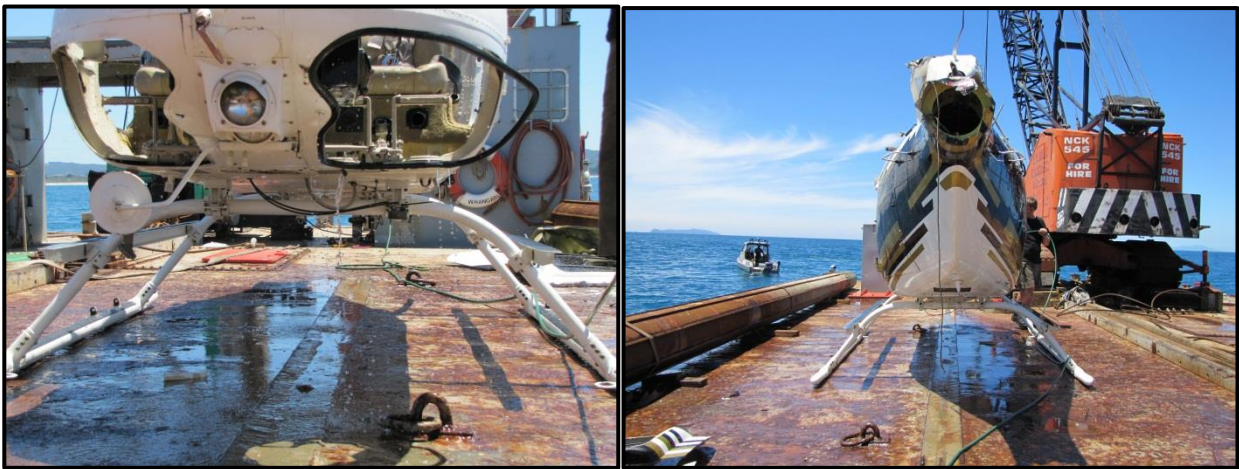
Figure 3  
Fuselage underside, after recovery

- 3.5.5 The lower fuselage and cabin sides were remarkably undamaged (see Figure 5), which indicated that the helicopter had entered the water with a low rate of descent. However, the disruption to the flight and engine controls caused when the engine and transmission broke free prevented a full determination of their continuity, proper functioning and positions before impact.
