Inquiry 11-002:  
Bombardier DHC-8-311, ZK-NEQ, landing without nose landing gear extended  
Woodbourne (Blenheim) Aerodrome, 9 February 2011

Aviation inquiry 11-002  
Bombardier DHC-8-311, ZK-NEQ  
Landing without nose landing gear extended  
Woodbourne (Blenheim) Aerodrome  
9 February 2011

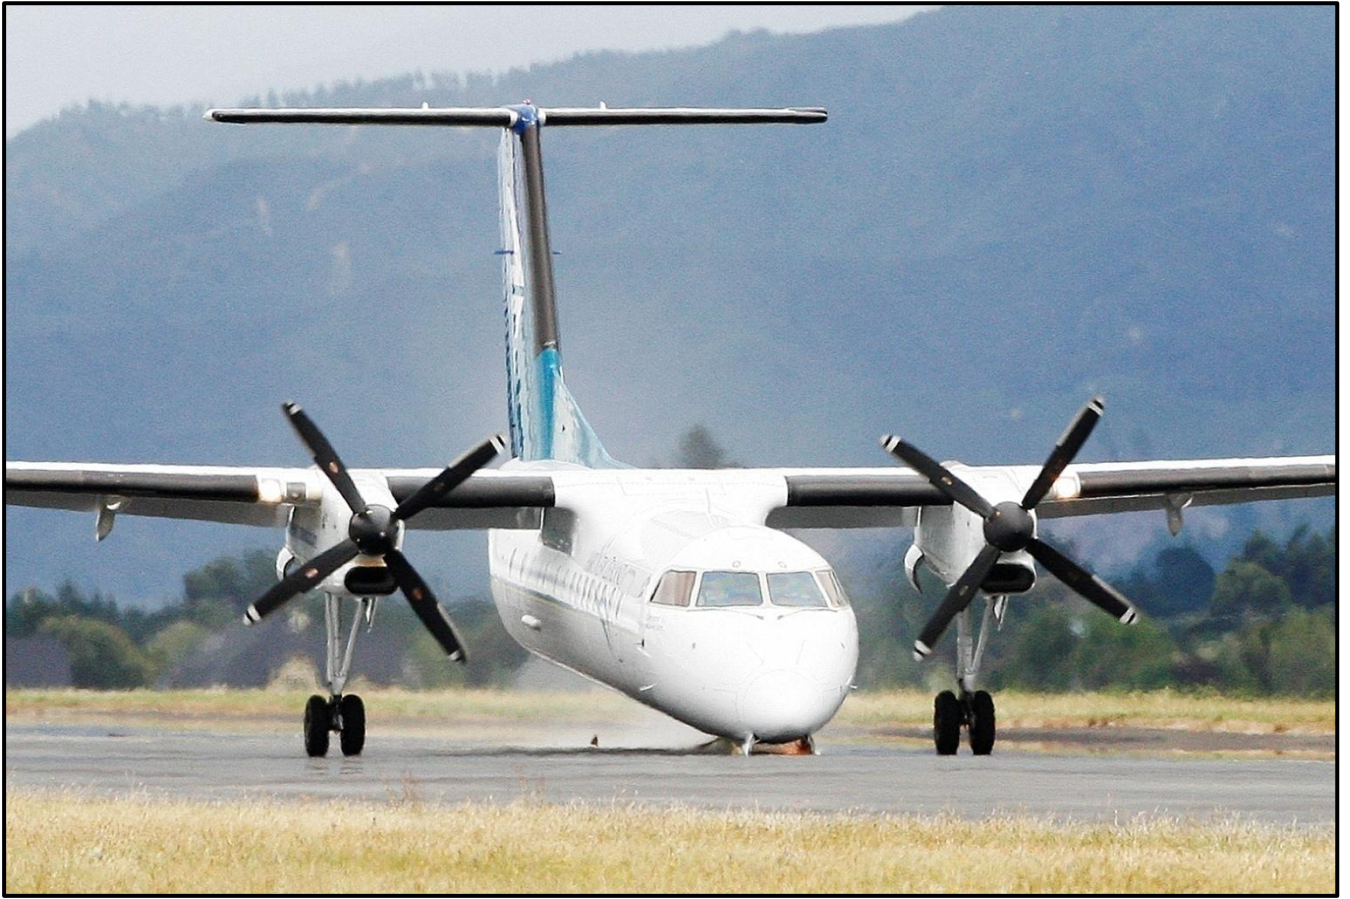
Bombardier DHC-8-311, ZK-NEQ landing at Woodbourne Aerodrome, 9 February 2011

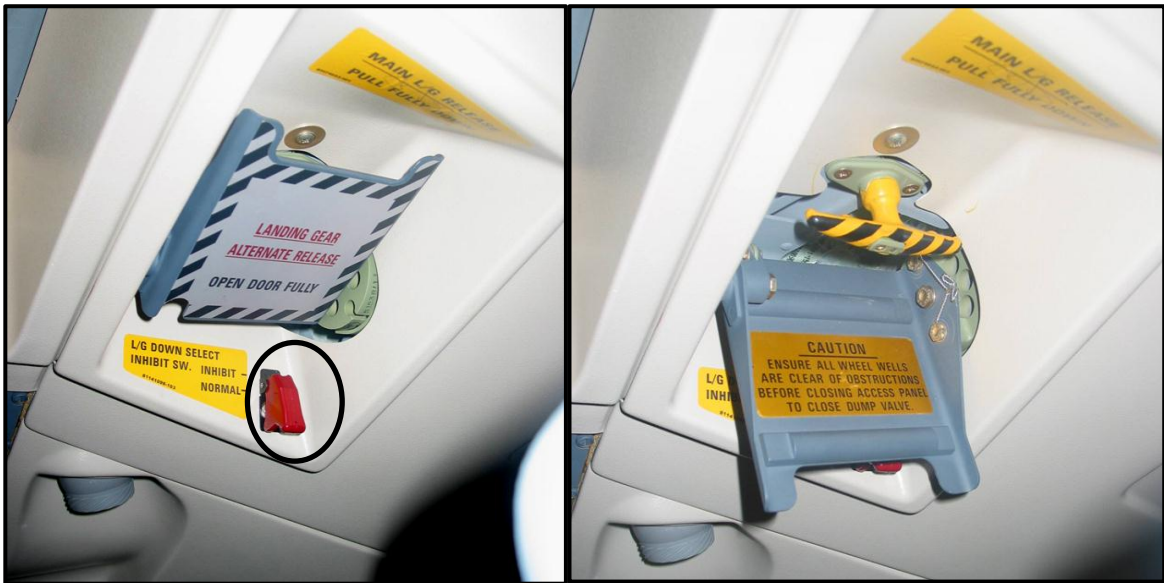
**Figure 1**  
 Landing gear alternate release door (above first officer's seat), with inhibit switch circled  
 (Photograph courtesy Air Nelson Limited)

- 3.2.10. A 2-position (NORMAL and INHIBIT) inhibit switch is located beside the alternate release door in the flight deck ceiling (see Figure 1).<sup>9</sup> The switch is used in the “Landing Gear INOP” procedure to prevent landing gear extension when a door might be closed or closing, and it can also be used to simulate a landing gear failure condition.

- 4.6. The nosewheel steering failure was caused by an intermittent defect in the inhibit switch. Although the switch was in the NORMAL position, the defect caused the landing gear extend solenoid to de-energise. Consequently the landing gear system hydraulic extend lines did not pressurise. The nosewheel steering system is pressurised by the extend line, which is why it stopped working.

A faulty inhibit switch caused the loss of nosewheel steering when the aircraft was departing from Hamilton.

The same faulty inhibit switch was the cause of the landing gear not extending normally when the aircraft was approaching Wellington.

- 4.9. Air Nelson considered the inhibit switch to have excellent reliability, and global data from Bombardier confirmed that. However, in order to reduce the chance of a similar defect causing multiple system failures, Bombardier promptly amended the Q300 Minimum Equipment List to require confirmation that hydraulic pressure was available for normal landing gear extension before an aeroplane may be dispatched with the nosewheel steering system inoperative.

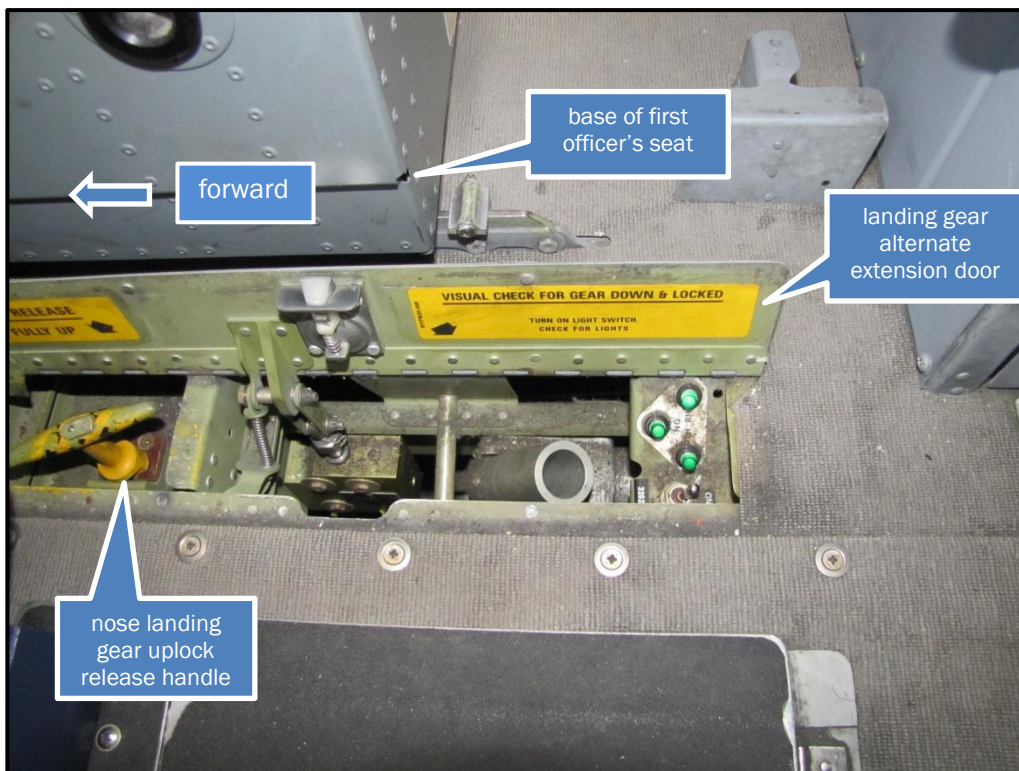
**Figure 2**  
 Landing gear alternate extension door and nose landing gear uplock release handle

- 4.12. If the uplock did not release either time that the first officer pulled the release handle, even though he was sure that he had pulled the handle hard enough, he must have been mistaken as to the force required. No other explanation was found for the nose landing gear not extending.

- 4.16. Following this accident Air Nelson amended its Q300 pilot training to recommend a 2-stage pull on the uplock release handle during an alternate extension procedure, a technique that the airline considered reduced the maximum force required. If pilots pause after releasing the door locks, then pull the handle hard and maintain the tension until the uplock releases, the alternate extension procedure should be successful.

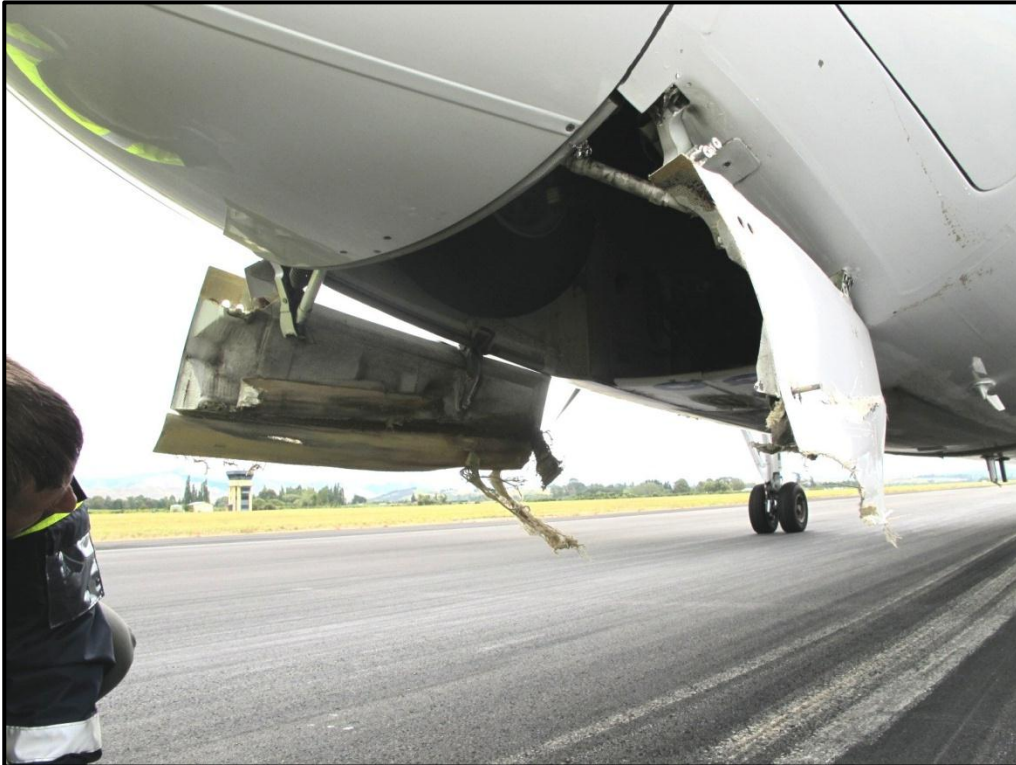
- 3.1.22. At about 1440 the aeroplane landed and the captain lowered the nose until the nose landing gear doors contacted the runway. The doors collapsed before the aeroplane came to a stop on the centreline. The pilots shut down the engines, turned off the electrical power and ordered a precautionary evacuation of the aeroplane. No-one was injured and there was no fire.

- 3.1.23. Damage was confined to the nose landing gear doors and surrounding structure, and 3 antennae on the lower fuselage (see Figure 3).

**Figure 3**  
**Damage to ZK-NEQ**
