Inquiry 11-005: Boeing 747, engine compressor surges  
18 September 2011

# Final Report

Aviation inquiry 11-005:  
Engine compressor surges  
18 September 2011

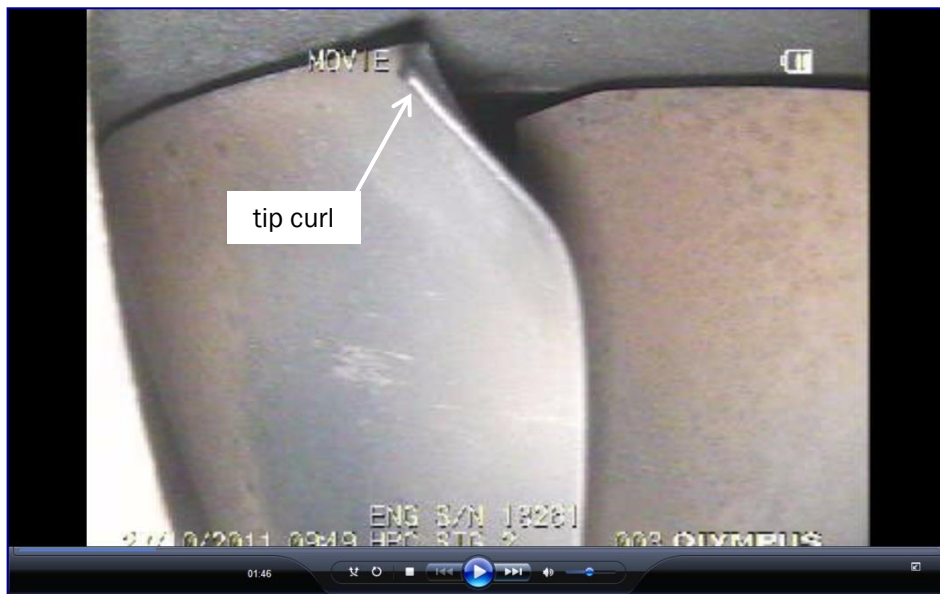
- 3.2.9. After the engine had been removed, a boroscope inspection showed that several high-pressure compressor stage 1 blades were bent and there was tip curl on 6 of the stage 2 blades. Sections of the high-pressure compressor case liner were also seen to be missing (see Figures 3 and 4). The amount missing was considered to be in keeping with the age of the engine, but not excessive.

**Figure 3**  
High-pressure compressor stage 2 tip curl

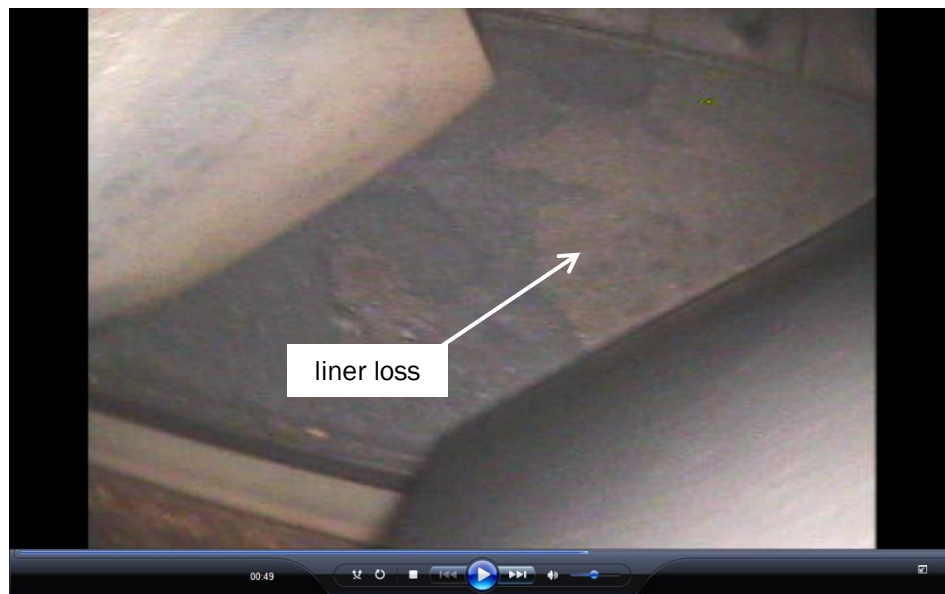
**Figure 4**  
High-pressure compressor stage 1 compressor lining

- 4.7. The San Francisco event was likely a result of environmental influences on a high-time but serviceable engine; similarly for the Auckland event. If the missing high-pressure compressor liner material had been lost during normal operations or as a consequence of the San Francisco event, the surge margin would have been reduced. The non-embodiment of the 'birdmouth' service bulletin could have reduced the margin further. However, because of the continued good EGT margin there was unlikely to have been any predictor of a surge or another problem that might have led to a surge.
