Inquiry 11-006: Britten-Norman BN.2A Mk.III-2, ZK-LGF, runway excursion  
Pauanui Beach Aerodrome, 22 October 2011

Aviation inquiry 11-006  
Britten-Norman BN.2A Mk.III-2, ZK-LGF  
runway excursion  
Pauanui Beach Aerodrome  
22 October 2011

Approved for publication: February 2014

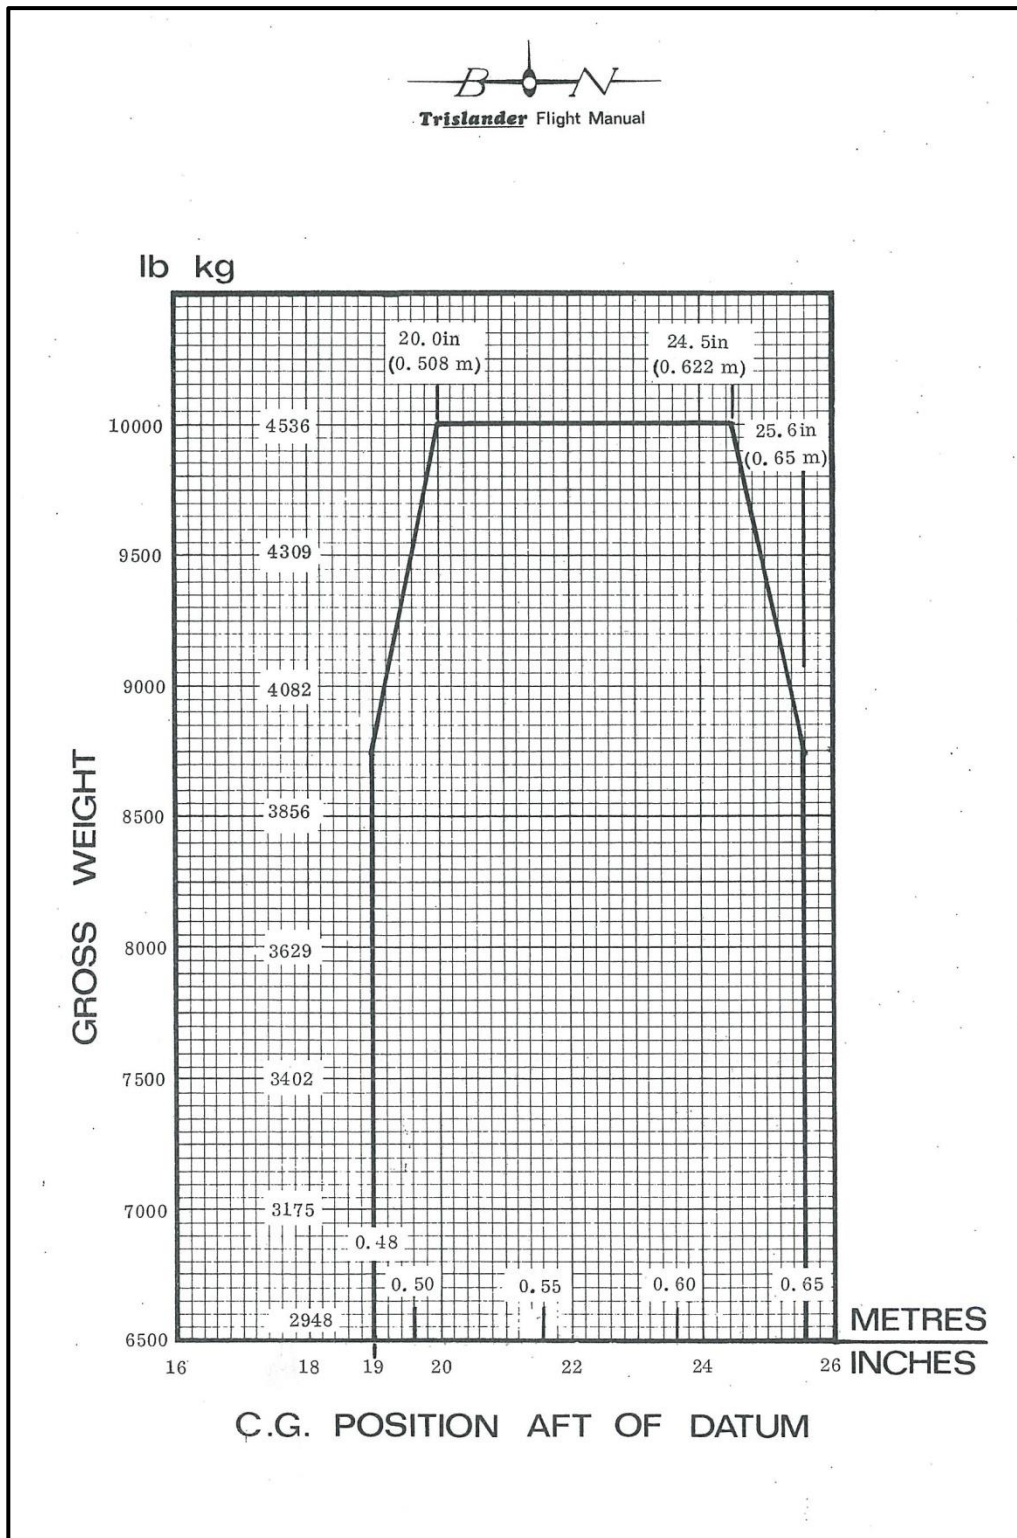
### Appendix 3: Trislander centre of gravity envelope.

1. The primary reason for the aeroplane's failure to take off was that its centre of gravity was well forward of the maximum permissible limit.
2. Neither the pilot nor Great Barrier Airlines had calculated the actual weight and balance of the aeroplane prior to the flight.
3. Great Barrier Airlines had not provided the portable scales that were necessary for the pilot to comply with the airline's procedures for determining the aeroplane weight and balance.
