Inquiry 11-102: Track occupation irregularity  
leading to near head-on collision  
Staircase-Craigieburn  
13 April 2011

Rail inquiry 11-102  
Track occupation irregularity leading to near head-on collision  
Staircase-Craigieburn  
13 April 2011

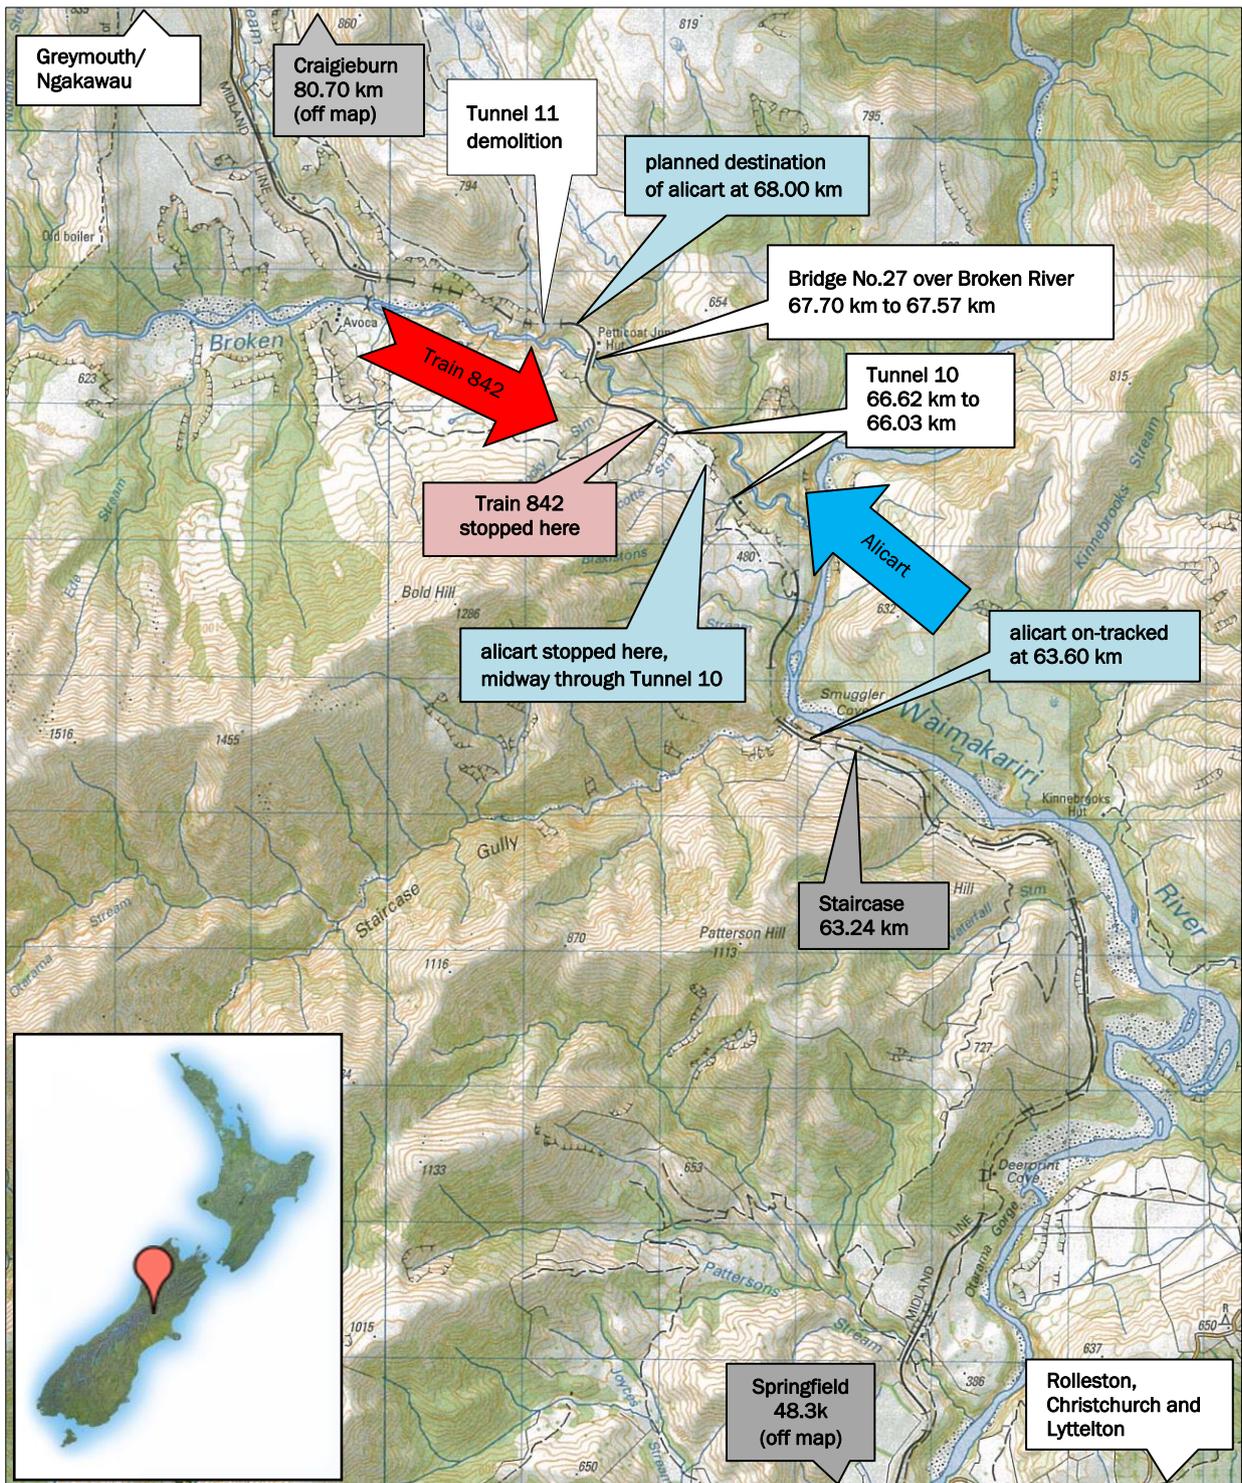
Journey of the loaded coal train and alicart

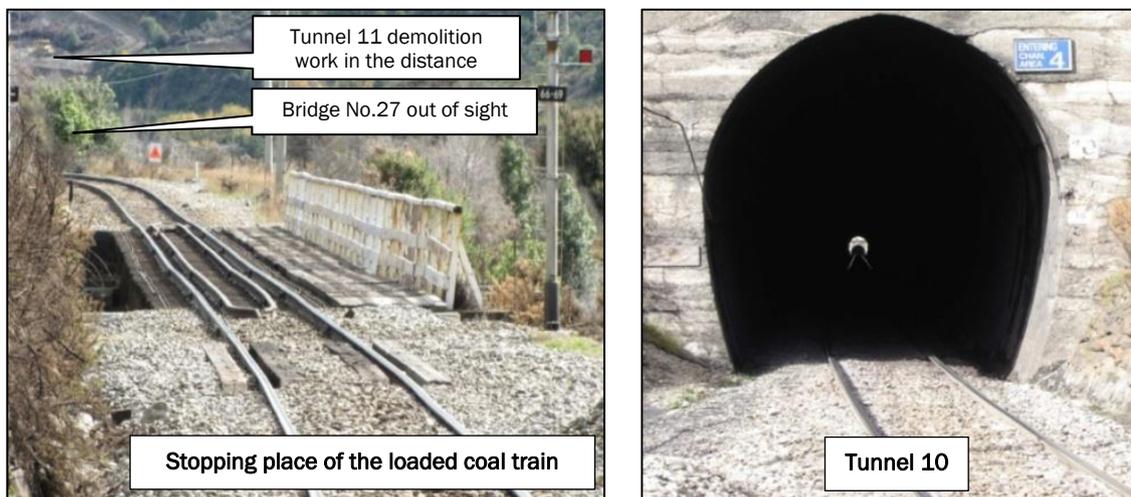
**Figure 1**  
**Near-collision site**

- 3.2.15. The structures inspector radioed train control twice to alert the train controller about the conflict, but he did not receive a response. He then selected the radio channel that the loaded coal train was on, called the driver and suggested that the driver stop his train. The driver complied, stopping the loaded coal train at 1202 about 60 metres from the entrance to Tunnel 10 (see Figure 1).

- 3.2.16. At this time the track engineer was about midway through the tunnel, but he stopped his alicart after seeing the train's headlights and hearing a long blast on the whistle. Shortly afterwards the track engineer slowly made his way towards the loaded coal train after realising that it was not moving. The track engineer then removed his alicart from the track and discussed the incident with the train driver after exiting the tunnel. They alerted train control to the incident, where a different train controller had taken over the merged desk following a shift change.

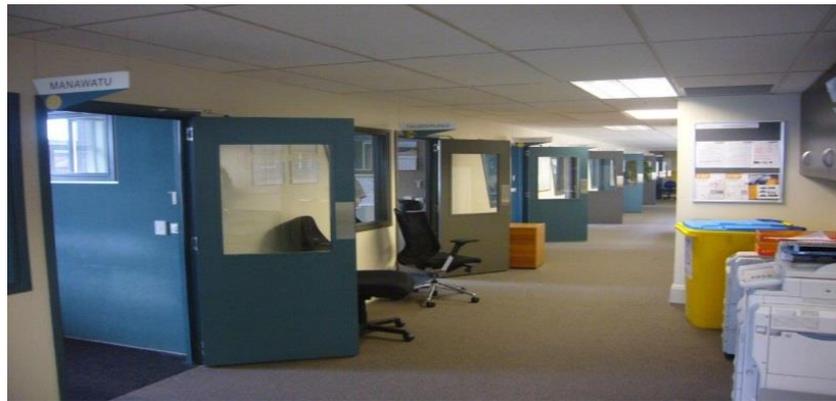
**Figure 2**  
**Photo of train control offices**

- 3.3.4. Train controllers generally work in separate rooms located side by side down a long corridor (see Figures 2 and 3). Each room has a door with a glass window. The wall in each room, which is adjacent to the corridor, has a large window, thereby enabling a person standing in the corridor directly outside a room to see a train controller at their desk. By comparison, train controllers controlling the Auckland metro area work in another room, which is open plan.

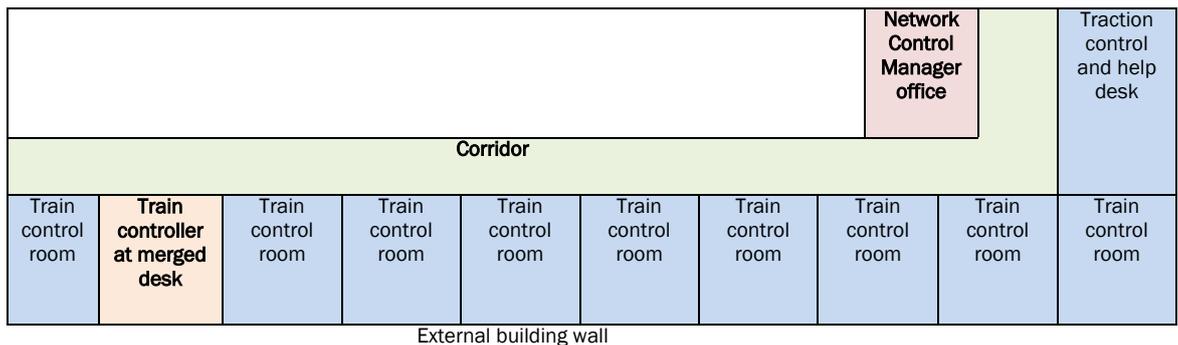
**Figure 3**  
**Floor plan for train control (not to scale)**

- 3.3.5. The train controller in this case was working in the second-to-last room at the end of the corridor on the day of the incident (see Figure 3). Her door was closed during her shift. The Network Control Manager's office was located at the opposite end of the corridor, away from the train controller.
