Report 11-104: Freight Train 261 collision with bus,
Beach Road level crossing, Paekakariki, 31 October 2011

Final Report

Rail inquiry 11-104
Freight Train 261 collision with bus,
Beach Road level crossing, Paekakariki
31 October 2011

Approved for publication: August 2012

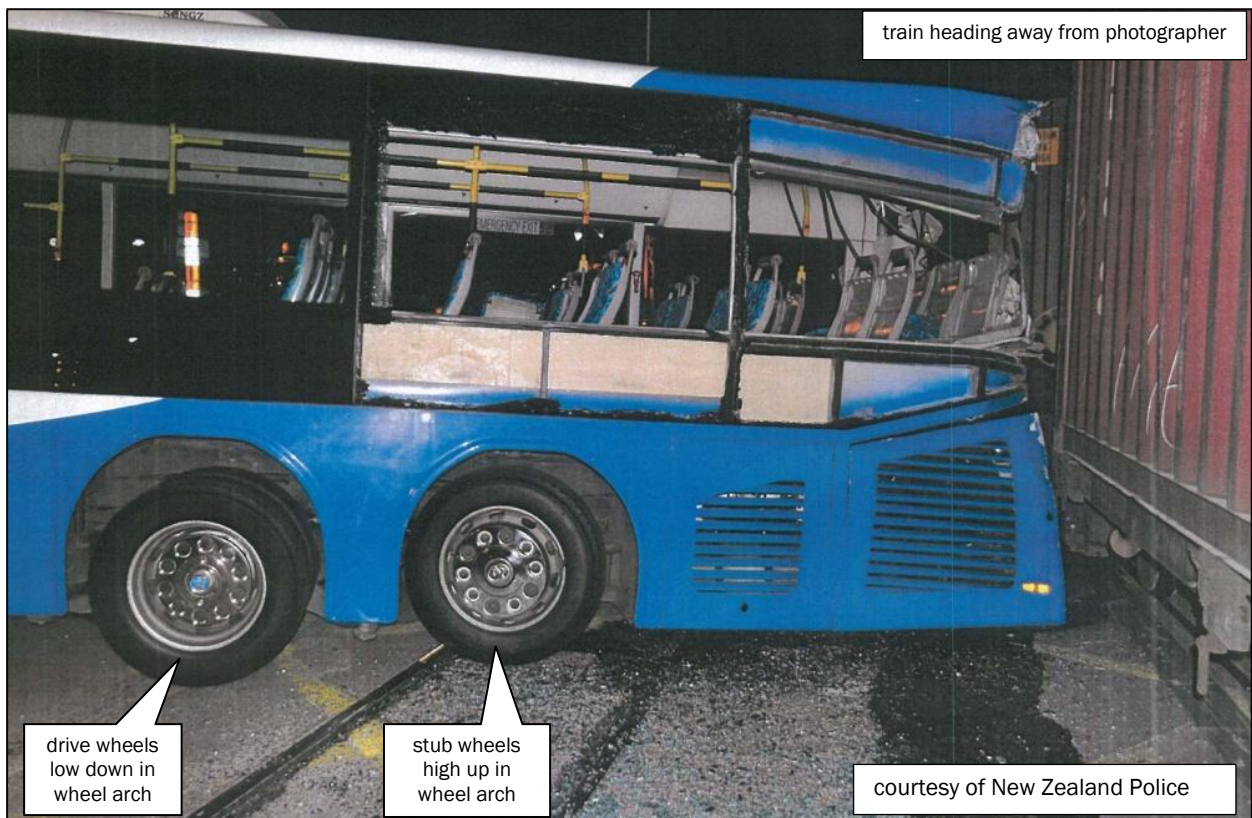
Figure 1
Photograph of the collision aftermath (looking south)

- 3.1.10. The level crossing comprised 3 sets of tracks: an Up main line, a Down main line and a Loop line. When the bus stopped, its back end encroached over the Loop line and the Down main line. The wheels of the stub axle were positioned on the Loop line and the drive axle was positioned over a covered drain on the outside of the Loop line (see Figures 1 and 2).

- 3.1.17. Train 261 collided with the empty bus 8 seconds later at a speed of 69 km/h. The train took 320 m to stop after the collision, with the second-to-last wagon standing adjacent to the bus. The train driver was showered with broken glass from the locomotive's windscreens, but he was not injured. Nobody from the bus was injured. The rear of the bus was shunted about one metre southwards and was extensively damaged. The train did not derail and damage to it was minor.

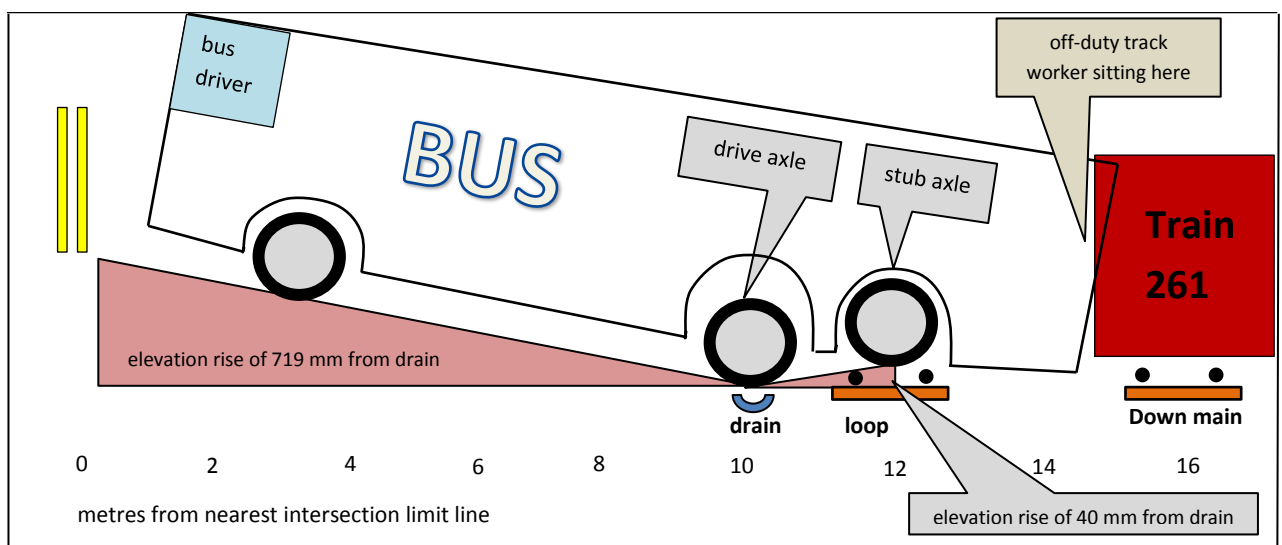
Figure 2
An elevation of the bus stopped over the level crossing (not to scale)

- 3.1.11. The drive axle was suspended from the bus under-frame, with the wheels having limited traction with the road surface.
- 3.1.12. The driver tried to drive the bus forward, but the driving wheels were spinning and the bus did not move. He tried to reverse the bus but it did not move then either. He left the bus to review his predicament. He was aware that his bus had encroached on the Down main line, but was not concerned because he assumed that no trains were running because his bus was replacing the train services.

- 4.2.6. In this case the profile of the road coming off the level crossing was not well suited to long and low road vehicles. Had this been considered as recommended in the Traffic Control Devices Manual, signage warning motorists should have been erected as a minimum. Both Tranz Metro, which specified the use of super-low-floor buses on the route, and the bus operator should have checked the route before operating buses on it.

The Commission recommends to the Chief Executive of the NZ Transport Agency that as a matter of urgency he address this safety issue (Recommendation 029/11).

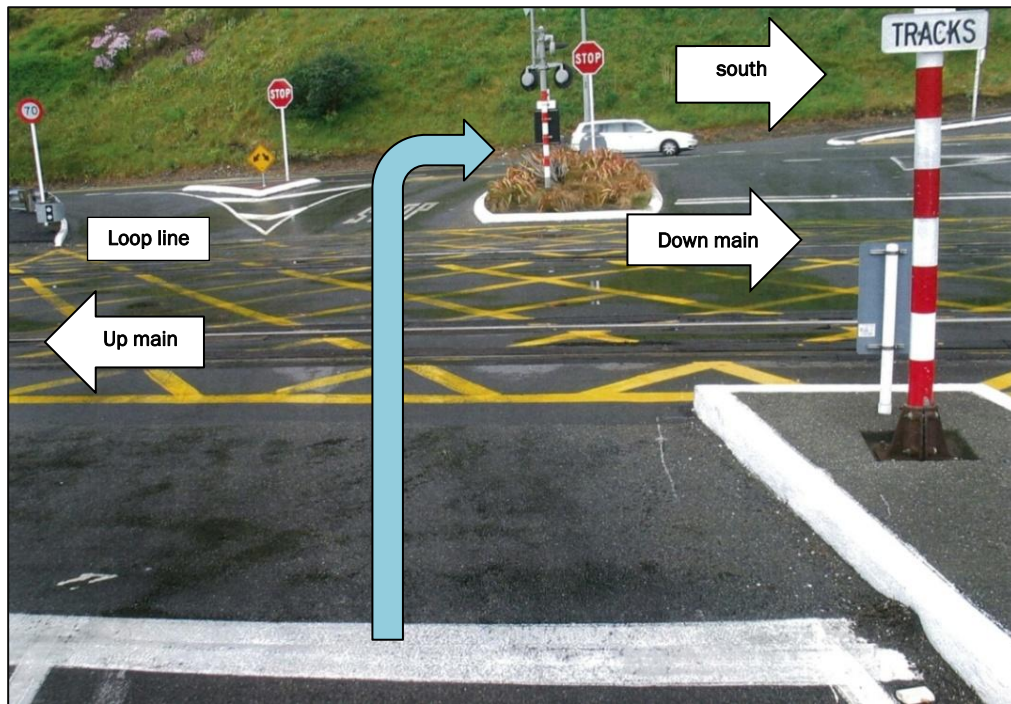
Figure 3
 Photograph showing the level crossing with the bus's intended movement shown in blue

- 3.1.21. The maximum speed of all trains travelling on the Up and Down main lines over the Beach Road level crossing was 70 km/h. The maximum train speed on the Loop line was 25 km/h. Road traffic on Beach Road was authorised to travel at up to 50 km/h.
- 3.1.22. Road traffic signage was erected to warn road users of the level crossing, but there was no signage to warn road users of the short stacking situation.

- 4.3.3. The bus was only 12.59 m long, whereas the maximum allowable length for a road vehicle is 20 m (25 m with a special permit). A 20 m vehicle would not be able to clear the Down main line when waiting at the stop markings on the road. Technically no vehicle over about 10 m could legally use the Beach Road intersection when turning right to State Highway 1. To do so would mean that either it could not stop at the stop sign or, if stopped, it would encroach on the rail corridor. This is a safety issue that the Commission has recommended that the Chief Executive of the NZ Transport Agency address (Recommendation 030/11).

The Commission recommends to the Chief Executive of the NZ Transport Agency that as a matter of urgency he address this safety issue (Recommendation O30/11).

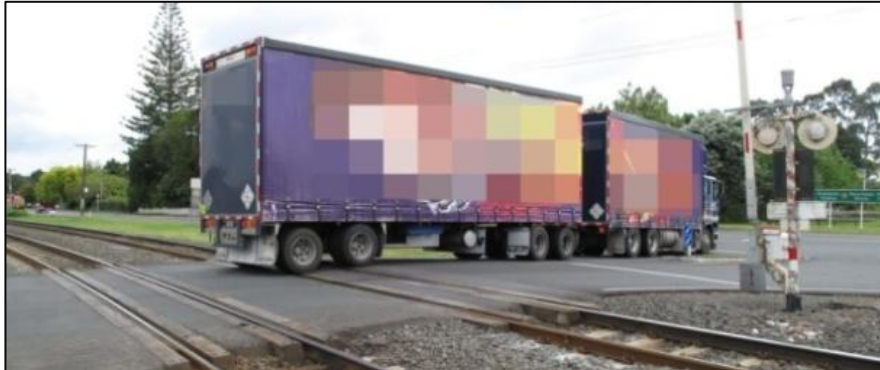
Figure 4
Photograph of a truck stopped over a level crossing in South Auckland

- 4.3.4. An example of a short stacking distance issue was witnessed by Commission investigators in South Auckland a few weeks after the collision at Paekakariki. In this instance the vehicle was stopped over a level crossing for some minutes while waiting to turn on to an adjacent provincial highway (see Figure 4). The rear trailer wheels were standing over a main line along which frequently timetabled Auckland metro passenger trains were authorised to travel at 100 km/h.

- 4.3.5. KiwiRail records show there are another 251 level crossings where there is an insufficient stacking distance to accommodate long road vehicles. This represents about 19% of all recorded level crossings. The level crossing shown in Figure 4 was one of those listed. The overall risk for each of the level crossings would depend on a number of factors, such as:

- 4.3.6. Generally, the longer a road vehicle, the heavier it is. A train colliding with a heavy vehicle is a serious safety issue. Not only are the occupants of the road vehicle at risk, so too is the train crew because the potential for damaging or derailing a train is higher. The Commission has issued an urgent recommendation to the Chief Executive of the NZ Transport Agency to address the stacking distance issues at these other identified level crossings (Recommendation O31/11).

The Commission recommends to the Chief Executive of the NZ Transport Agency that as a matter of urgency he address this safety issue. (Recommendation O31/11)
