Inquiry AO-2012-002: Airbus A320 ZK-OJQ, Bird strike and subsequent engine failure,
Wellington and Auckland International Airports, 20 June 2012

Final Report

Aviation inquiry 12-002
Airbus A320 ZK-OJQ
Bird strike and subsequent engine failure
Wellington and Auckland International Airports
20 June 2012

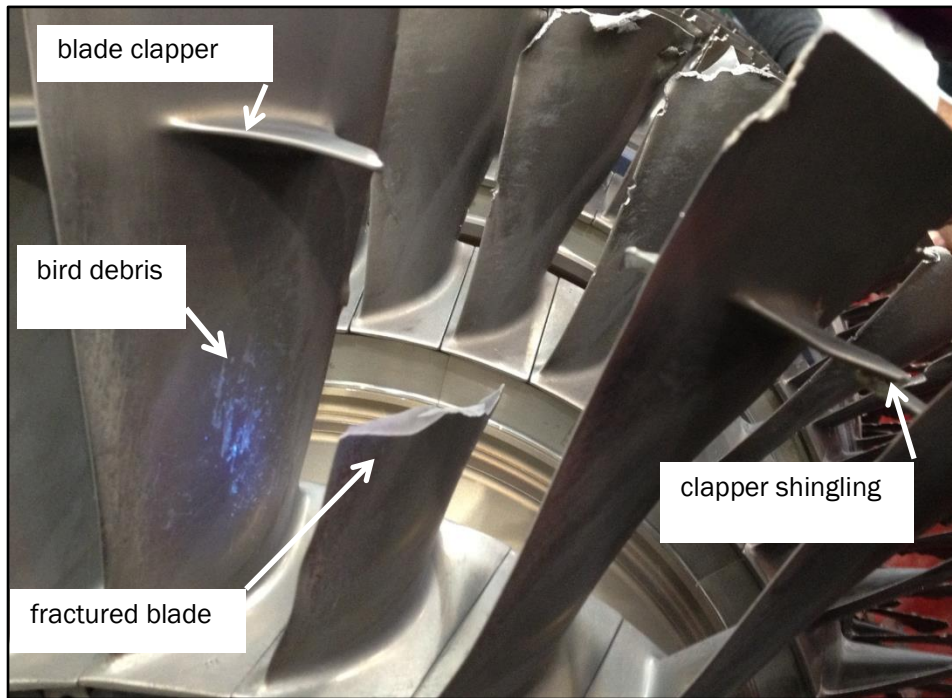
- 3.2.4. One third-stage compressor blade was found fractured and the adjacent blades had soft body impact damage typical of a bird strike. A piece of the fractured blade that was found in the 3-8 rotor drum showed signs of soft impact damage to the leading edge. Extensive hard body impact damage caused by the released blade was evident on all stages downstream of stage 3.

Figure 1
Fractured third-stage blade and an example of clapper shingling

- 4.2.2. The ingestion of the bird into the core of the engine forced the blades out of alignment, causing blade movement during the flight to Auckland. This movement resulted in the clappers¹⁷ shingling¹⁸ and a crack forming and growing under the stresses present. Eventually the crack ruptured and the blade separated, causing the engine surge. It is also possible that because of the disrupted airflow from the then excessive blade movement and shingling, the engine surged, causing the section of blade to rupture and separate. Regardless of the final sequence of events, the initiator was the bird strike and the resulting soft impact damage.

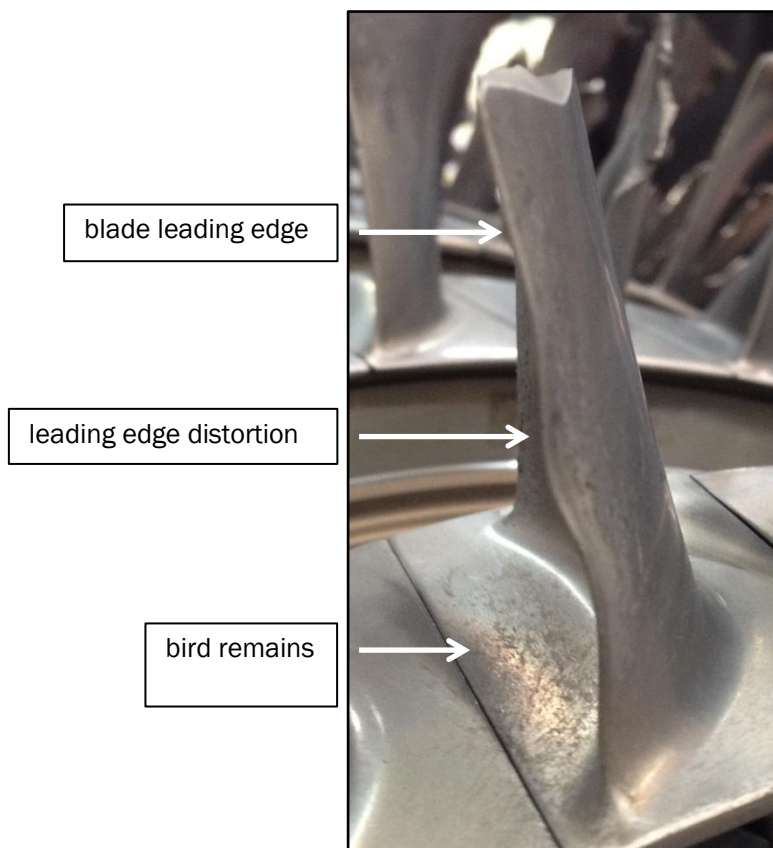
Figure 2
Fractured third-stage blade showing soft body impact damage to the leading edge

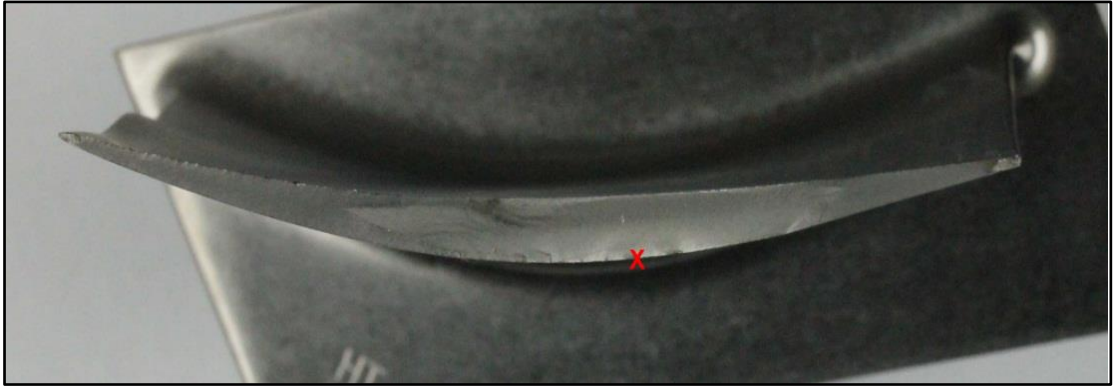
Figure 3
Crack initiation x

- 3.2.5. All 31 of the third-stage high-pressure-compressor blades and the fractured piece of blade were removed and sent to an approved laboratory for further analysis. The fractured blade displayed high-cycle-fatigue crack growth (propagation) followed by aerofoil liberation. High-cycle-fatigue crack growth is caused by stresses placed on the blade during in-service vibrations. The crack originated from the mid chord on the suction side (convex) of the blade about 43 millimetres above the platform and 23 millimetres from the blade leading edge.
