Report RO-2012-102:  
Train control power failure, 26 April 2012

Rail inquiry RO-2012-102  
Train control power failure, 26 April 2012

Approved for publication: October 2014

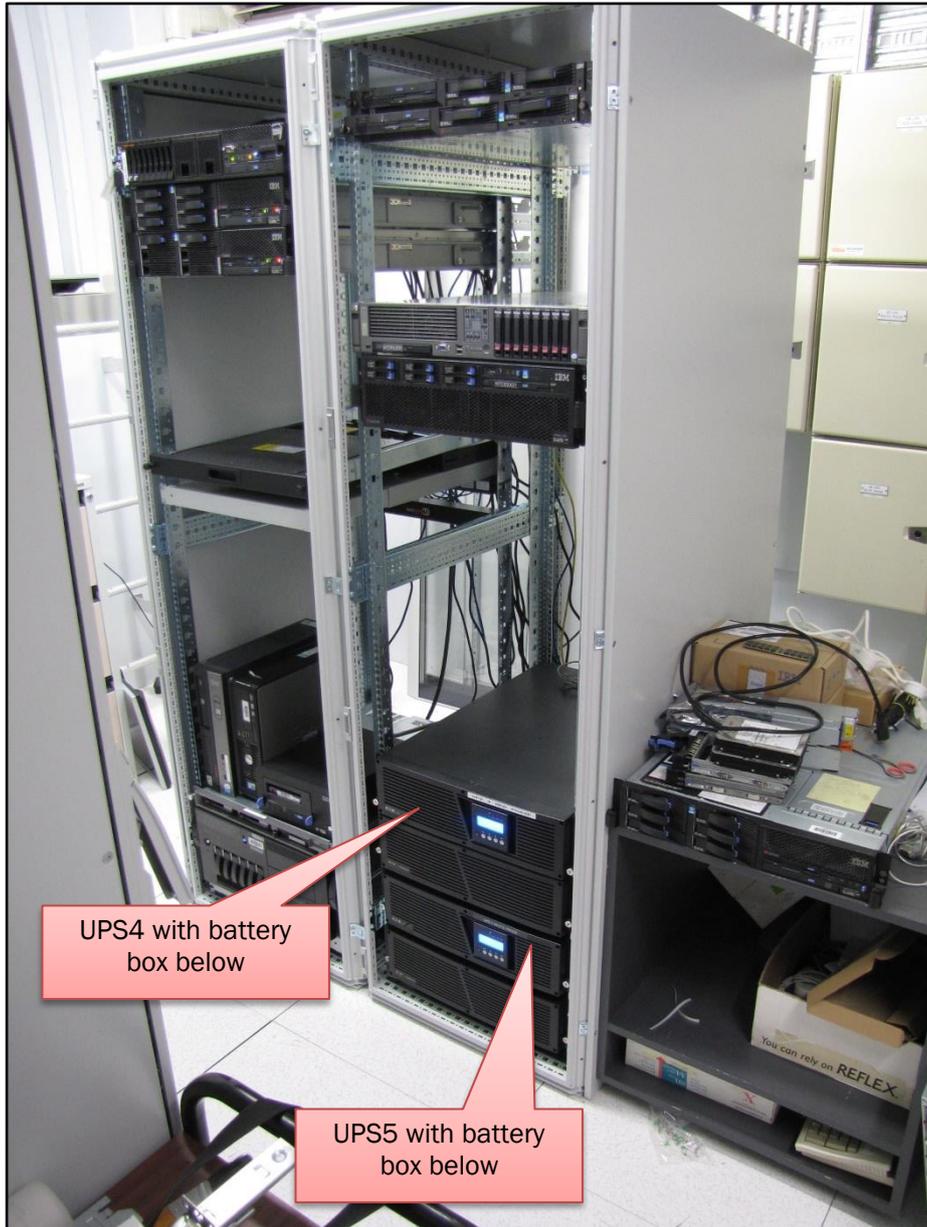
UPS4 with battery box below

UPS5 with battery box below

- 6.2. KiwiRail took immediate action to investigate and rectify the deficiencies described in this report. Some of the critical points that were corrected were:
- UPS circuit breaker discrimination has been improved for UPS4 and UPS5
  - UPS output load diversity in the Auckland control room and the traction control room has been improved
  - all UPS alarms are now remotely monitored
  - as-built drawings and manuals have been provided and are held on site
  - technician training on the UPS has been completed
  - the emergency power supply system is regularly tested
  - all train control power supply outlets have been audited to ensure loads are connected to the right type of supply
  - management control processes are in place to manage new appliance loads in train control.

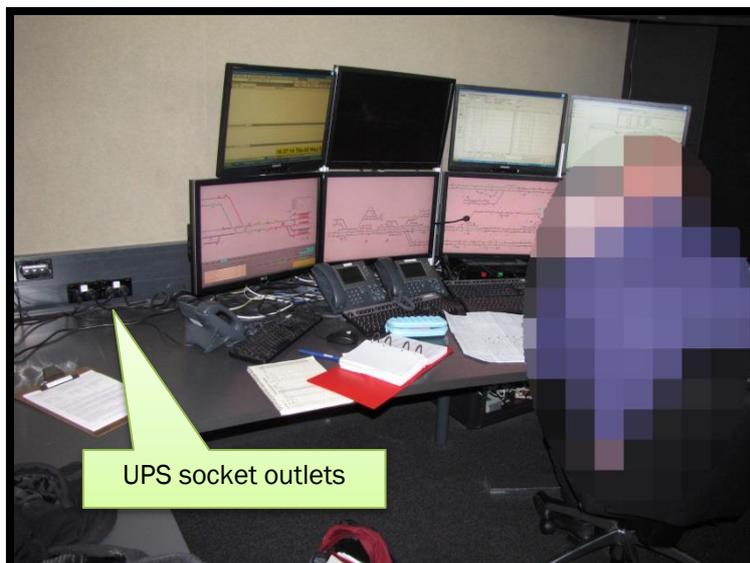
**Figure 1**  
Photograph showing typical train controller workstation at train control

3.2.3. Each train controller workstation has multiple computers and monitors and associated radio and telephone communication systems (see Figure 1).

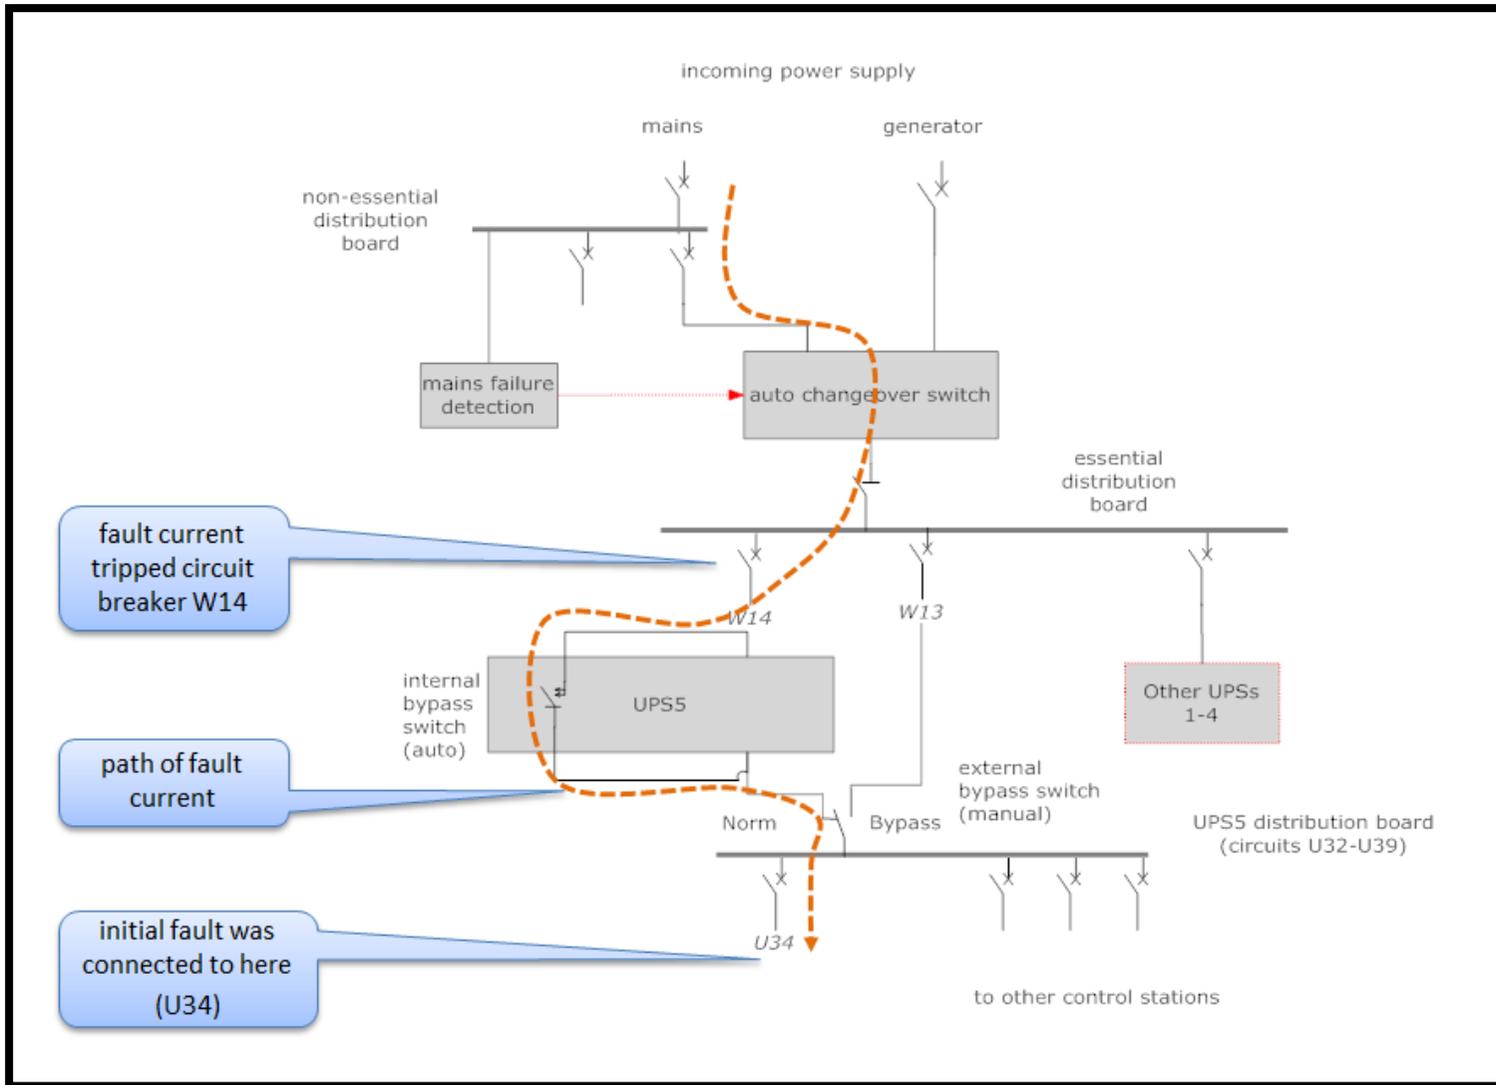
Figure 2  
Single line power schematic of train control

- 4.2.1. Figure 2 is a simplified schematic of the emergency power distribution system for Wellington train control. The train control workstations were considered by KiwiRail to be “essential services”. For this reason a generator was provided as an automatic back-up if the external mains power to the entire building were lost. However, in this case there was no loss of external mains power to the building. Instead, the loss of power affected only the Auckland control room within the building, so the back-up generator was not required and did not start.

- 4.2.2. Five uninterruptable power supply (UPS) devices were installed in the emergency power distribution system to ensure a constant power supply to the train control workstations. If the mains power supply failed, or was interrupted for any reason, a battery within each UPS continued to supply power to the wall socket into which the various computers and screens making up the workstation were plugged.

- 4.2.4. When the fault developed in one of the multi-boxes, or in a device that was plugged into the multi-box, this should have tripped the closest protection device to that fault (circuit breaker U34). Had this occurred, only one of the four Auckland workstations would have been lost. Instead, the next protection device up the line (circuit breaker W14) tripped first, which caused a loss of power to all four Auckland workstations.

- 4.2.7. The UPS manufacturer’s installation manual recommended that the input circuit breaker (W14) have a 32-amp rating but with a D-type trip curve. It also recommended that the UPS output distribution circuit breakers (U34) have six-amp ratings with C-type trip curves. Instead, both circuit breakers were installed with C-type trip curves. W14 was rated at 32 amps but circuit breaker U34 had a 20-amp rating instead of the recommended six-amp rating. Without the appropriate discrimination between the two circuit breakers, after a period of less than one second from the initial fault occurring circuit breaker W14 tripped, causing the loss of power to all four Auckland workstations.

- 4.3.9. The result was that all four of the Auckland train controller workstations were connected to the same UPS, creating a single point of failure for Auckland's train control, thus not achieving an appropriate level of redundancy for such an essential service.

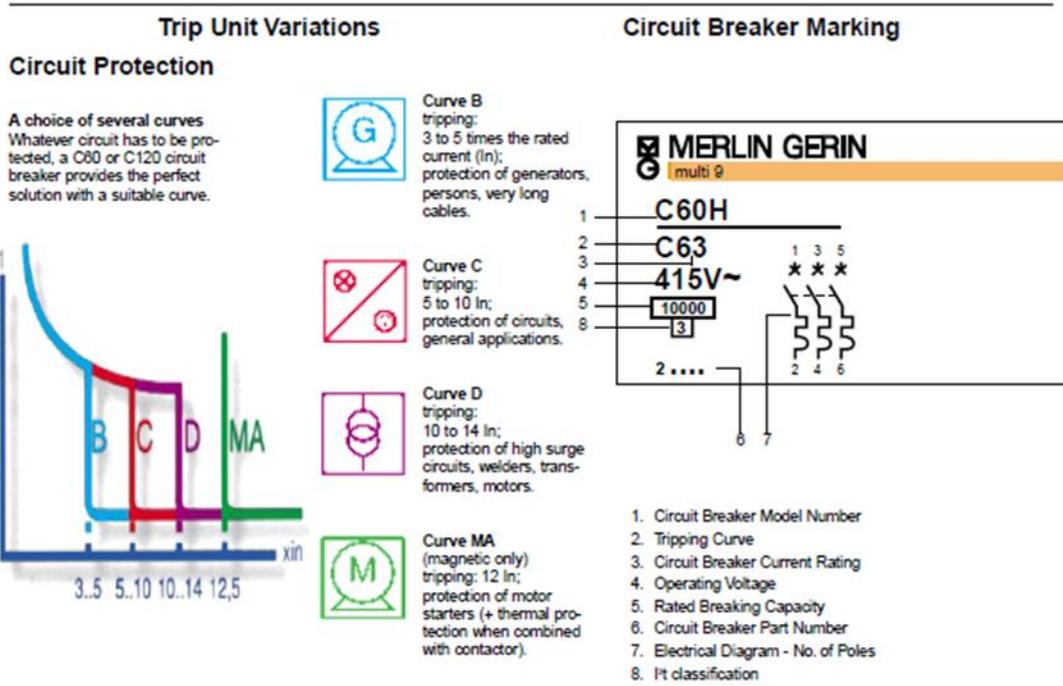
Merlin Gerin Multi 9 System  
 Miniature circuit breakers  
 Tripping curves  
 Markings & limitation capability

An electrical designer usually selects protection devices with trip curves that ensure that although multiple protection devices may “see” a fault current pass through them, only the one closest to the fault will trip. That is, the protection devices will discriminate on which one should trip first. If this does not occur, the fault current will escalate and may eventually trip a protection device further upstream towards the power source or cause damage to the installation. If the upstream protection device trips instead, a wider area is affected by the power loss.
