Inquiry 12-201:  
Fishing vessel Easy Rider, capsize and foundering,  
Foveaux Strait, 15 March 2012

Marine inquiry 12-201

Fishing vessel *Easy Rider*, capsized and foundering, Foveaux Strait,  
15 March 2012

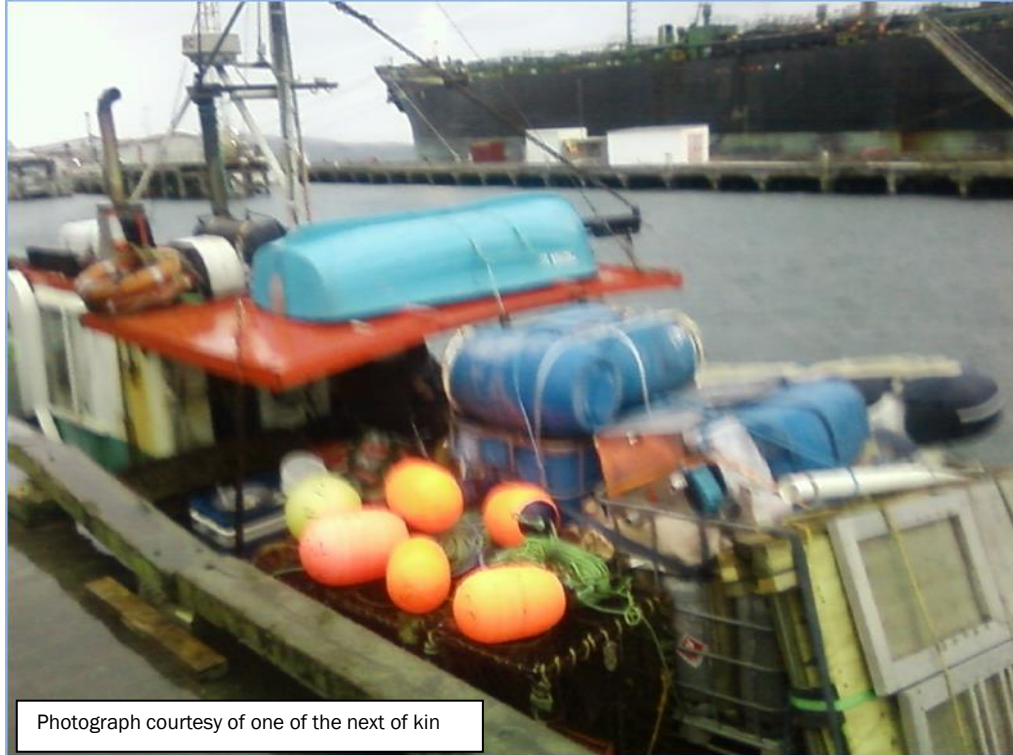
**Figure 2**  
**The *Easy Rider* loading alongside in Bluff before departure**

- 3.1.8. An observer on the opposite quay noted that as the equipment and stores were loaded the vessel sat lower in the water towards the stern. Towards the end of the loading a quantity of wood was lifted from the truck and lowered, by crane, to one side of the vessel. However, the vessel listed heavily to that side, so the wood was lifted clear then lowered to sit transversely across the vessel at the stern (see Figure 2).

- 3.1.11. At about 2000 the *Easy Rider* departed. On board were the skipper, 2 crew members and 6 passengers. As the vessel manoeuvred away from the wharf, an observer on the opposite quay noted that the sea water was sloshing onto the after-deck and draining out of the aft-most freeing ports<sup>2</sup>.

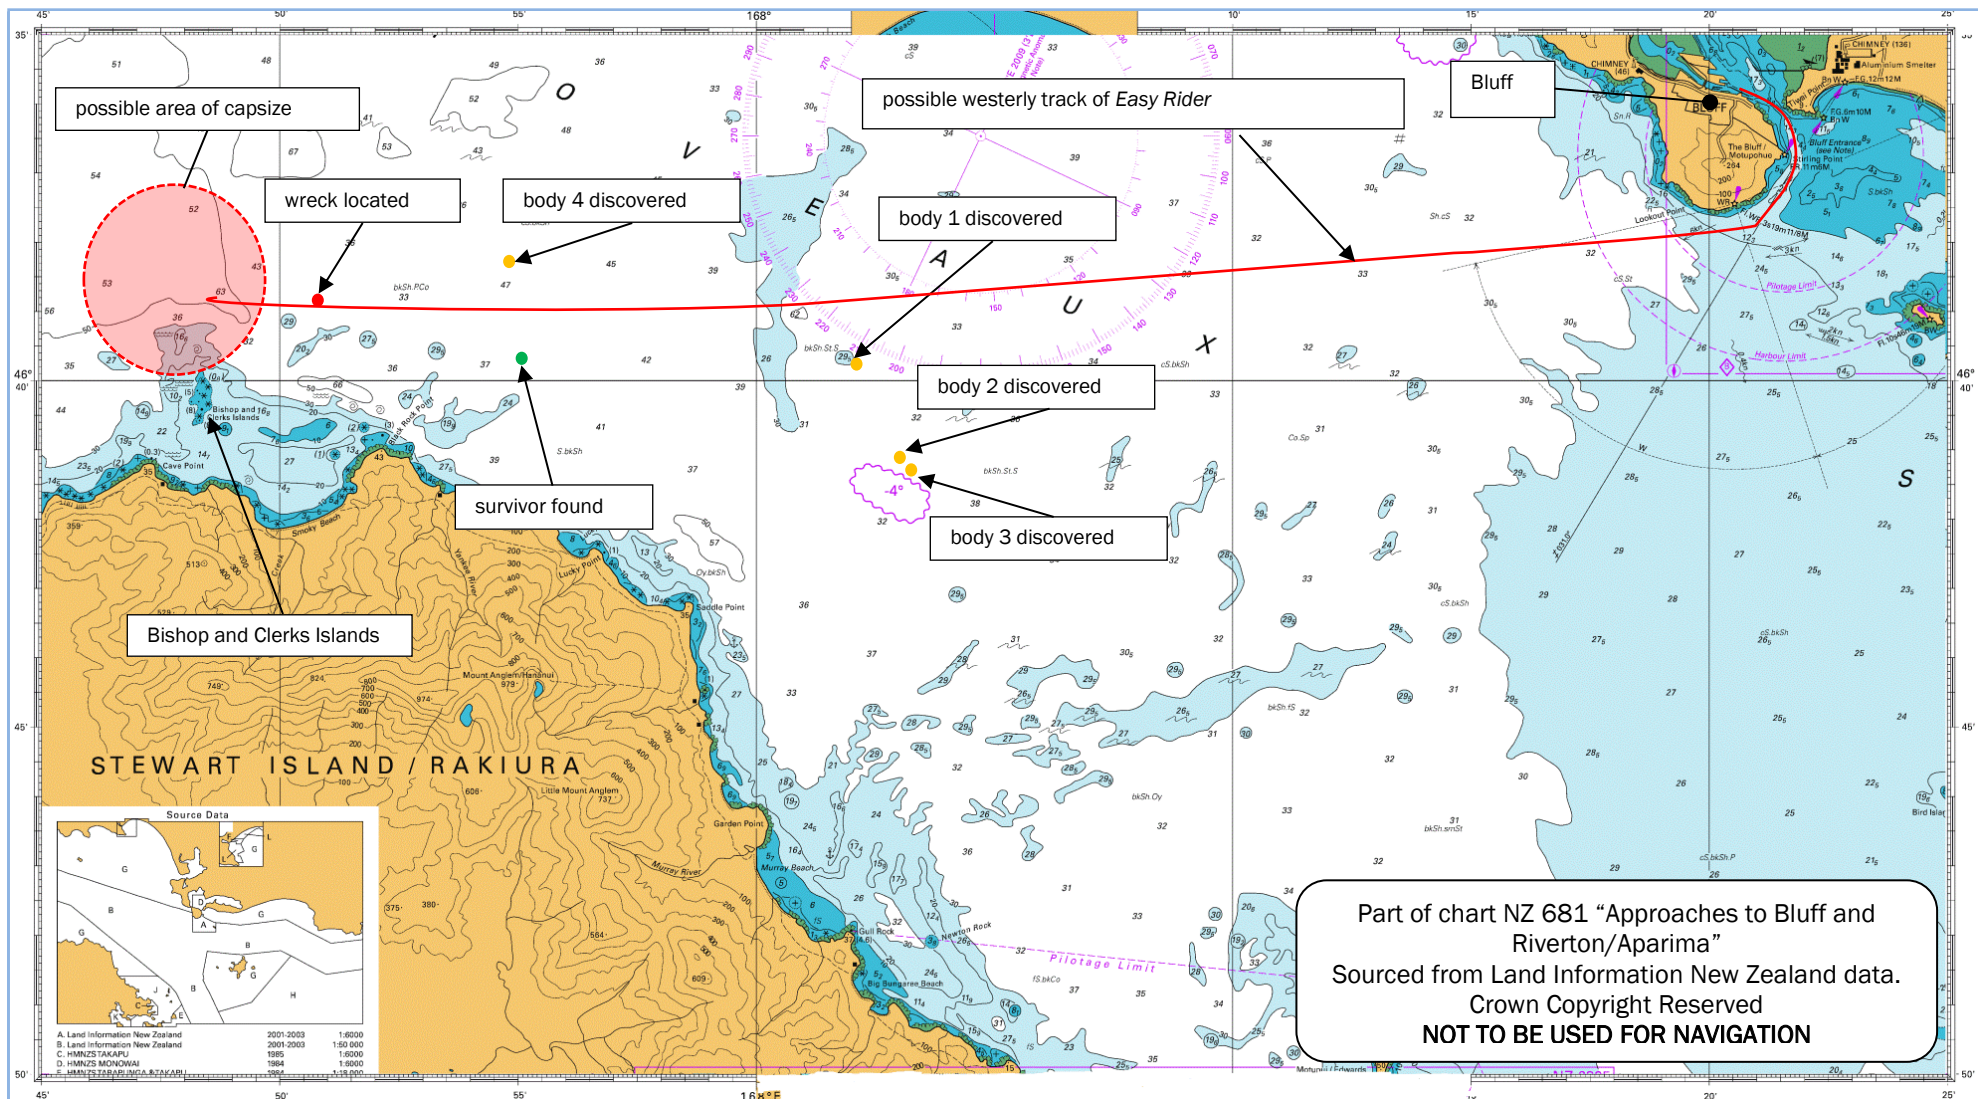
Figure 3  
 Chart showing positions of wreck, survivor and bodies as found

- 3.2.6. The Police search and rescue co-ordinator arranged for land, air and sea units to take part in a search. At about 1810 one of the sea units, the Royal New Zealand Coastguard vessel stationed in Bluff, was proceeding to the area of the accident when a lookout saw the fuel canister being thrown into the air by the survivor. The Coastguard vessel manoeuvred alongside and the survivor was rescued (see Figure 3). The first body was found at about 2030.

- 3.2.7. On Friday 16 March the wreck of the *Easy Rider* was identified on the sea bed at about 0930. The wreck at the time was lying on its side in approximately 40 metres of water. Bodies 2 and 3 were found at about 1245 that same afternoon and body 4 was found at about 1530.

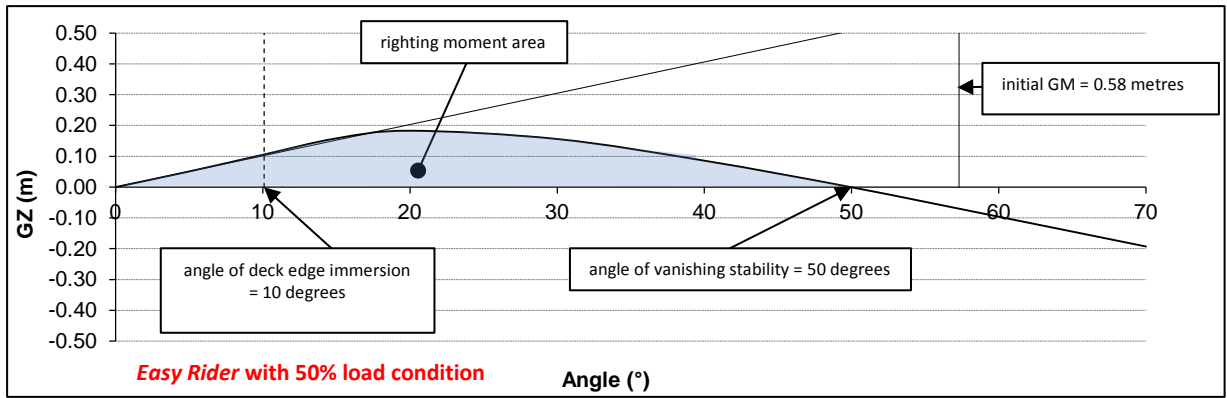
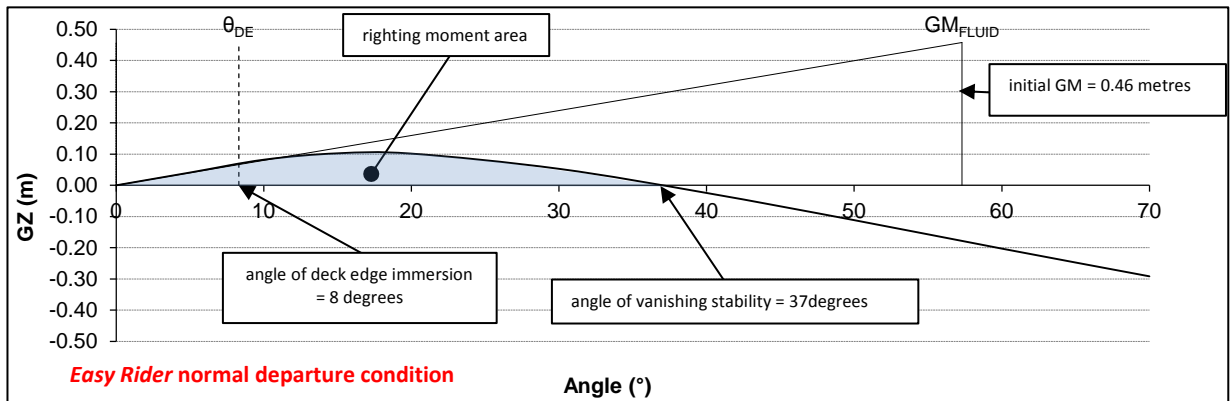
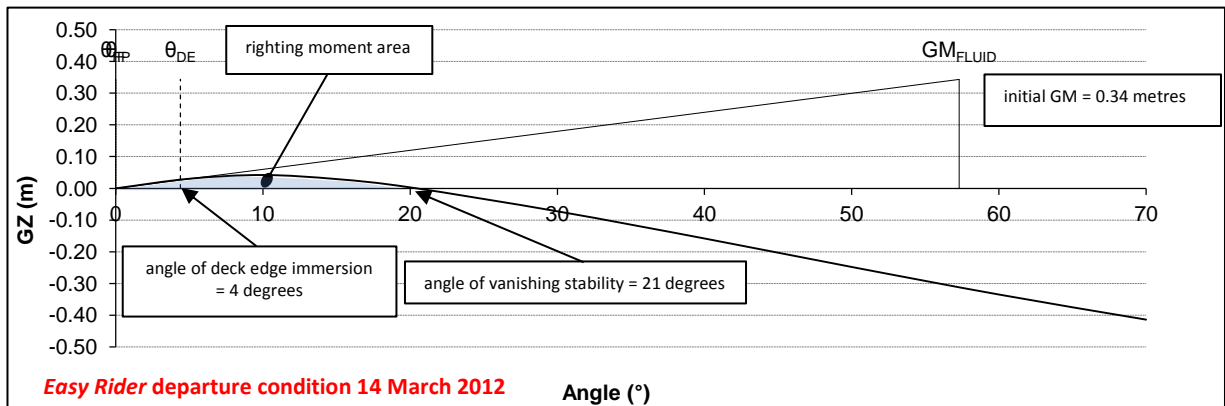
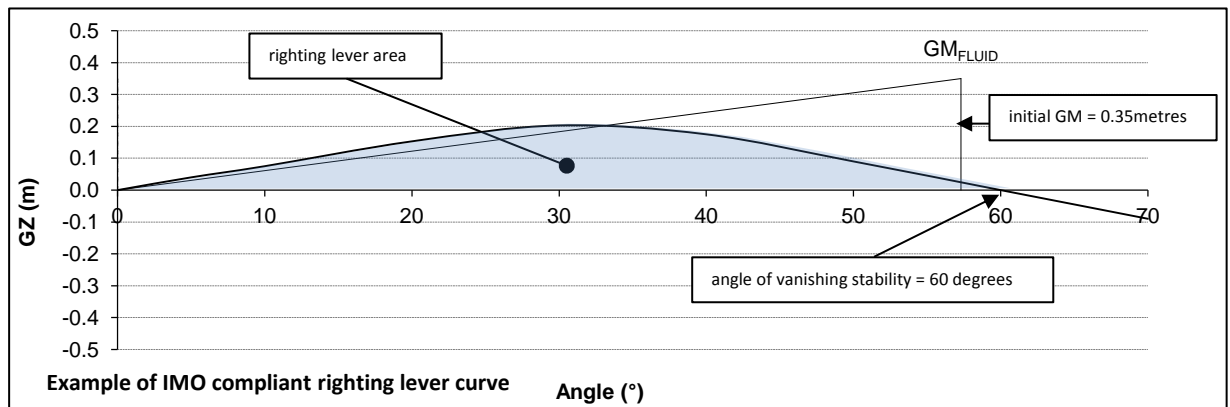
Figure 4

- 4.2.2. There did not appear to be any malfunction with the boat or its equipment, although this could not be entirely ruled out because the sole survivor was not in the wheelhouse at the time, but was instead out on deck. The description he gave was of the boat being overwhelmed by a wave, or waves. This possibility is now explored further.

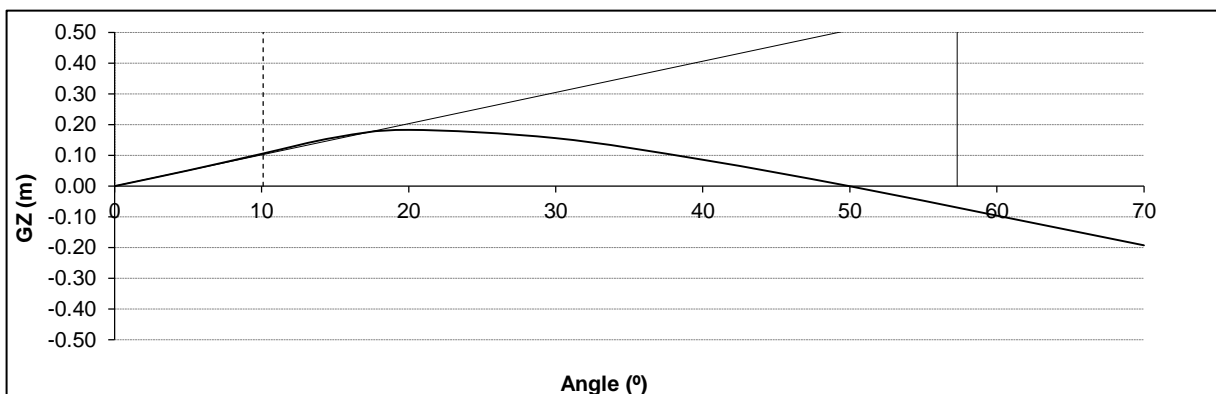
θ<sub>DE</sub>= DECK EDGE IMMERSION ANGLE = 10 degrees

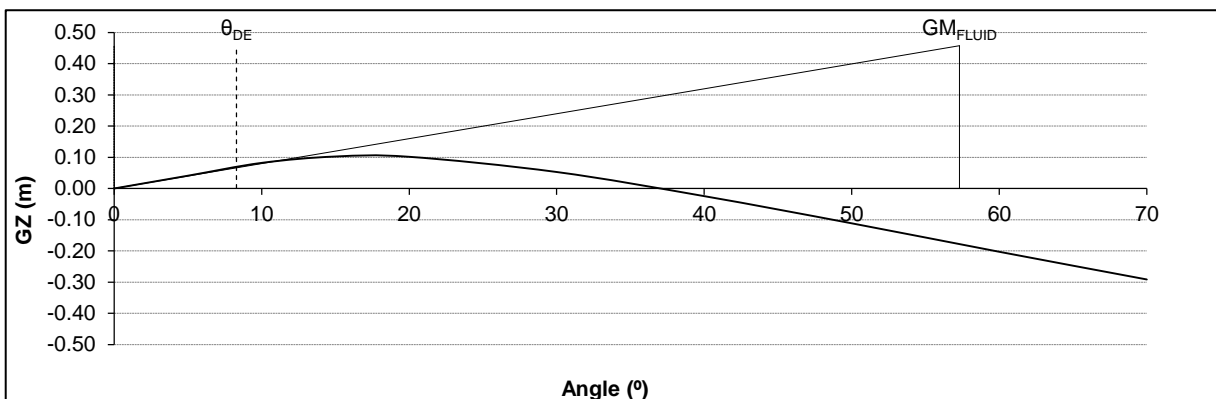
$\theta_{DE} =$  DECK EDGE IMMERSION ANGLE = 8 degrees

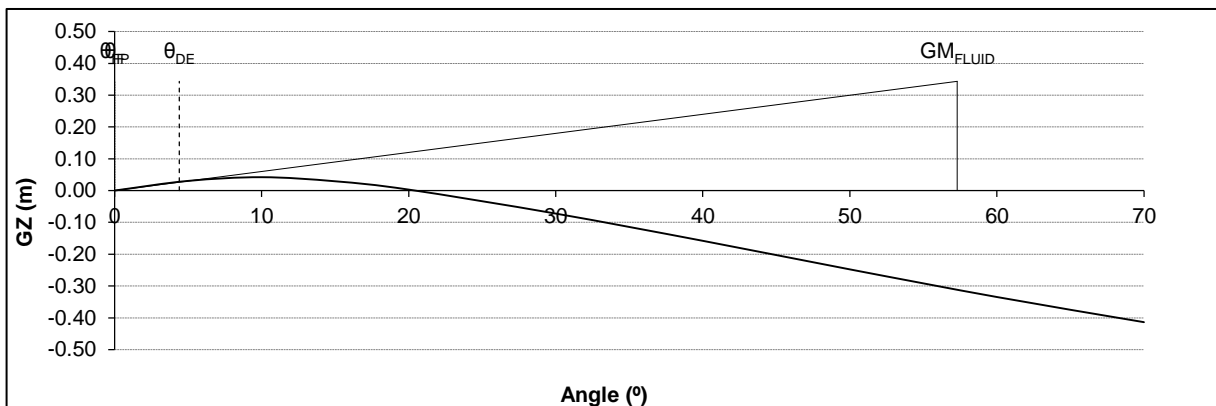
θ<sub>DE</sub>= DECK EDGE IMMERSION ANGLE = 4 degrees
