Inquiry AO-2013-005: In-flight loss of control, Robinson R22,
ZK-HIE, near New Plymouth, 30 March 2013

Final Report

Aviation inquiry AO-2013-005
In-flight loss of control
Robinson R22, ZK-HIE
near New Plymouth
30 March 2013

Approved for circulation: May 2015

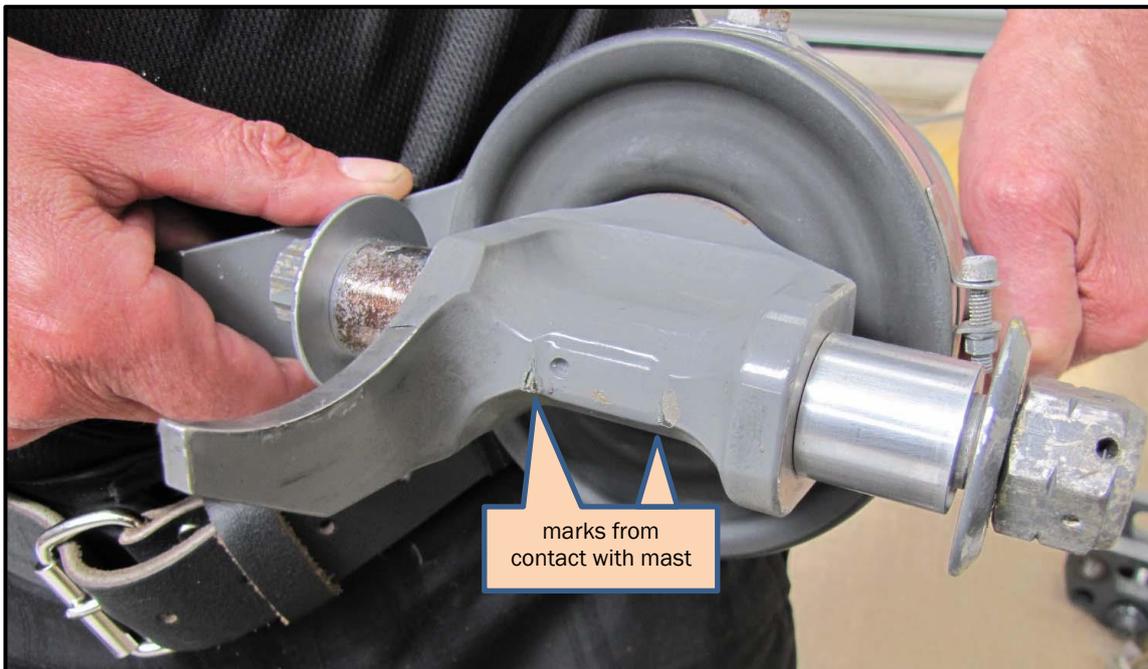
Figure 1
Blade spindle, showing evidence of mast contact

- 4.1.2. The instructor recognised that the extreme attitudes reached by the helicopter during the event presented a great risk of a substantial mast bump or of the main rotor contacting the fuselage, either of which could have been catastrophic. The damage to the rotor head showed that a mast bump did occur.

3.2.2. The manufacturer advised the engineer of the special inspections to be made after a mast bump. The main rotor blades did not require replacement, but the following major parts were replaced (see Figure 3):

- main rotor hub
- main rotor gearbox and rotor drive shaft
- droop stops and teeter stops
- main rotor blade spindles
- main rotor teeter and coning (or “flapping”) bolts
- main rotor blade pitch links.

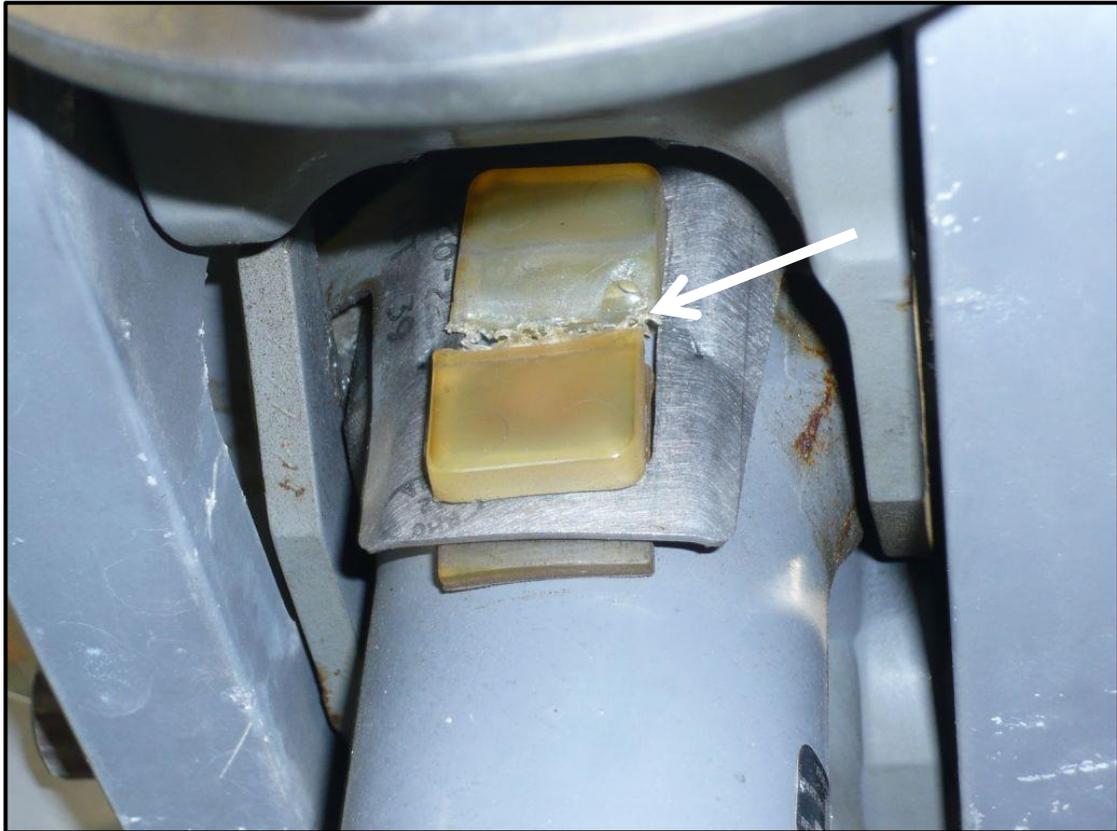
Figure 2
Crushed and split teeter stop
