Inquiry RO-2013-104: Derailment of metro passenger Train 8219  
Wellington, 20 May 2013

# Final Report

Rail inquiry RO-2013-104  
Derailment of metro passenger Train 8219 Wellington  
20 May 2013

Approved for publication: August 2015

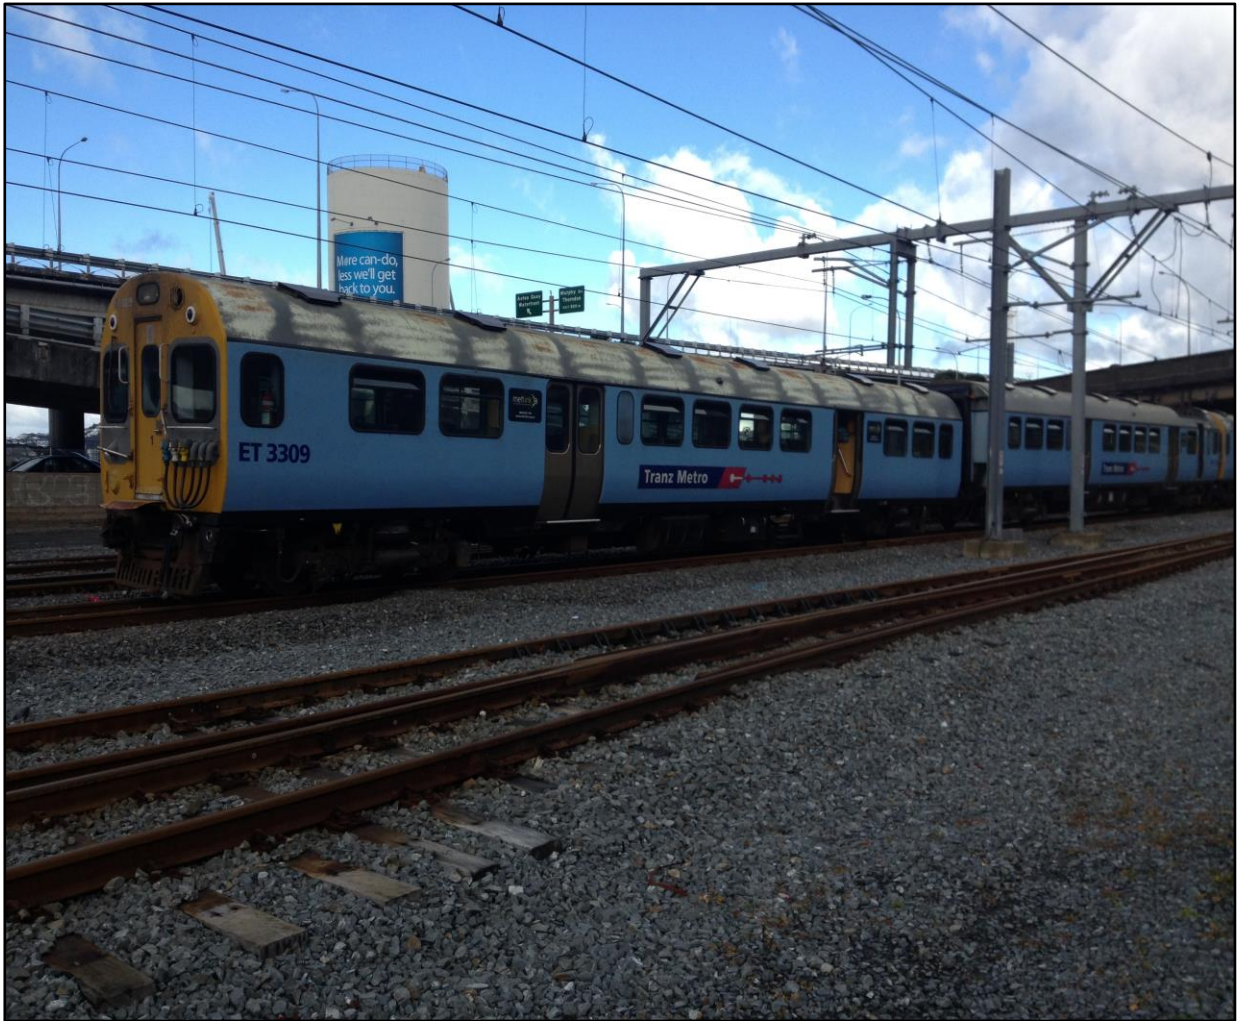
Train 8219 showing rear derailed coach

- 1.2. At 0743 the rear coach of the train derailed as it was entering Wellington Station limits. Four of the 315 passengers on board the train received minor injuries. The derailed coach remained upright but sustained extensive damage to machinery underneath the coach floor. An air compressor was forced up through the coach floor into the passenger compartment.

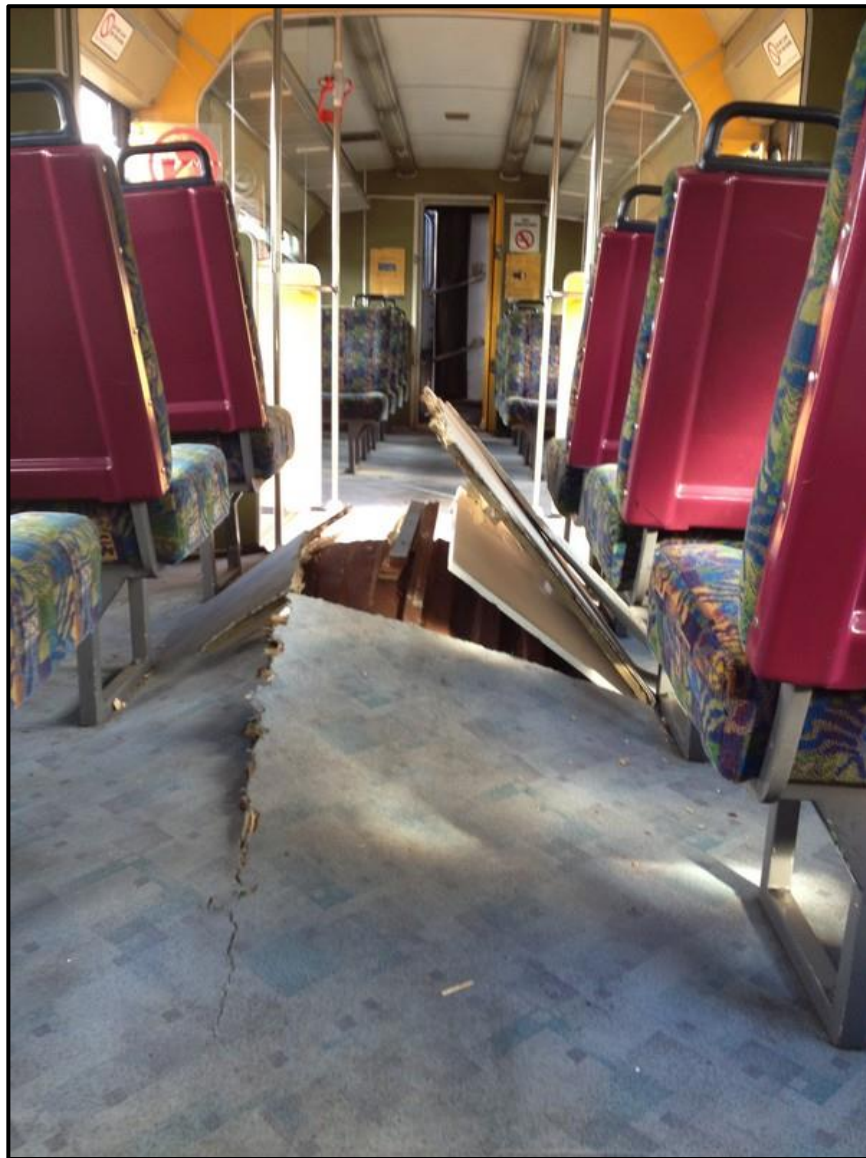
**Figure 1**  
**Under-slung air compressor protruding into passenger compartment**

- 4.1.4. Eventually the welded connection failed, allowing the spring park brake assembly to fall to the track, where it jammed on the underslung air reservoirs and air compressor. The forces involved pushed the air compressor up through the coach floor and were sufficient to derail the train.

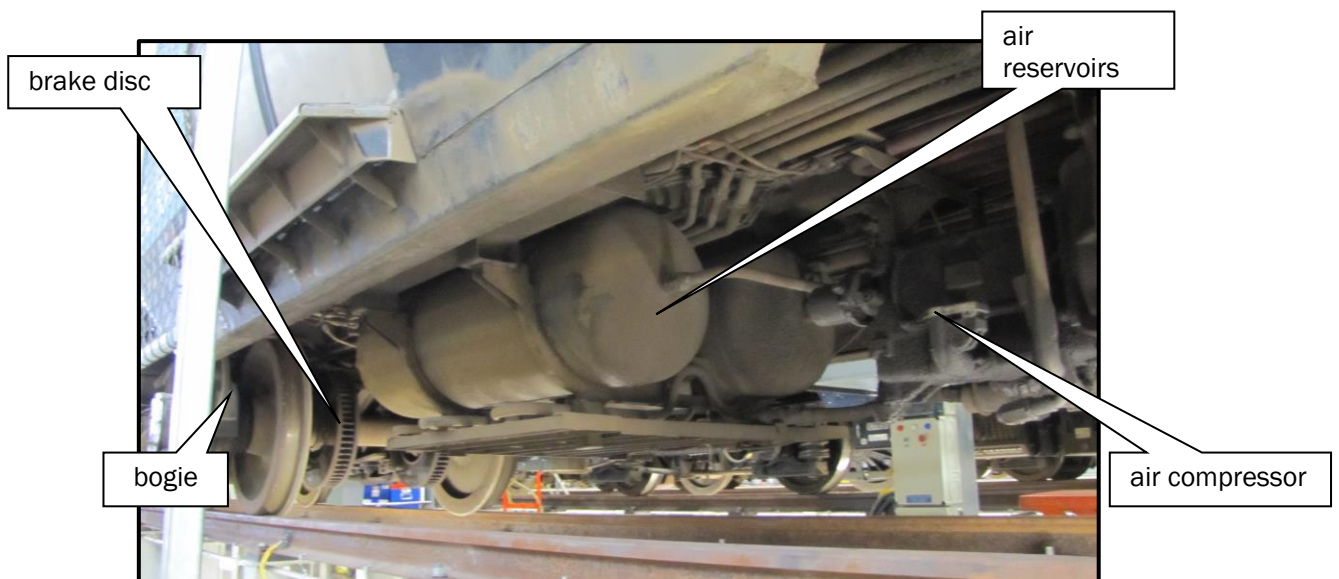
- 3.2.1. Each passenger coach had two bogies; one at each end. Each bogie had two sets of wheels. The derailed coach was a trailer class of coach that was fitted with disc brakes. There were two spring park brake assemblies fitted to each bogie, meaning the derailed coach was fitted with four of these assemblies.
- 3.2.2. Immediately behind the leading bogie were two low-pressure air reservoirs strapped underneath the coach floor. Immediately behind them sat the main air compressor, which kept the air reservoirs pressurised (see Figure 2). A third high-pressure air reservoir sat still further back. The three air reservoirs collectively supplied air to the train brake system and other train services.

**Figure 2**  
Underside of coach arrangement

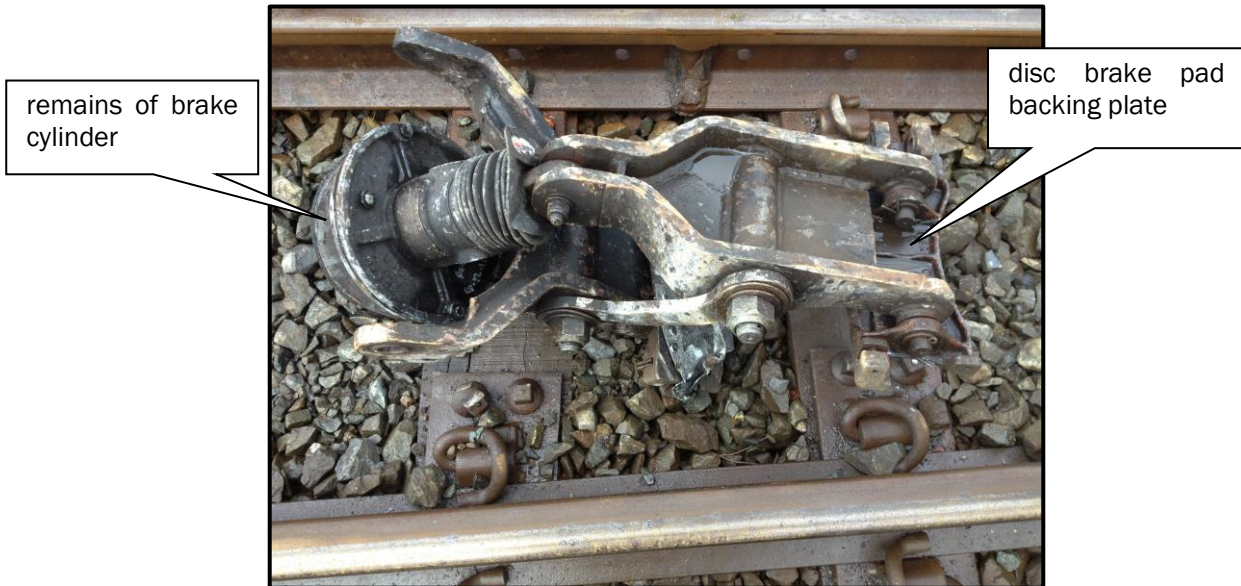
- 3.2.4. The rear of the train was 1.83 kilometres from Wellington Station when the train stopped. A spring park brake assembly from the rear (derailed) coach was found between the rails some 113 metres back from the rear of the train (see Figure 3). The spring park brake assembly was extensively damaged, with parts of the brake cylinder having separated from the main assembly.

**Figure 3**  
Spring park brake mounting bracket with part of the brake cylinder

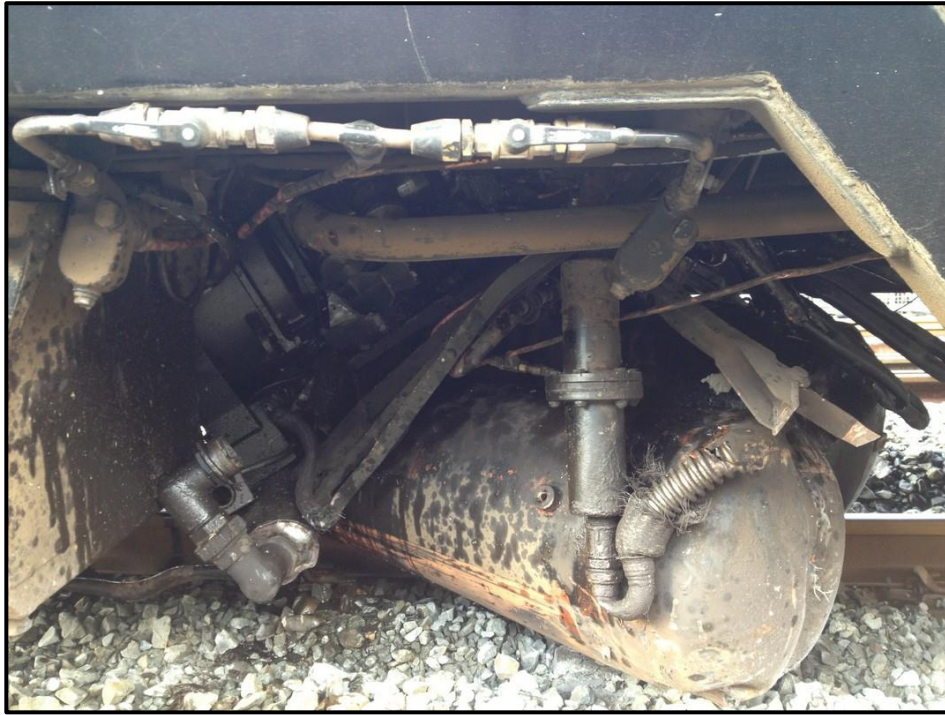
- 3.2.5. The two main air reservoirs had broken free of their mounts and were extensively damaged. They had both been jack-knifed rearwards through 180 degrees and were jammed under the air compressor, forcing the air compressor up through the floor and into the passenger compartment (see Figure 4).

**Figure 4**  
Air reservoirs jammed under air compressor

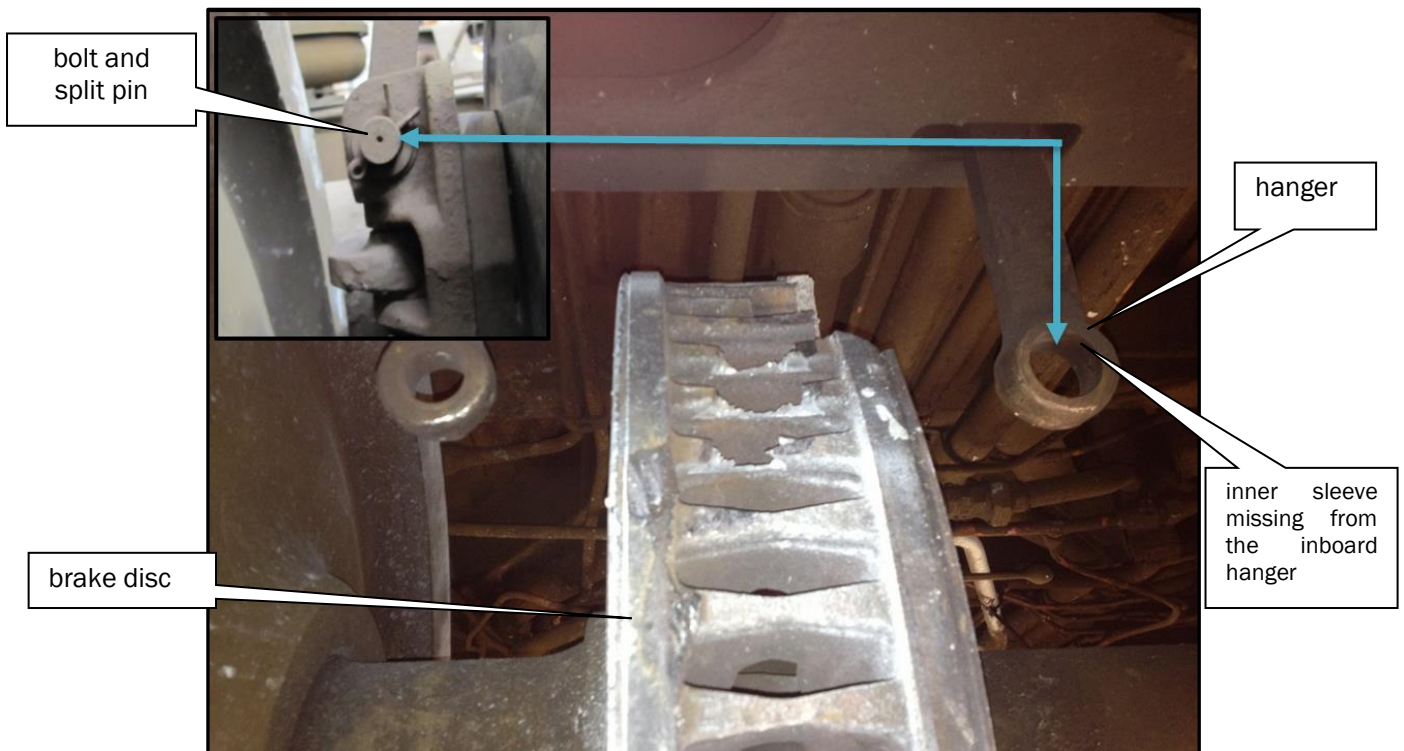
3.2.6. An examination of the number 3 spring park brake assembly from the derailed coach (found 113 metres back from the point of derailment) showed that neither the lug that normally took the bolt and split pin to secure it to the bogie hangers nor the hangers themselves were damaged, except that the inner sleeve was missing from the bolt hole on the inboard hanger (see Figure 5). The two bolts and their split pins were missing and were not found, despite an extensive search of the rail track between the accident site and Porirua.

**Figure 5**  
Undamaged hangers either side of brake disc  
(Inset – bolt and split pin securing spring park brake assembly to hanger)

- 3.2.8. The fact that the spring park brake assembly was torn away from its location without damaging the lug or hangers to which it should have been attached is an indication that the two bolts and split pins were not present when the train derailed. This led the Commission to examine the maintenance history of the coach.

- 4.1.3. Without anything to secure the bolts in place, they worked loose over the following 10 weeks in service and eventually dropped out. Without being supported by the hangers, the entire weight of the assembly was taken on its welded connection to the bogie frame. The main purpose of the connection between the spring park brake assembly and the hangers was to absorb the rotational force applied by the brake pads to the brake disc when the brakes were applied. Without the hanger pins in place to react against the braking forces, the application of the brake would have exerted higher-than-normal forces on the welded connection, which was already supporting the entire weight of the spring park brake assembly.

6.5 KiwiRail implemented a programme to replace all split pins associated with the brake rigging assemblies in the entire Ganz Mavag fleet at the next scheduled maintenance service checks.

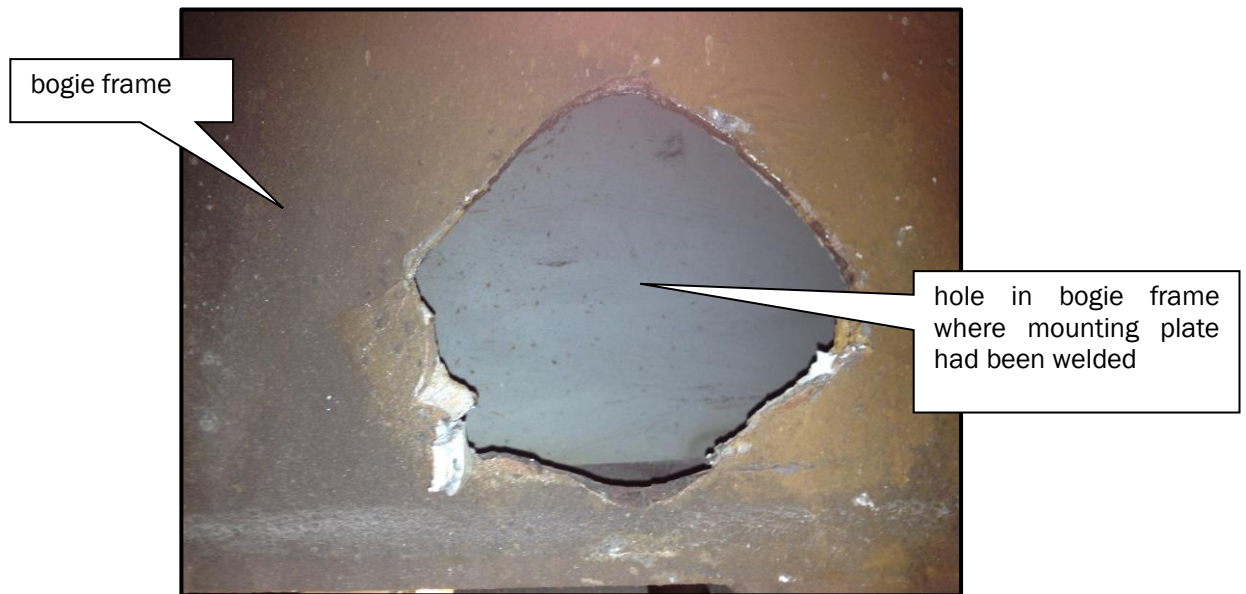
- 3.2.7. The opposite end of the spring park brake assembly was normally attached to a mounting plate, which was welded directly to the bogie frame. This mounting plate had torn away from the bogie (see Figure 6).

**Figure 6**  
Hole in bogie frame where spring park brake mounting plate had been welded
