Final Report AO-2014-004: Piper PA32-300, ZK-DOJ,
Collision with terrain, Near Poolburn Reservoir, Central Otago, 5 August 2014

Aviation inquiry AO-2014-004

Piper PA32-300, ZK-DOJ
Collision with terrain
Near Poolburn Reservoir, Central Otago
5 August 2014

Approved for publication: August 2016

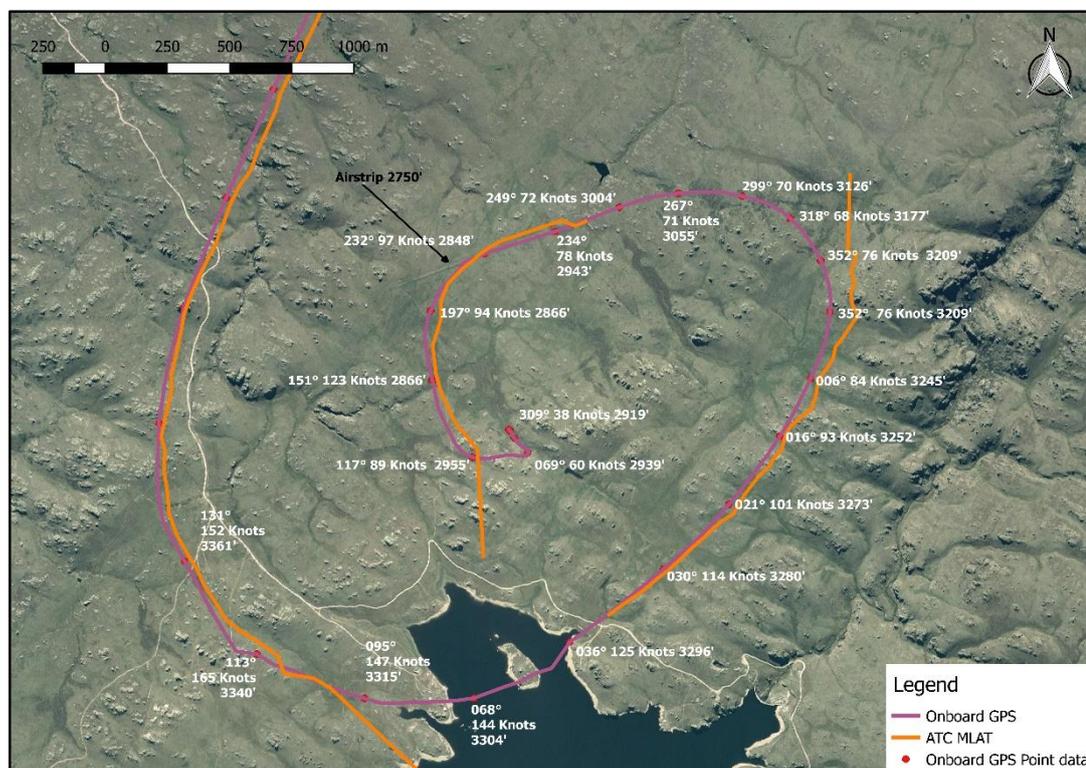
Figure 1
Flight path data
 Aeroplane's track (degrees magnetic), groundspeed (knots) and altitude (GPS height, feet, above sea level)
 Sourced from Topographic Map CC14 Ophir. Crown Copyright Reserved

the airstrip and the pilot flew the aeroplane on a low pass along the runway to scare them away. The pilot flew along the runway between 100 feet and 150 feet AGL, at a groundspeed⁷ of approximately 95 knots (see Figure 1). After passing over the airstrip the aeroplane remained at approximately 150 feet AGL then turned left. The groundspeed increased to 123 knots before the rate of turn⁸ increased and the groundspeed decreased to below 60 knots, at which time the aircraft struck the ground.

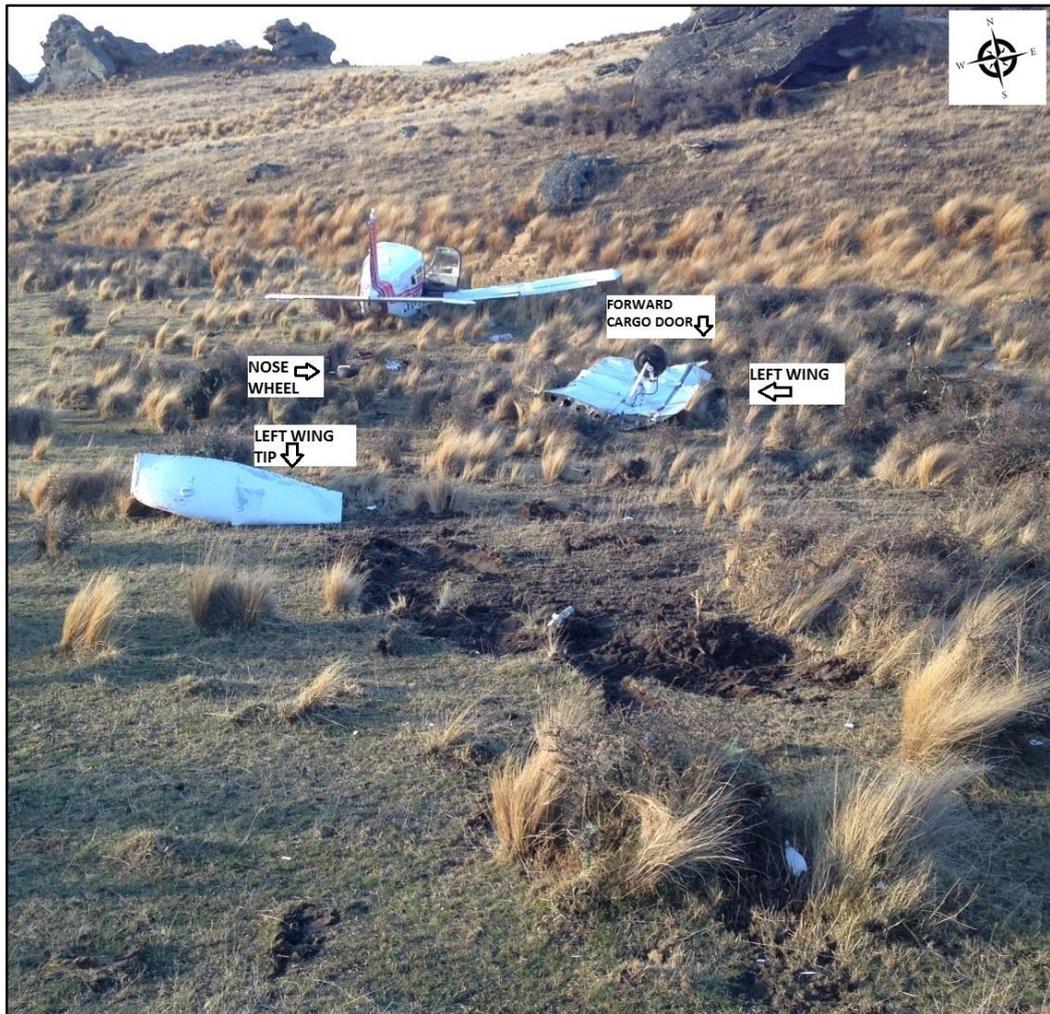
Figure 2
Accident site

- 3.2.3. Fuel from the ruptured left-wing-tip tank was around the accident site, and there was fuel present in the main fuel tanks inside the wings. A sample was taken from the right main fuel tank.

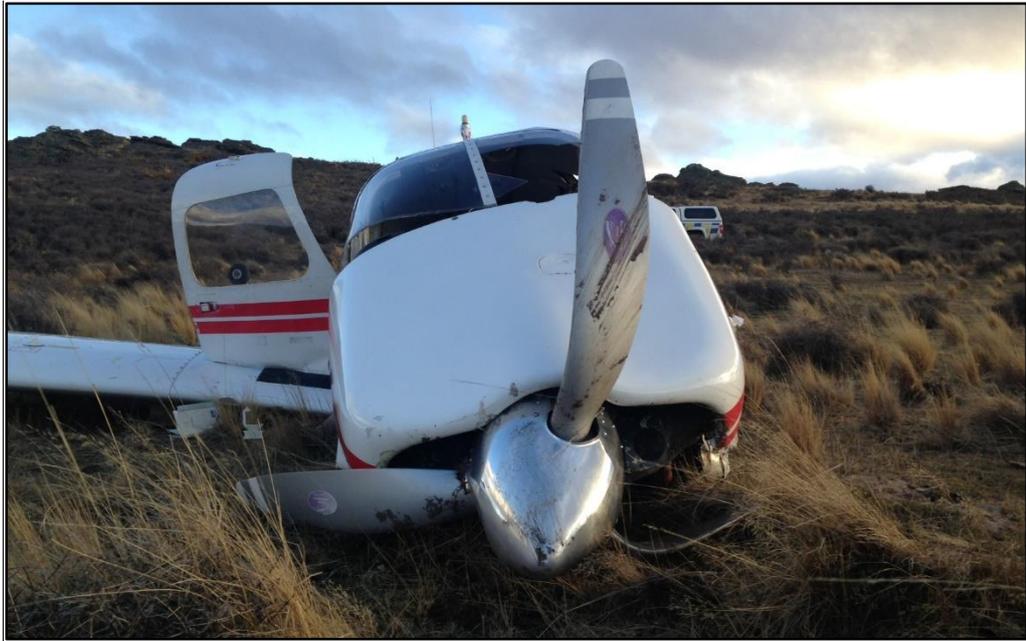
Figure 4
Damage to propeller

- 3.5.4. All three propeller blades were found attached to the propeller hub and bent backwards towards the engine cowl (see Figure 4). There was little damage to the blade tips, edges or surfaces. The pattern of bending and lack of significant scoring marks in the ground or on the blades suggested that the propeller had been turning at low power at impact. The propeller was removed and sent to a propeller examination and overhaul specialist. No evidence was found during the examination of a pre-existing failure of the propeller.

- 4.3.8. The engine, fuel control unit (see Appendix 1) and ignition system were inspected at a specialist engine overhaul facility (see paragraph 3.4.12). No pre-existing defects were found that would have caused a loss in power. The propeller was inspected at a specialist propeller overhaul facility (see paragraph 3.4.13). No pre-existing defects were found, and it was determined that the propeller had been under low power when it struck the ground.

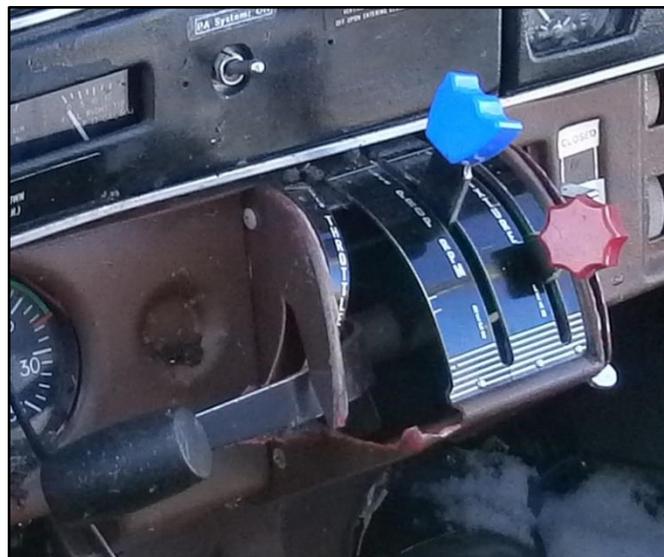
Figure 5
Cockpit engine controls
(throttle, propeller pitch, fuel mixture)

3.5.5. An examination of the cockpit engine controls found the mixture control²³ in a partially leaned position, and the propeller was set to the maximum RPM (revolutions per minute) position. The throttle was full aft (idle) and bent to the left (see Figure 5). The fuel selector²⁴ valve was set to the RIGHT MAIN fuel tank, the electric fuel pump was selected ON, and the ignition was selected to BOTH.

- 4.3.9. The engine throttle lever was found in the idle position and bent sideways to the left. The pilot had an injury to his right hand that indicated it was very likely that he had been holding the throttle when the aeroplane hit the ground. The throttle could not be moved out of this position after the accident, which suggested that the throttle was at idle prior to ground impact. The pre-impact idle position supported the conclusion from the propeller examination that the propeller was at low power when it hit the ground. One explanation for a low power setting is that the pilot closed the throttle when he realised that a crash was imminent.

- 4.3.10. The mixture lever that controlled the fuel-to-air ratio within the induction system was found in a partially leaned position after the accident. In order to maintain the same fuel-to-air ratio, the amount of fuel supplied to an engine needs to be reduced as an aircraft climbs, due to the reduction of air pressure as altitude increases. As a rule of thumb, operating at altitudes above 3,000 feet requires the mixture to be leaned by moving the lever rearward. The lever is returned to the full forward or rich position as part of the before-landing checklist during the final approach to land. The aeroplane had been flown to Poolburn at an altitude of about 7,000 feet, so this would have required the fuel mixture to be leaned.

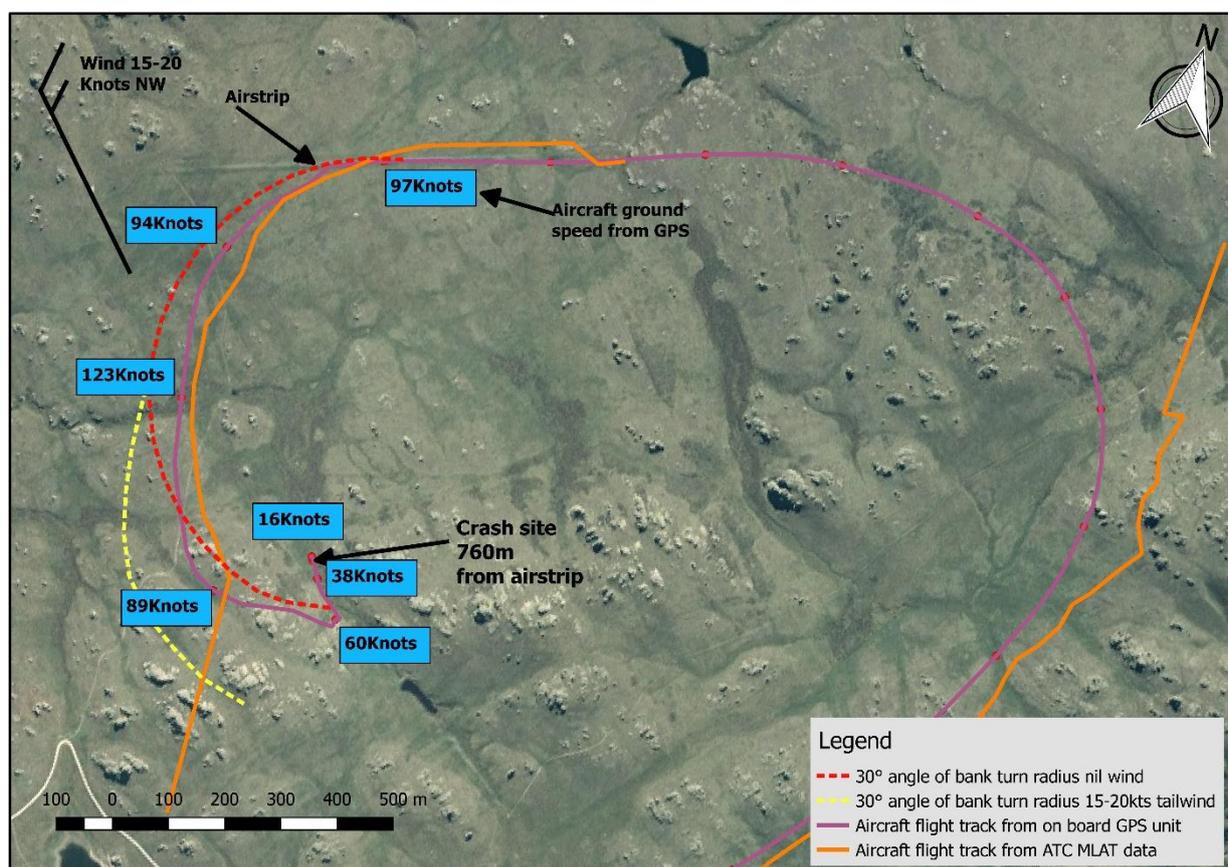
Figure 6
iPad GPS flight track data
(actual and theoretical flight track display, and MLAT³² data)
Sourced from Topographic Map CC14 Ophir. Crown Copyright Reserved

4.5.1. The GPS flight path data (see Figures 1 and 6), recovered from the on-board iPad, showed the aeroplane flying in a wide arc around the airstrip before descending and flying directly above the airstrip at a height estimated at between 100 and 150 feet AGL. About halfway along the airstrip the aeroplane was turned to the left through approximately 180 degrees. Its groundspeed initially increased during the turn, then decreased rapidly just before impact.

4.5.2. The rate of turn³¹ was initially moderate, then a southerly direction was maintained for about 400 m before the aeroplane turned left in a tighter turn. The turn radius of the initial turn away from the airstrip approximated that of a turn made with 30 degrees angle of bank in still wind (see Figure 6, dashed red line). The smaller turn radius during the last part of the turn would have required 45 to 60 degrees angle of bank.

- 4.5.3. Figure 6 shows the flight track (in magenta) of the aeroplane as displayed on the on-board iPad by an application called AirNav Pro™. Due to buffering of the GPS data, and in order to show a 'live' view of the flight, the application had to predict the next position of the aeroplane. This feature has resulted in an impossible track being depicted between the points at 89 knots and 16 knots. This part of the data is invalid, and was most likely caused by the software predicting the position shown at the 60 knots point then 'filling in' the track to the final data point at 16 knots. In fact the aeroplane stalled at about the 89 knots point and followed a line between the 89 knots point and the crash site.

- 4.5.4. The dashed red line in Figure 6 represents the calculated radius (380 m) of a turn carried out in still air (no wind) with an entry airspeed of 90 knots and 30 degrees angle of bank. The dashed yellow line at the bottom of the figure represents the expected flight track of a turn carried out in the wind conditions present at the time (15-20 knots from the northwest) and with 30 degrees angle of bank. The rate of turn is the same for both, but with a tailwind more ground is covered during the turn. This put the aircraft closer to the higher terrain to the south of the airstrip, and the pilot would have had to increase the rate of turn or climb to avoid it.

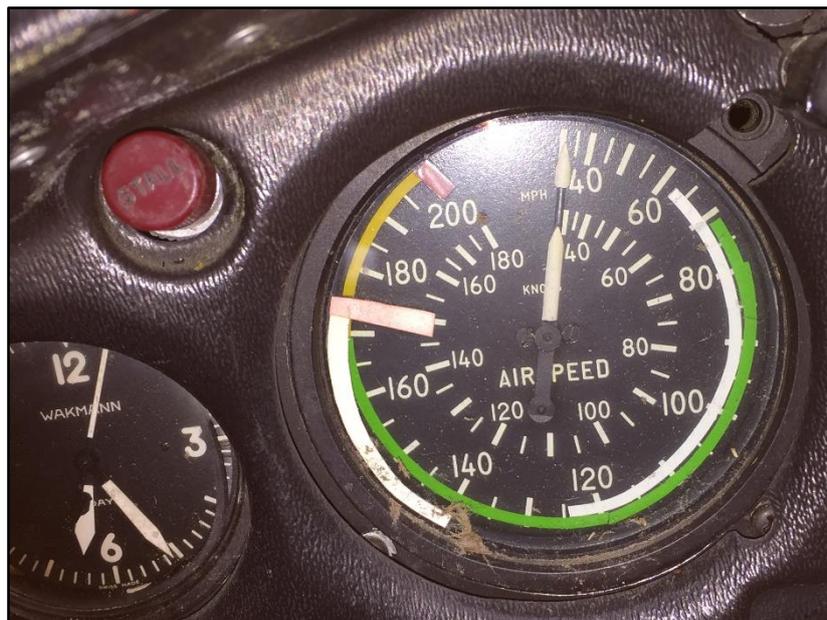
Figure 7
Airspeed indicator and stall warning light (upper left)

- 4.5.10. The lack of an aural stall warning may have been a factor that prevented the pilot recognising an impending stall and taking action to avoid it. The stall warning light was operable, but if the pilot had been looking out the side window in the direction of the turn he may not have noticed the light illuminate. A warning horn could have immediately drawn his attention to the impending stall. Later-model PA32-300 aeroplanes were fitted with a stall warning horn as well as the light.

- 4.5.11. The outer scale of the airspeed indicator (see Figure 8) was calibrated in mph, while the smaller inner scale was in knots. One knot is equal to about 1.15 mph. The airspeed indicators in the other aeroplanes the pilot regularly flew were calibrated in knots only. According to the pilot's training records, he had used knots when learning the airspeed limitations for the PA32-300 type rating. The pilot could have read the airspeed off the outer scale (mph) thinking it was in knots, and thought they were flying faster than they actually were. An airspeed of 90 mph on the outer scale would equate to about 77 knots (the stall speed at 60 degrees angle of bank).

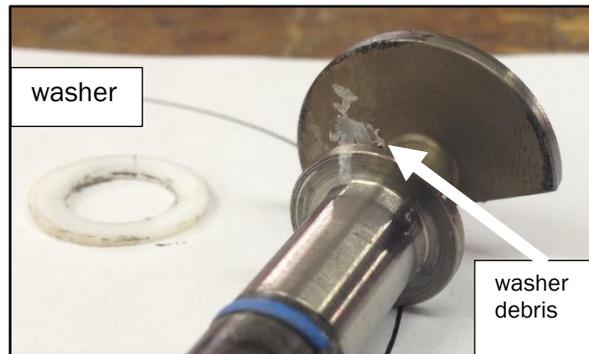
Washer and debris

The FCU was taken apart and inspected at an approved engine overhaul facility under the supervision of the investigator in charge. The FCU, fuel nozzles, fuel filter and pump were tested and found to be serviceable and free of blockages. However, a small amount of delamination was detected on washer part number 367757 (see Figure below).

The Commission notified the Director of Civil Aviation that similar delamination had been found on the washer from the aeroplane's FCU. Following this and further reports from other aeroplane operators, the CAA issued Airworthiness Directive DCA/MA/19 that was applicable to all aircraft fitted with RSA-10ED1 model FCUs and other Precision Airmotive FCUs that contained the Teflon washer.
