Final report AO-2014-005: Eurocopter AS350-B2 (ZK-HYO), collision with terrain during heli-skiing flight, Mount Alta, near Mount Aspiring National Park, 16 August 2014

Aviation inquiry AO-2014-005
Eurocopter AS350-B2 (ZK-HYO)
collision with terrain during heli-skiing flight
Mount Alta, near Mount Aspiring National Park
16 August 2014

Approved for publication: November 2017

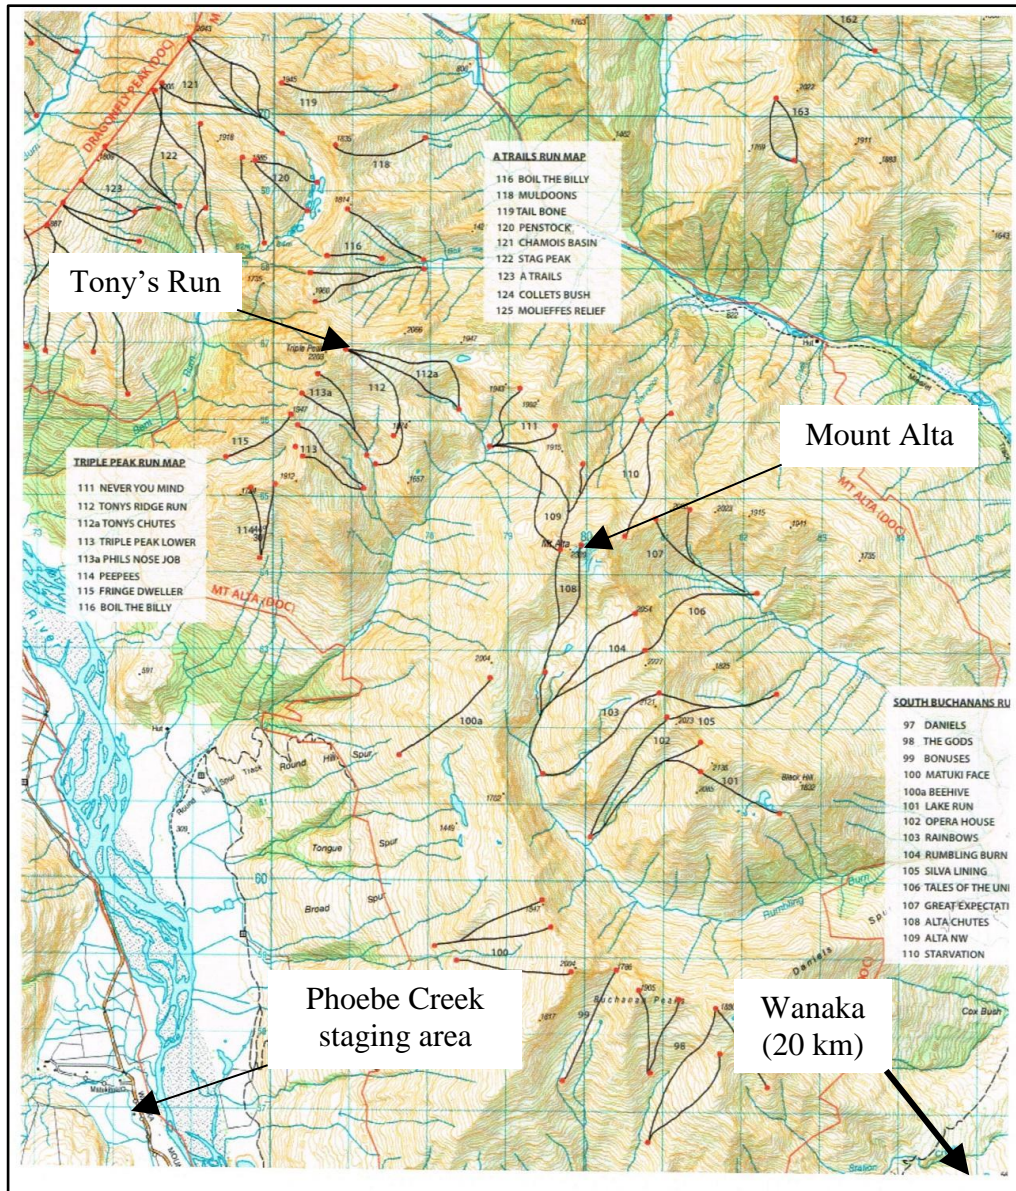
Figure 1
Ski run map
(Courtesy of The Helicopter Line)

3.1.10. The pilot then flew group C to the top of Tony's Run and descended to the bottom of the run to uplift group A for their next run, which was to be from near the summit of Mount Alta. The smaller passenger returned to his allocated front-centre seat. The guide sat in the front-left seat and donned a headset to talk to the pilot and discuss the next run. The pilot then flew the helicopter in a climbing left-hand orbit around Mount Alta to enable the pilot and guide to assess the conditions. The pilot and guide agreed to land groups A and B at a designated landing site on a flat ridge near the summit and group C further down the mountain.⁶

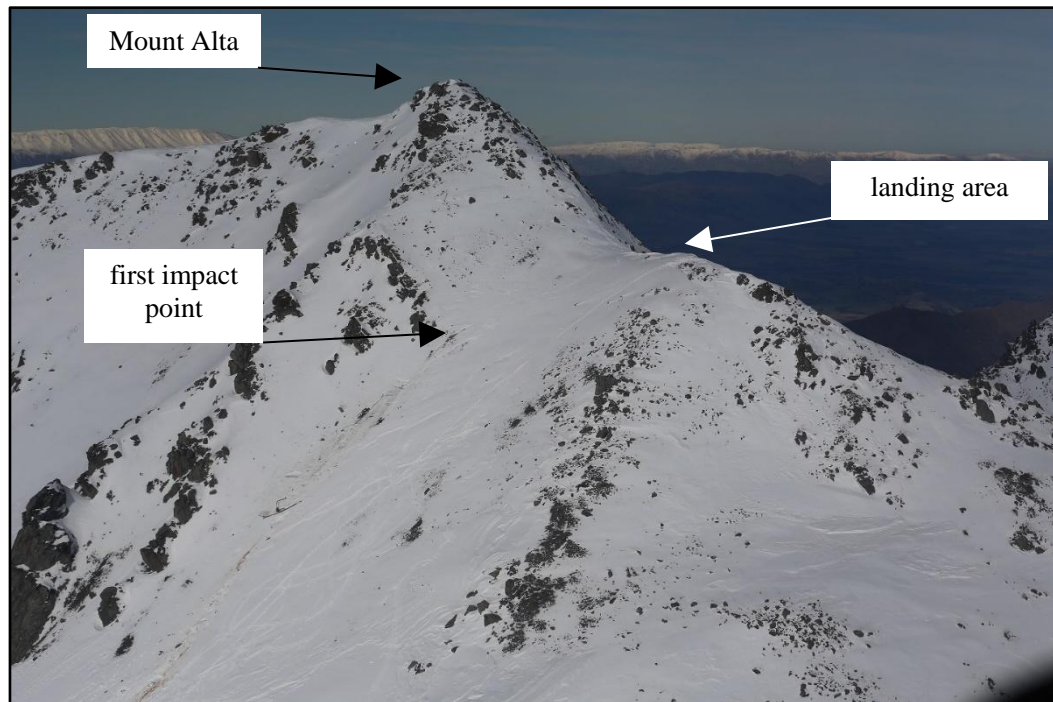
Figure 2
Mount Alta looking southeast in the direction of the landing approach

- 3.1.11. The weather conditions were nearly calm with a very light southerly wind. The pilot elected to approach the landing site from the northwest, into the light southerly wind. A length of orange ribbon on a cane pole had previously been placed close to the landing site to act as a wind marker for pilots. As the helicopter neared the landing site the pilot was unable to see the wind marker, because it was below a small snowbank. He was not sure where the wind was from and considered the possibility that there was a tailwind, so he maintained his airspeed and overflew the ridge.
- 3.1.12. After passing over the ridge, the pilot and guide saw the wind marker below the ridgeline. The wind marker indicated a light southerly breeze, so the pilot overflew the landing site a second time and repositioned the helicopter on the north side of the ridge for an approach (see Figures 2 and 3).

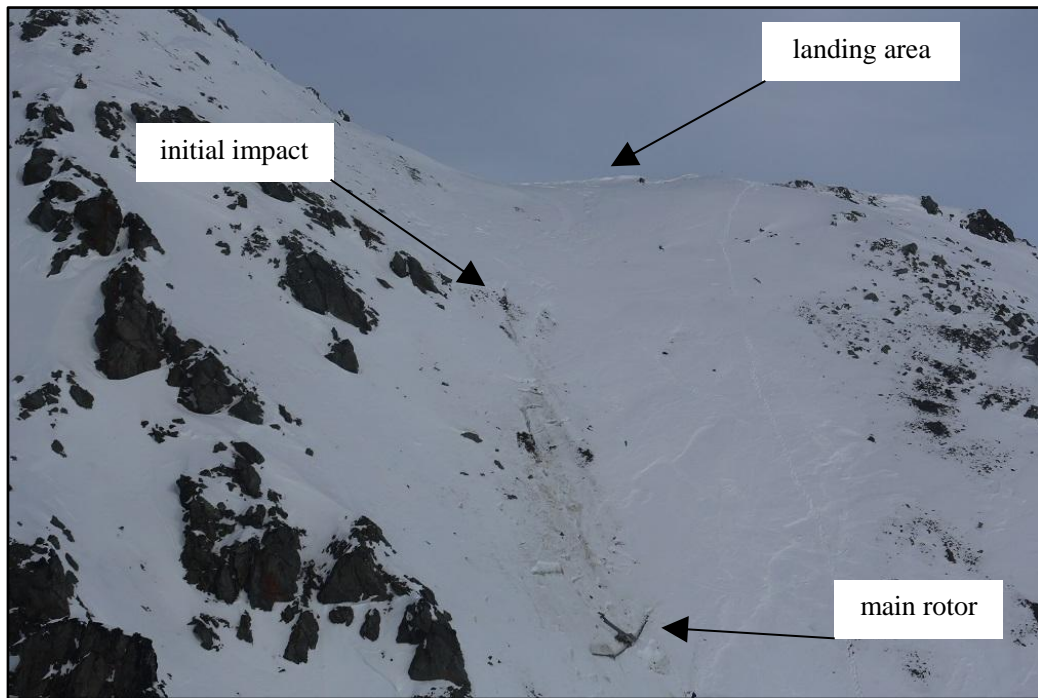
Figure 4
Initial impact site

- 3.2.3. The first impact mark was a cut through the snow about 20 m below and 47 m from the intended landing site. The cut extended for several metres and was adjacent to a flattened or compressed area of snow and rock. Paint transfer was found on some of the exposed rocks in this area. The shape of the cut suggested that one of the helicopter's skids had struck first. The confused nature of the following marks in the snow and the paint transfer marks on the rocks were consistent with the fuselage having started to tumble immediately after the first impact.

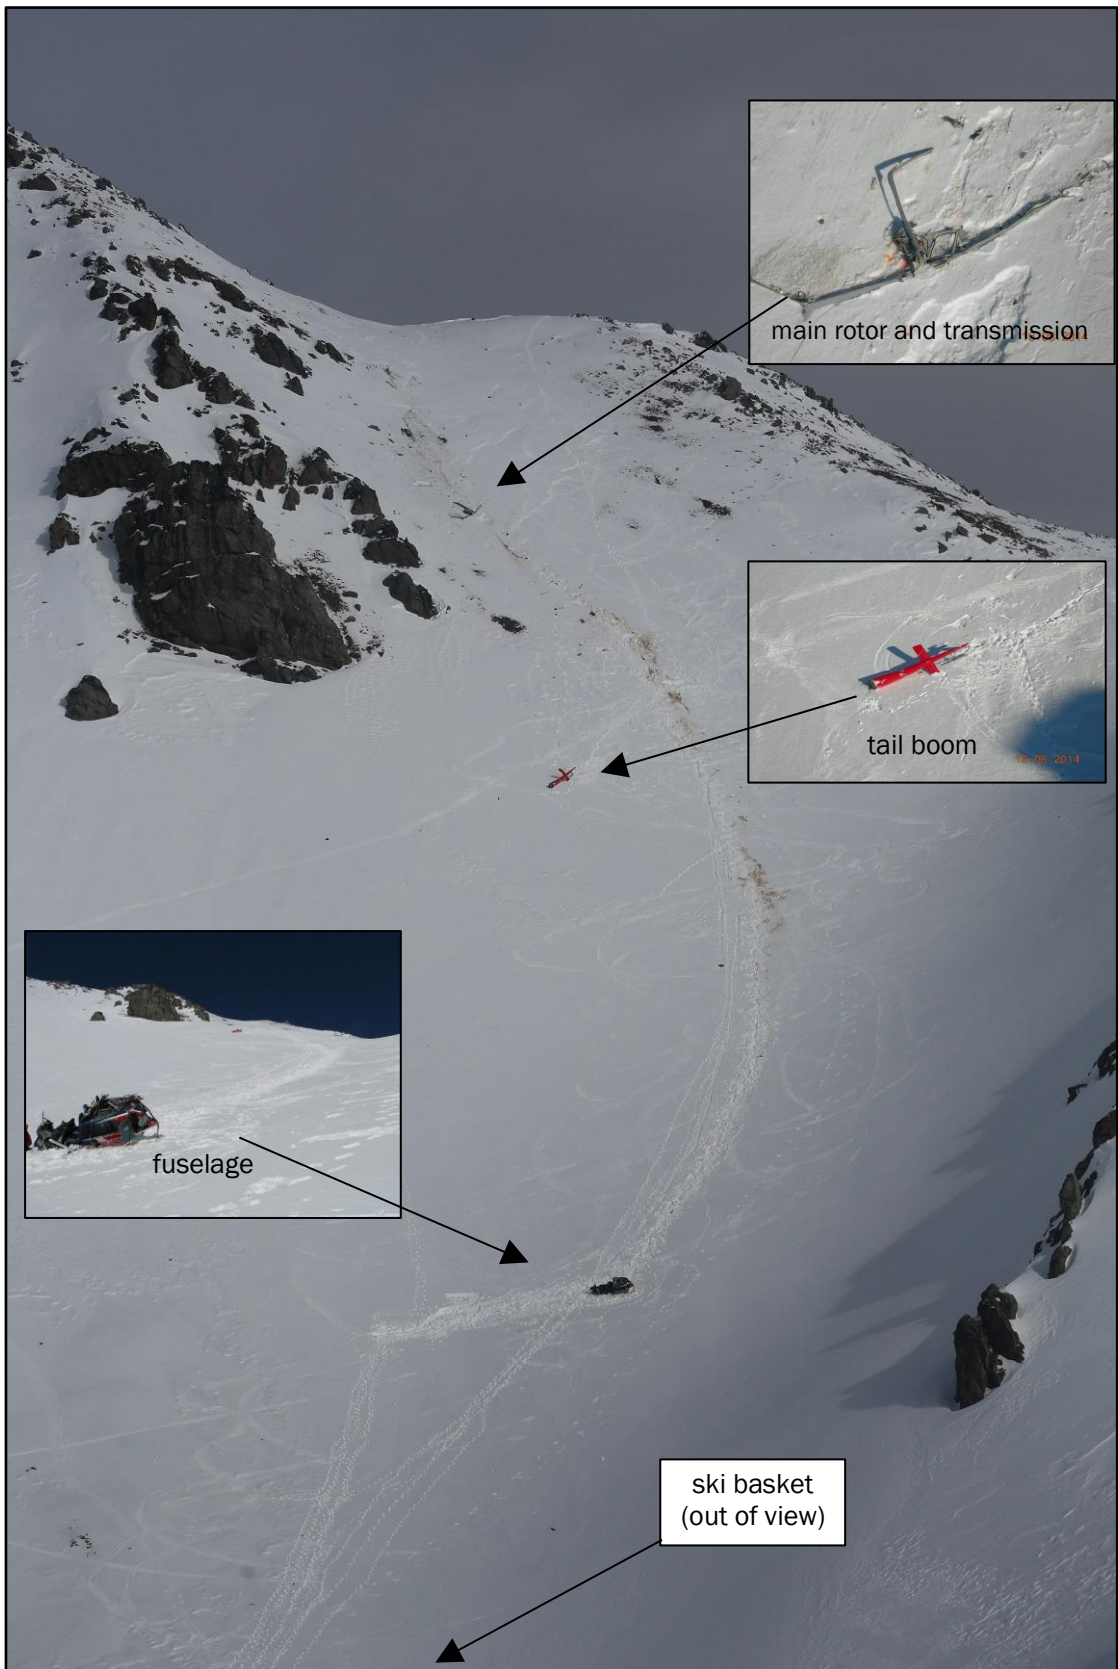
Figure 5
Accident site – general

- 3.2.4. The main rotor assembly, including the transmission and three main rotor blades, was found a further 45 m along the wreckage trail. The number and pattern of rotor blade strikes in the snow and on the exposed rock were consistent with the main rotor blades having been turning at high speed (see Figure 5).

- 3.2.8. The structure around the cabin, including all the doors, roof and nose cowling, had separated, exposing the seats (see Figure 5). The instrument panel had broken from its mounting but remained attached by wiring. Both skids had broken in several locations. The fuel tank was intact but a small amount of fuel was found leaking from the fuel line leading to the engine. The emergency locator transmitter had activated but the cable leading to the aerial had broken as a result of the tail boom separating. The emergency locator transmitter was reported to have been turned off soon after rescue personnel arrived on-site.

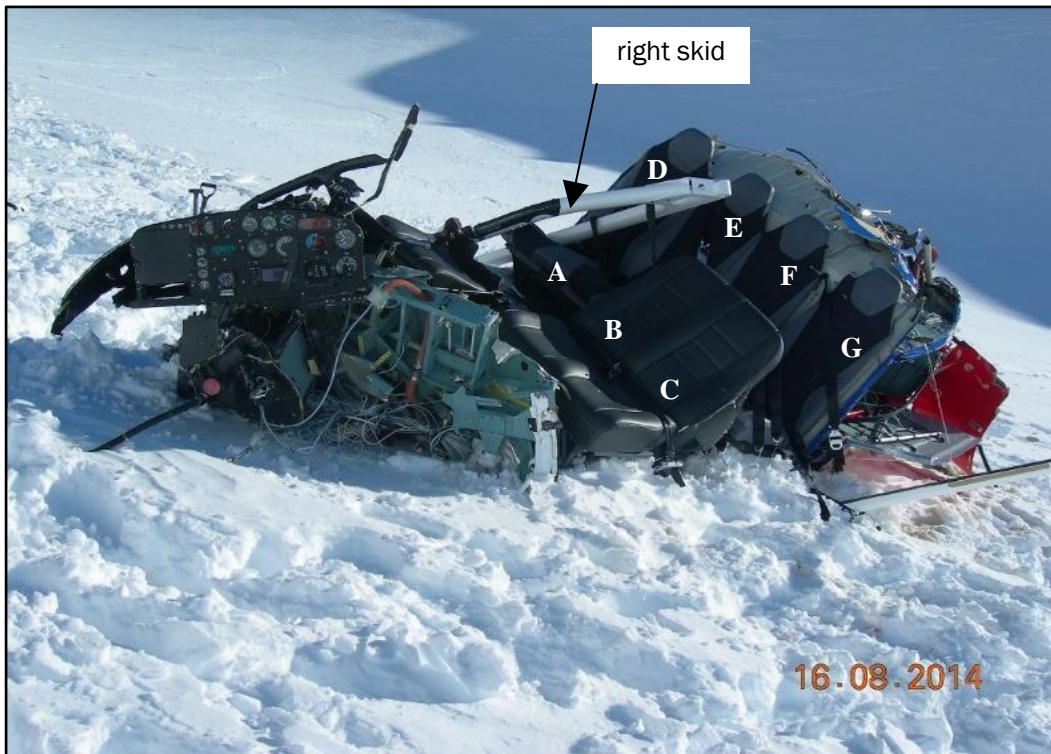
Figure 6
Seating positions

- 4.6.1. The injuries sustained by the deceased passenger were consistent with his having been struck by the broken right skid (see Figure 6), and being ejected from the helicopter and caught between it and the snow-covered slope as the helicopter came to rest. His injuries were unsurvivable. Three of the surviving occupants sustained serious injuries, including fractures, internal injuries and extensive bruising. The remaining three occupants sustained minor to moderate injuries, predominantly extensive bruising and sprains.

Occupant	Injuries	Seatbelt (type, status found, fitting)	Retained/Thrown out
A (pilot)	Moderate	Four-point harness, buckled, pulled tight	Thrown out (probably up and forward)
B	Minor	Four-point harness, buckled, pulled firm	Retained
C (guide)	Serious	Four-point harness, buckled, but broken, pulled firm	Thrown out
D	Fatal	Lap-diagonal, lap unbuckled, loose	Thrown out
E	Serious	Lap-diagonal, buckled, loose	Thrown out
F	Moderate	Lap-diagonal, buckled, firm	Retained
G	Serious	Lap-diagonal, lap unbuckled, loose	Thrown out
