Final report RO-2014-101: Collision between heavy road vehicle and the Northern Explorer passenger train, Te Onetea Road level crossing, Rangiriri, 27 February 2014

Rail inquiry RO-2014-101  
Collision between heavy road vehicle and the  
Northern Explorer passenger train  
Te Onetea Road level crossing, Rangiriri

27 February 2014

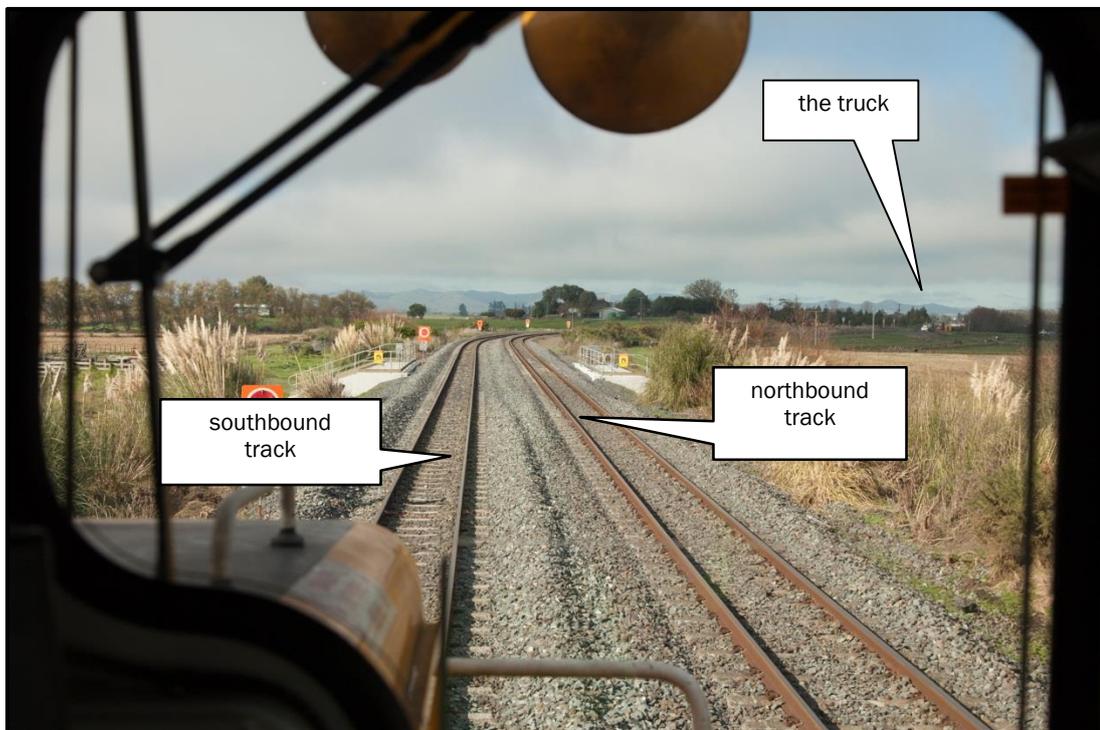
Figure 1

- 3.1.6. The train was travelling at 85 kilometres per hour when 500 metres from the level crossing. The train driver saw the truck approaching the level crossing from his right-hand side (see Figure 1).

The train driver's first sighting of the truck approaching the Te Onetea Road level crossing (photograph taken by New Zealand Police at incident reconstruction held on 10 May 2014)

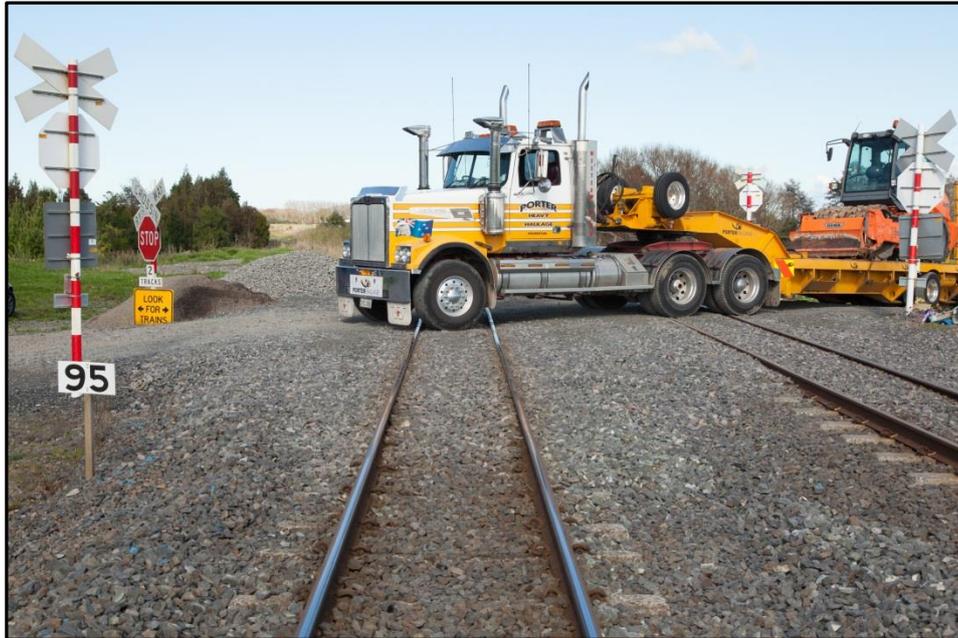
**Figure 2**  
The approximate position of the truck before impact  
(photograph taken by New Zealand Police at the incident reconstruction held on 10 May 2014)

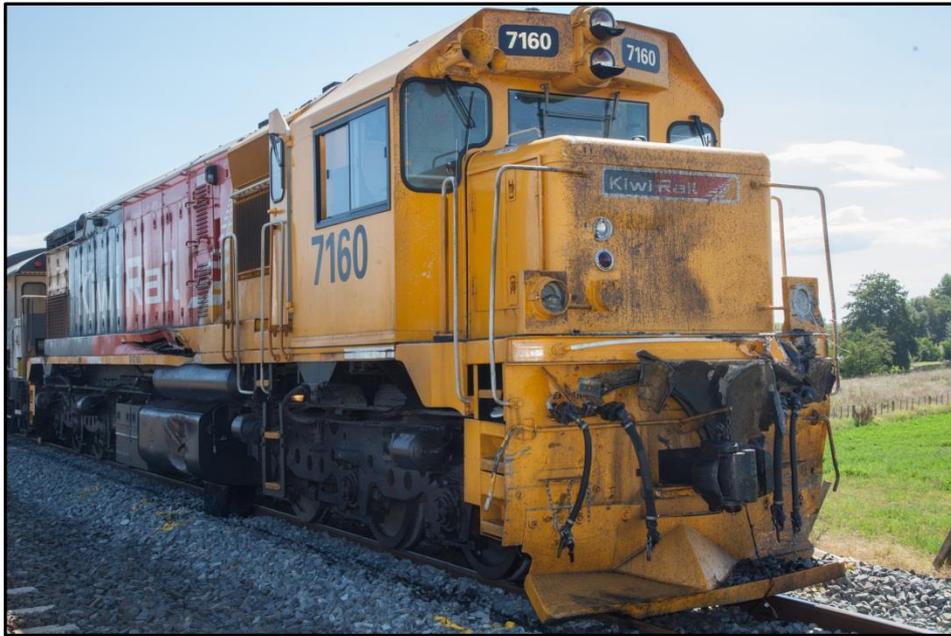
- 3.2.1. There was damage to the cowcatcher<sup>7</sup> and the front structure of the locomotive (see Figure 3). The diesel fuel tank was punctured, resulting in slight seepage that was later contained.

**Figure 3**  
Contact damage to the right side of the locomotive  
(photograph provided by New Zealand Police)

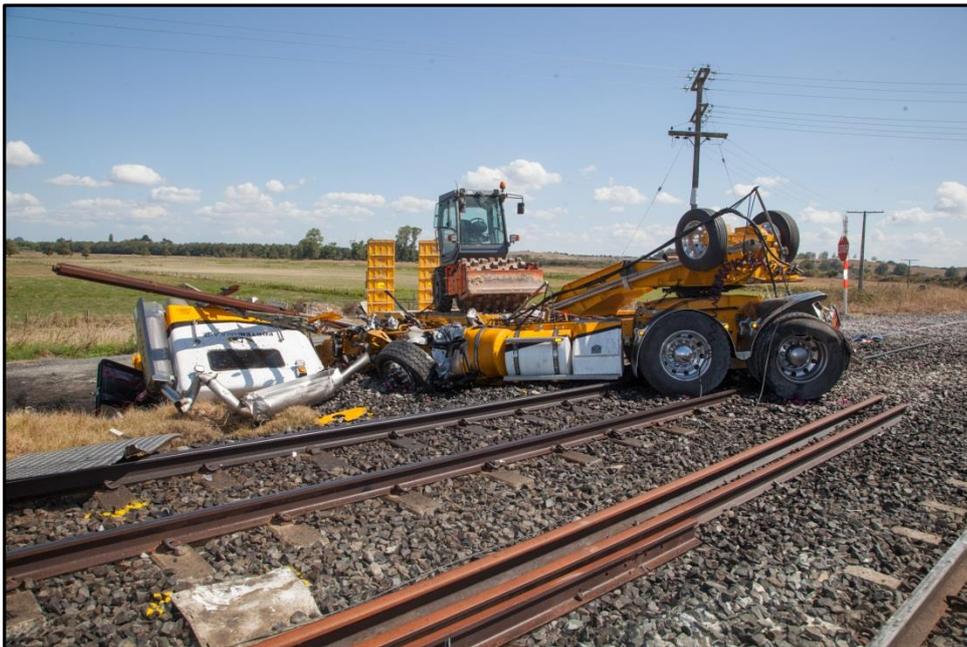
3.2.2. On impact, the truck rotated clockwise and slid in a southerly direction (see Figure 4). The driving unit was damaged beyond repair.

**Figure 4**  
Damage to the truck  
(photograph provided by New Zealand Police)

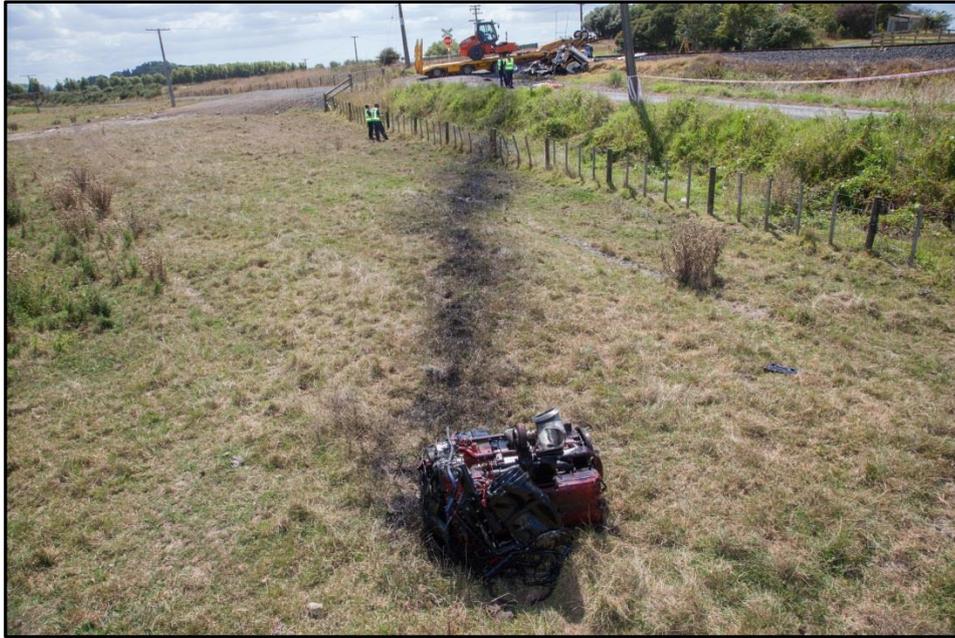
3.2.3. The truck's engine was torn from its mountings and came to rest 46 metres from the southbound line (see Figure 5).

**Figure 5**  
**The at-rest location of the truck's engine**  
**(photograph provided by New Zealand Police)**

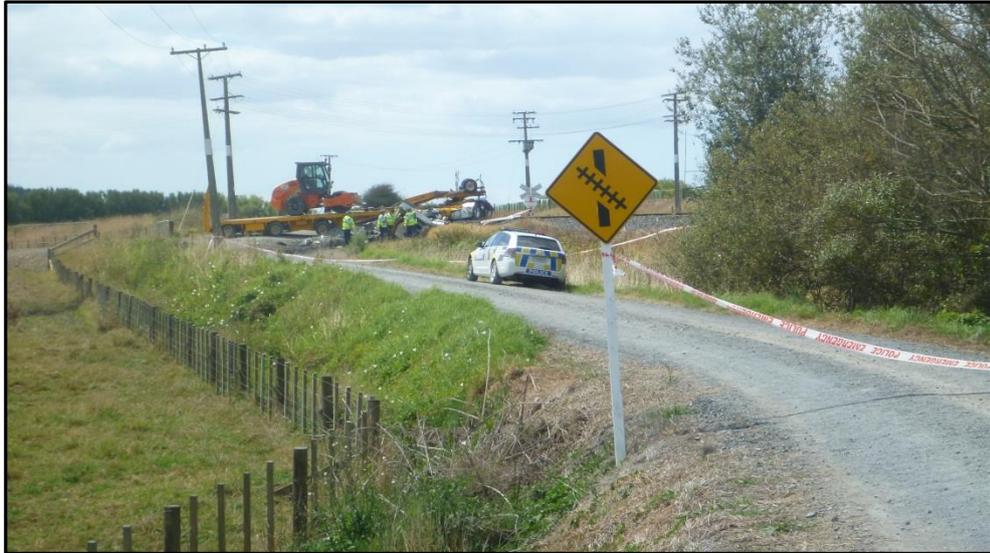
**Figure 6**  
The WX42 acute-to-the-right sign (photograph provided by New Zealand Police)

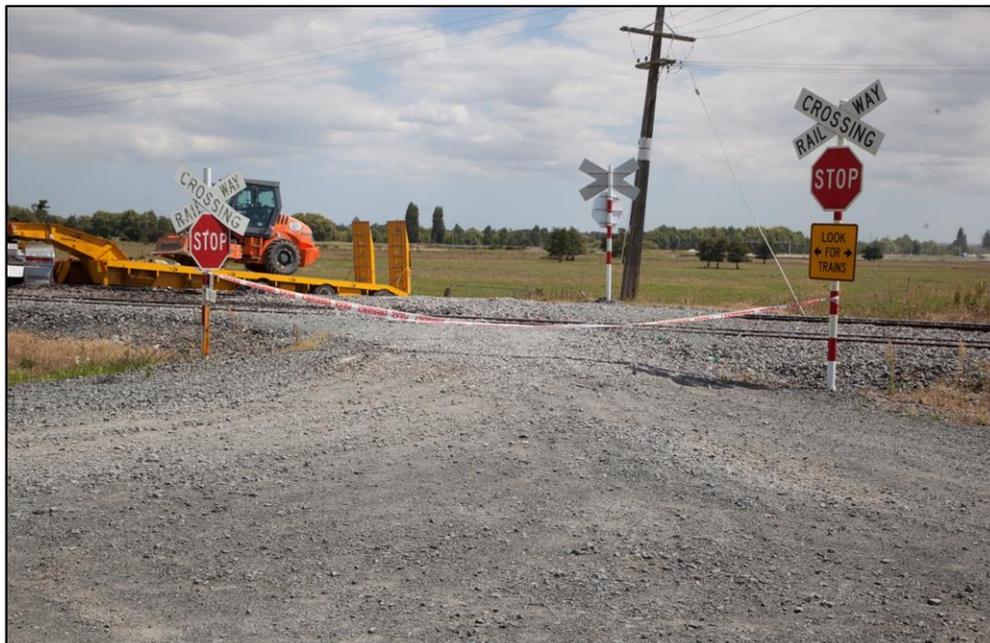
3.2.11. Pole-mounted railway stop assemblies, each consisting of a crossbuck 'RAILWAY CROSSING' mounted above a 'STOP' sign, were erected on each side of the road in both directions (four in total) (see Figure 7). Additionally, one pole assembly in each approach direction had a yellow 'LOOK FOR TRAINS' sign. Similarly, a '2 TRACKS' sign warning drivers that there were two tracks to cross was attached to the other pole on either side of the crossing.

**Figure 7**  
Stop assembly for the westbound road approach

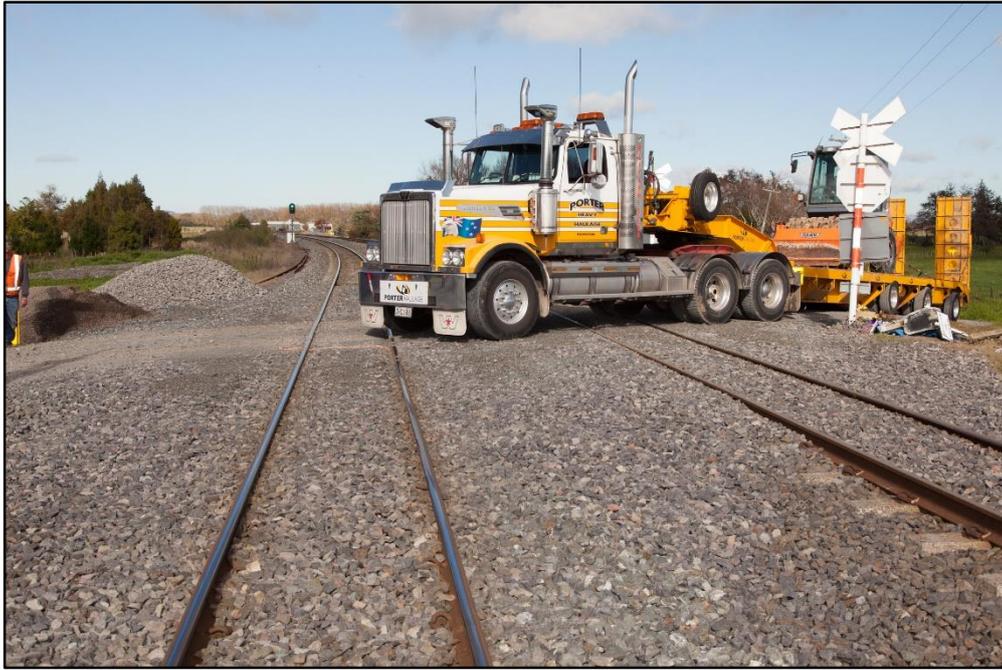
Figure 8  
The stopping position when the ground clearance height was set at 150 millimetres (photograph provided by New Zealand Police)

- 4.4.4. The reconstruction exercise showed that the trailer grounded and the truck became stuck on the level crossing when the trailer height was set at the legal minimum height of 100 millimetres. The exercise was repeated with the ground clearance height set at 150 millimetres with similar results – the trailer grounded and the truck became stuck (see Figure 8). Only with the minimum ground clearance height set at 200 millimetres (twice the minimum legal standard) was the truck able to pass over the level crossing.

- 7.4.1. The Commission recommends that the Chief Executive of the NZ Transport Agency work with KiwiRail and all road controlling authorities to ensure that rail level crossing assessments include a measure of the road profile and compatibility with the allowable dimensions for long and low road vehicles. (013/16)

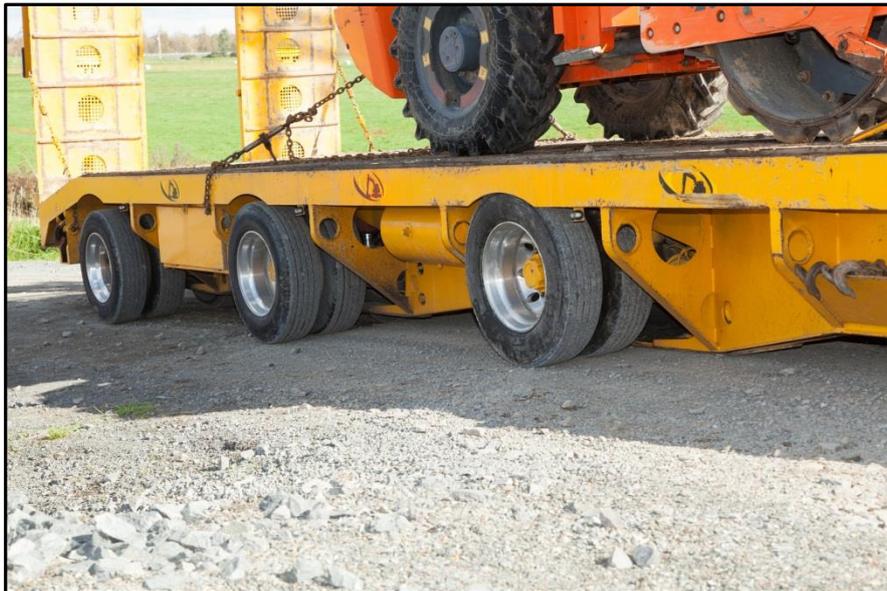
Figure 9  
The trailer underframe in contact with the road surface (photograph provided by New Zealand Police)

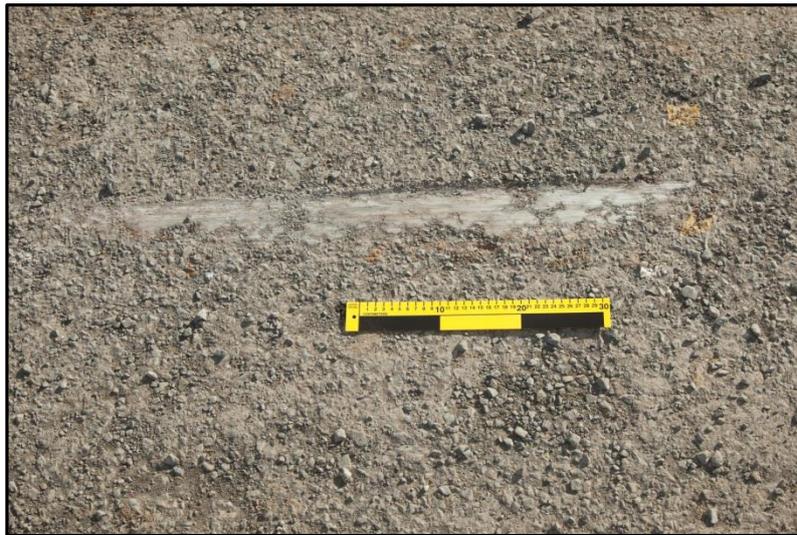
- 4.4.3. The gouge mark on the road surface (see Figure 10) had similar characteristics to the gouge mark identified on the day of the accident.

**Figure 10**  
Gouge mark on the road surface (photograph provided by New Zealand Police)
