Report RO-2014-102: High-speed roll-over, empty passenger Train 5153,
Westfield, South Auckland, 2 March 2014

Final Report

Rail inquiry RO-2014-102,
high-speed roll-over,
empty passenger Train 5153,
Westfield, South Auckland
2 March 2014

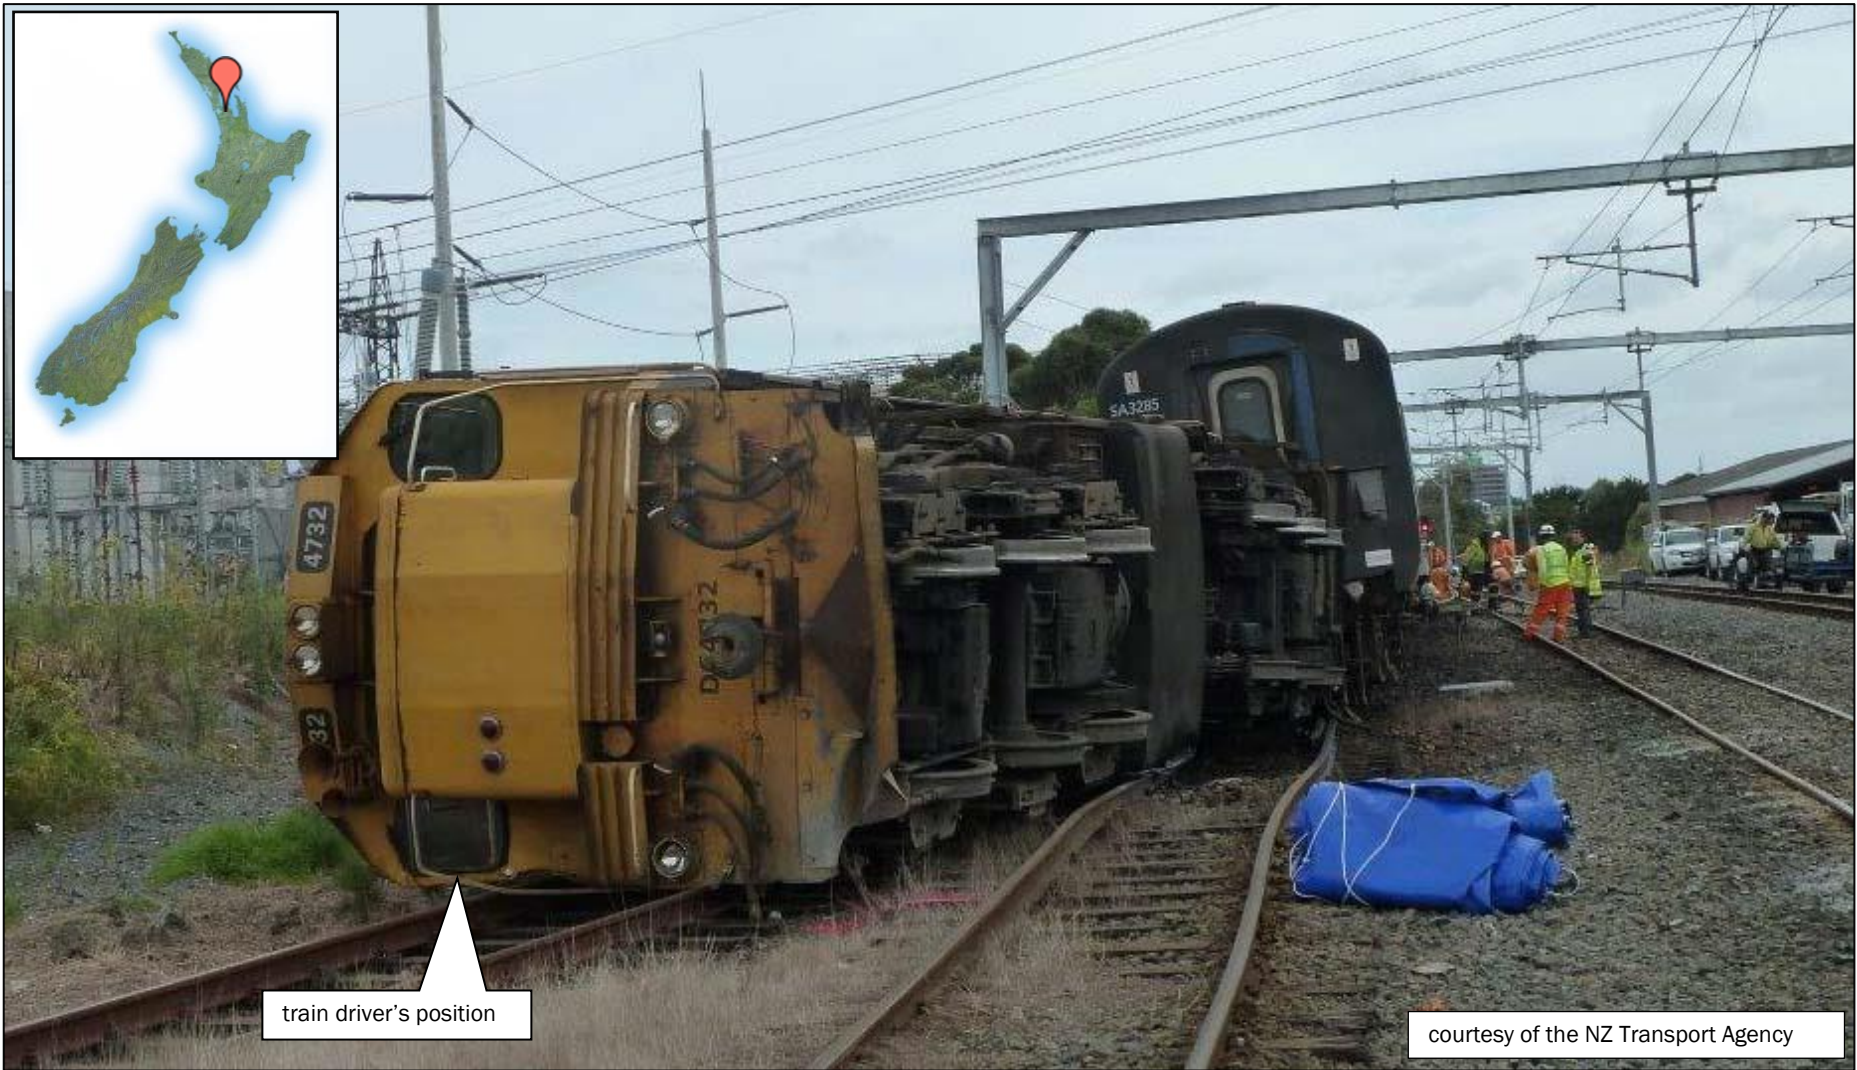
The roll-over site

- 3.1.10. At 0147:07, eight seconds after passing the third signal, the train entered the curved track at the crossover at a speed of 71 km per hour. The locomotive rolled over on to its right-hand side and slid on its side for 94 metres (refer the figure on page iv). The first two carriages derailed but remained upright. The two rear carriages remained upright and on the track.

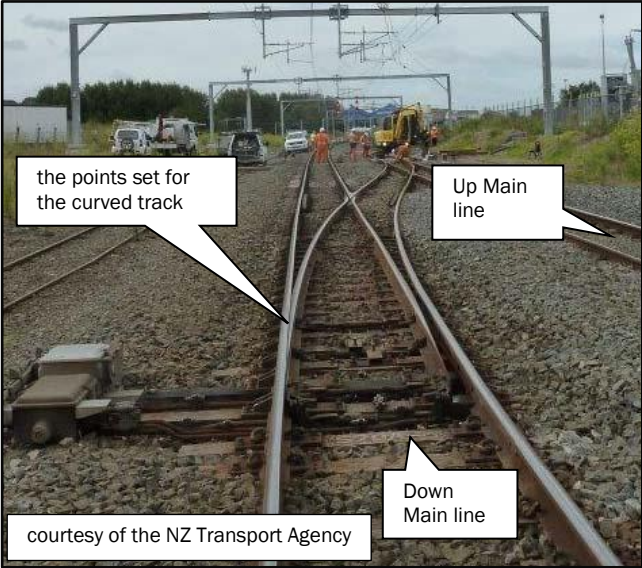
Figure 2
The Westfield crossover points

the No.1570A and No.1570B crossover points at the north end of Westfield used to divert trains between the Down and Up Main lines (see Figure 2)

- 3.1.7. The crossover points between the Down and Up main lines at Westfield had a permanent 25 km per hour speed restriction due to the tight radius curves that trains had to negotiate. The default setting for any crossover was 25 km per hour unless a higher speed was indicated at the final signal. When the train controller selected the new path, the aspects of the three signals preceding the Westfield crossover points changed to an increasing level of warning for the train driver that the path ahead was set to cross to another line. The sequence of aspects shown by all three signals approaching Westfield was identical to those with which the driver had complied when approaching Newmarket about eight minutes earlier.

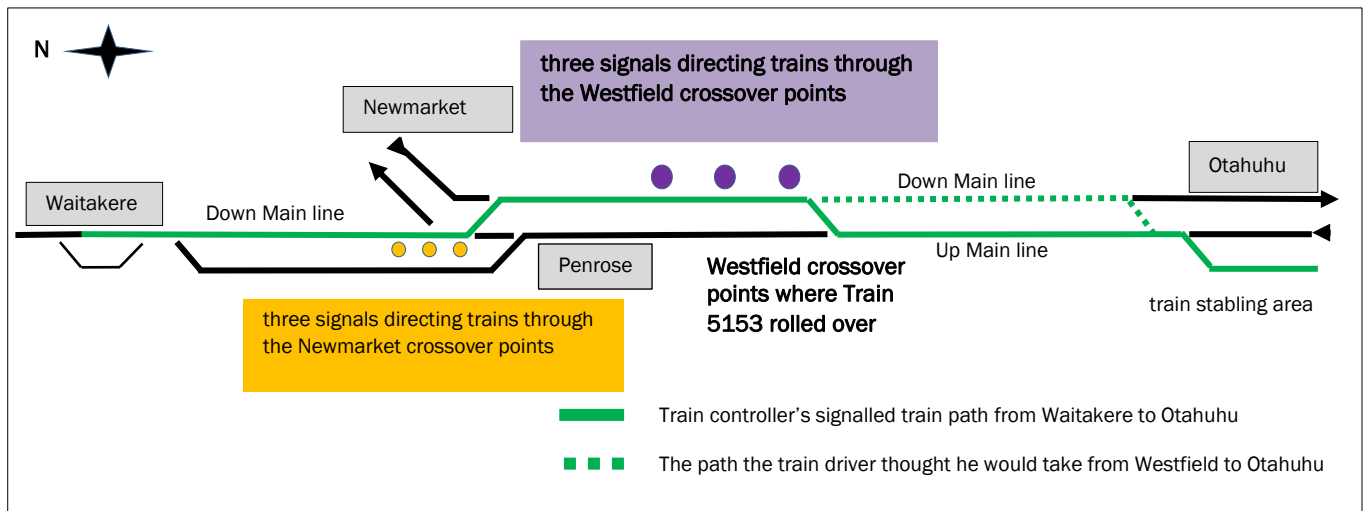
Figure 3
The path of Train 5153 from Waitakere to Otahuhu (not to scale)

- 3.1.4. At 0139 the train passed through the crossover points at Newmarket at a speed less than the authorised 40 kilometres (km) per hour³.
- 3.1.5. At 0142 the train controller selected a path ahead of the train to cross it from the Down Main line on which it was travelling to the adjacent Up Main line, then on to the Otahuhu train stabling area. The train was about 3 km from the first signal at Penrose when the signals were changed to indicate the path through the Westfield crossover points (see Figure 3). The controller made the change in order to co-ordinate several trains that were also returning to the Otahuhu train stabling area.
