Final report RO-2013-103 and RO-2014-103: Passenger train collisions with Melling Station stop block, 15 April 2013 and 27 May 2014

Rail inquiries RO-2013-103 and RO-2014-103

Passenger train collisions with Melling Station stop block, 15 April
2013 and 27 May 2014

Approved for publication: November 2016

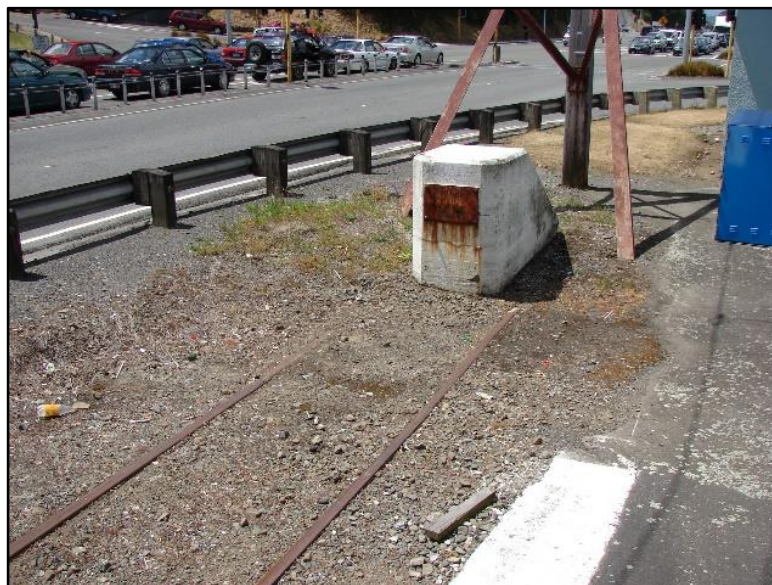
Figure 3
The original Melling stop block
(Matthew25187 at en.wikipedia (<http://en.wikipedia.org>))

- 3.2.3. The stop block was a partially buried concrete structure (see Figure 3). The collision forced the stop block out of the ground and the train rebounded back but remained on the rails (see Figure 4).

4.3.3. The concrete stop block had been installed in 1954. It lacked the impact-absorbing qualities of more modern stop blocks. The less effective they are, the greater the damage to the train and its occupants, as both these collisions demonstrated. The Commission recommended that KiwiRail replace the concrete stop block with a more appropriate shock-absorbing system similar to the type being installed in Auckland at the time. KiwiRail accepted this recommendation and replaced the stop block.

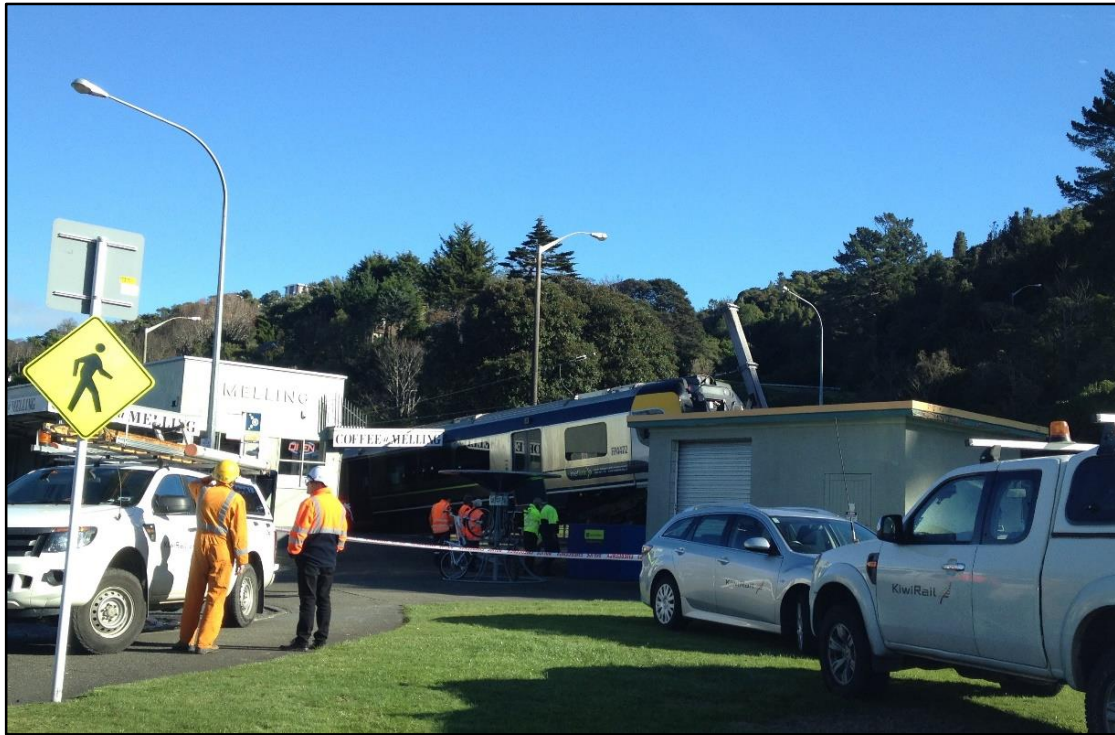
Figure 5
Melling 2 impact

3.2.7. The train collided with the concrete stop block that had been reinstalled after Melling 1 (see Figure 5 and Figure 6).

3.2.8. The train came to rest on top of the stop block. The concrete block split and the terminal pole for the overhead power line, mounted directly behind the stop block, was severed at ground level. The overhead contact wire drooped and momentarily touched the roof of the train.

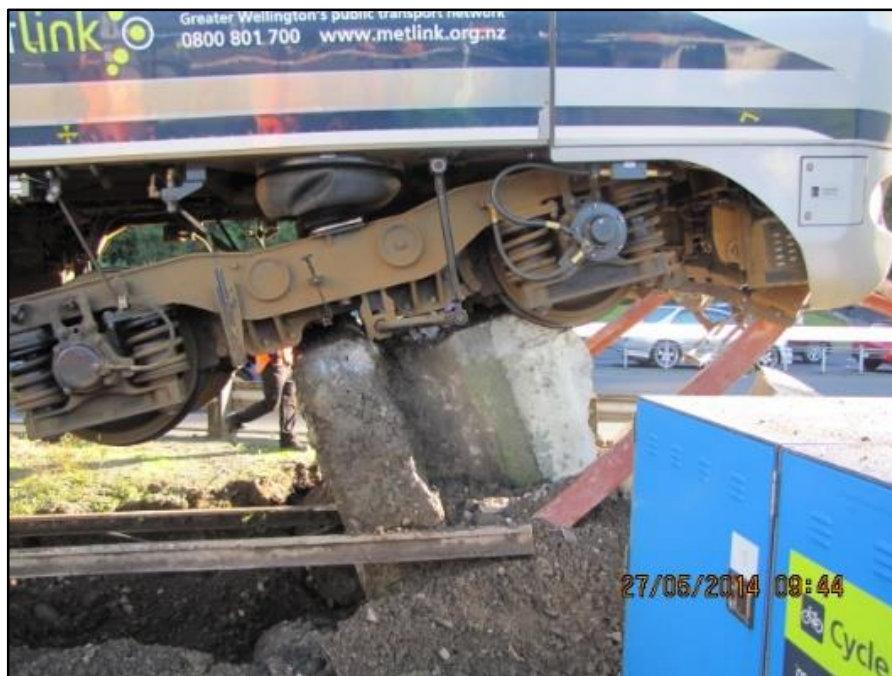
Figure 6
The stop block in Melling 2

3.2.9. When the live contact wire touched the train, it tripped the circuit breaker in the local electrical substation. The KiwiRail traction controller on duty at the time in the Wellington National Train Control Centre noted that the circuit breaker had tripped. The train controller called the Melling 2 driver on the radio but did not get a response, so the train controller and the traction controller agreed they would reset the circuit breaker remotely.

4.3.5. The Commission recommended that KiwiRail relocate the terminal pole out of line with a direct overrun. This has since been completed with a new cantilevered pole mounted off to one side of the rail centreline and the safety recommendation has been closed.
