Final report RO-2014-105: Near collision between train and hi-rail excavator,  
Wairarapa Line near Featherston, 11 August 2014

Rail inquiry RO-2014-105  
Near collision between train and hi-rail  
excavator,

Wairarapa Line near Featherston

11 August 2014

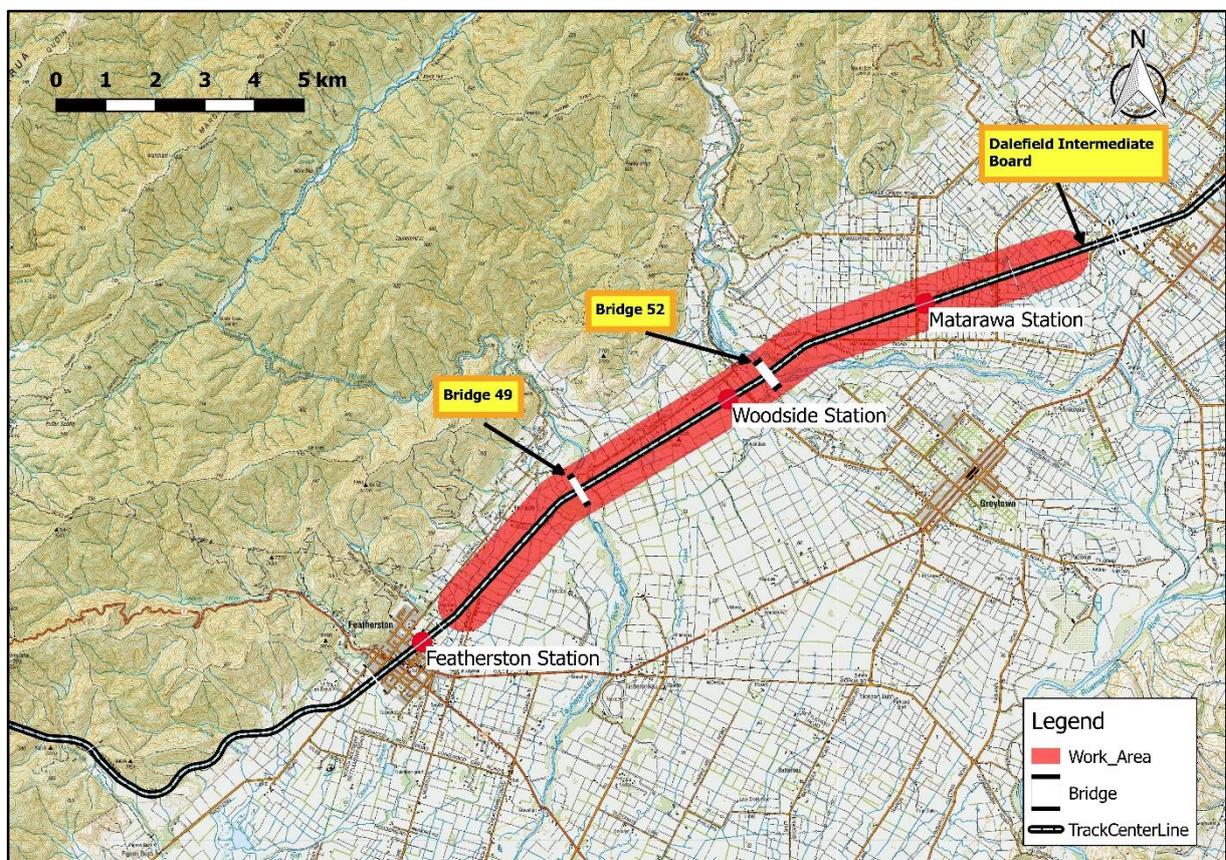
Figure 1  
The protected work area

- 3.2.5. The rail protection officer drove from Featherston Station to Bridge 49 (see Figure 1) after he completed his cell phone call with the structures field engineer. The track warrant was shown to the leading hand before he gave a pre-shift safety briefing to all personnel on site.

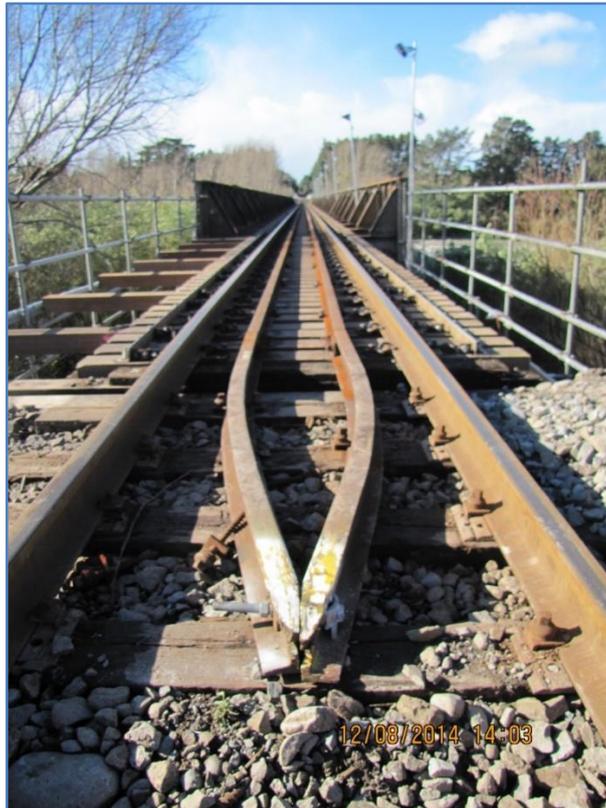
**Figure 2**  
**The approach to Bridge 49 from the south**

- 3.2.26. The repositioning train departed from Featherston at about 0313. At 0318 the driver was slowing his train for the 25-kilometre-per-hour temporary speed restriction across Bridge 49 when he saw flashing lights from a vehicle that appeared to be on track at the north end of the bridge. He stopped the train a few metres from the south end of the bridge, some 180 metres short of the hi-rail excavator and the work group that was occupying the track.
