Final report MO-2014-203: Fatal injury, Purse seine fishing vessel,
Captain M. J. Souza, 24 August 2014

Marine inquiry MO-2014-203
Fatal injury
Purse seine fishing vessel, *Captain M. J. Souza*
24 August 2014

Approved for publication: September 2016

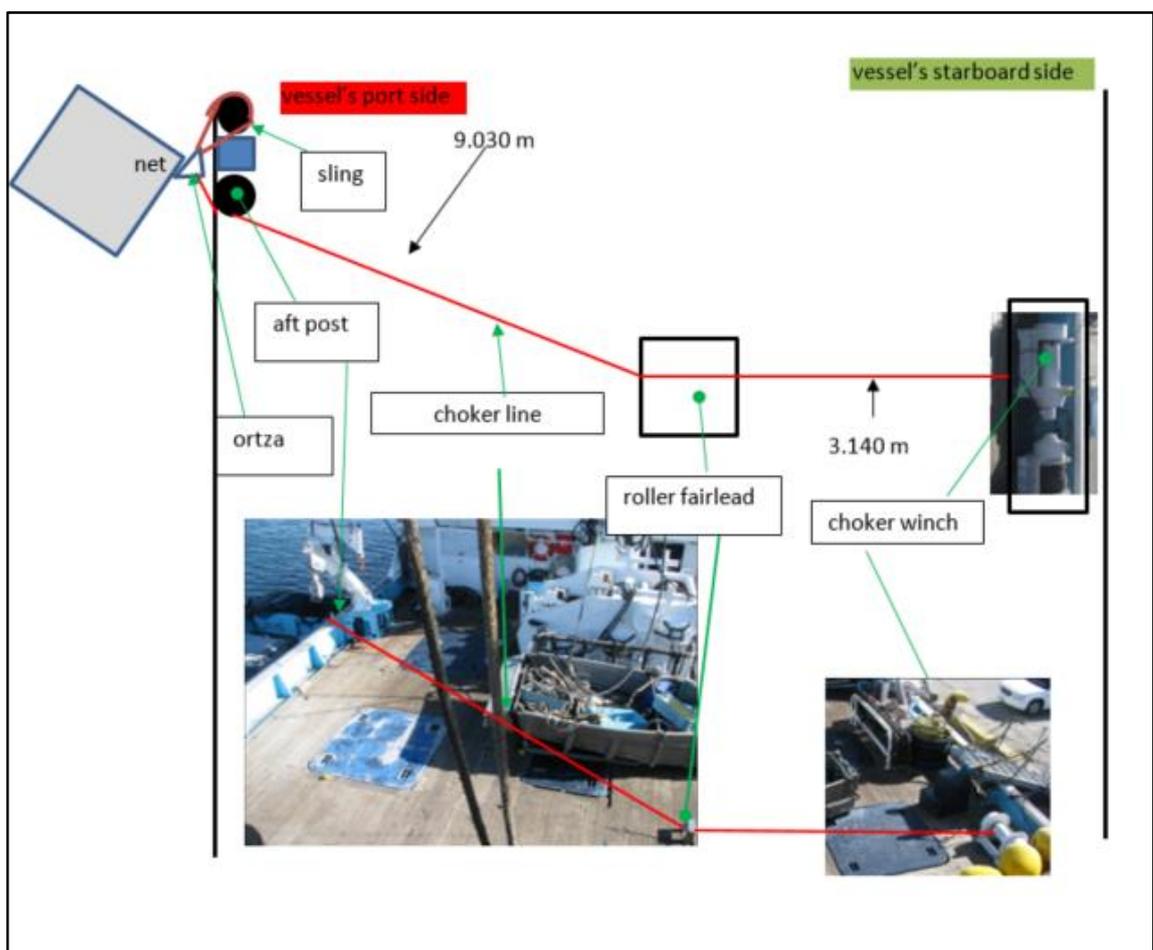
Figure 2
Location of the choker line on the upper deck

- 3.2.6. The crew also attached a 48-millimetre (mm) diameter double-braided nylon rope⁷ called the 'safety choker line' (choker line) to the ortza as a backup in the event that the sling parted.
- 3.2.7. One end of the choker line was attached to the ortza using a bowline knot⁸ (see Figure 5). The other end was attached to the choker winch on the starboard side of the vessel (see Figure 2).

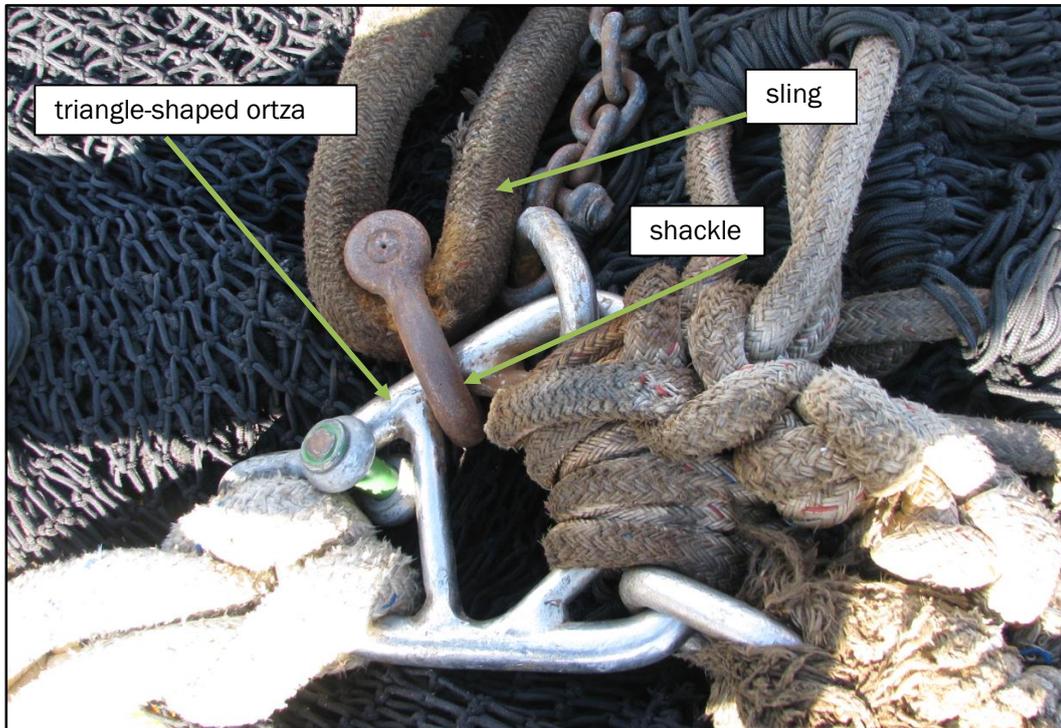
Figure 3
Photograph of an ortza on board the *Captain M. J. Souza*

- 3.1.4. The skiff end of the net is attached to an ortza⁵ (see Figures 3 and 4). When recovering the net from the skiff, the ortza is hauled on board using a winch⁶. When the ortza is within reach, a double-braided nylon sling, already attached to the ortza, is secured to a stainless-steel post on the port side of the ship. The weight of the ortza and the net is transferred from the winch to the post.

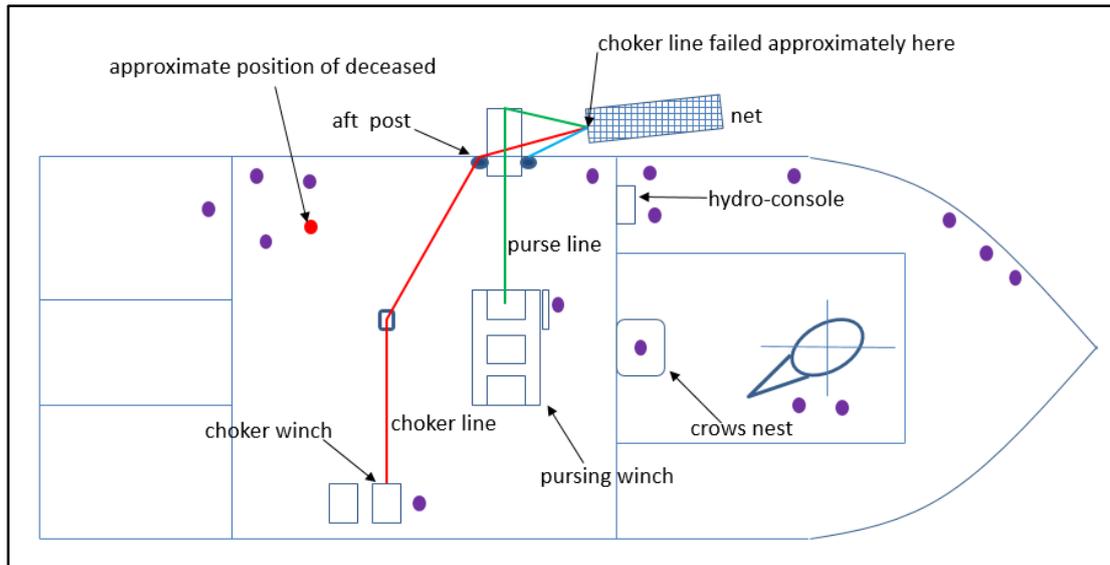
Figure 4
Location of the crew and equipment at the time of the accident

3.2.15. A few minutes after the pursing operation had restarted, the crew heard a loud bang. The choker line had parted at or near the bowline knot and snapped backwards, striking a crewmember, one of the deckhands, in the head. The deckhand died instantly.

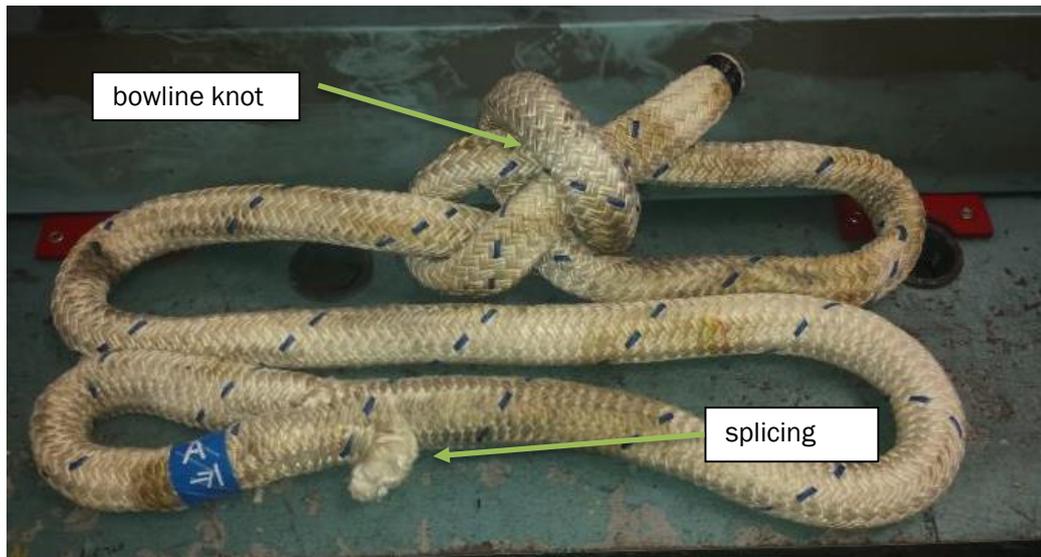
3.3.2. The ortza end of the choker line had originally had an eye splice¹³, which had parted a few weeks prior to the accident. The broken eye splice was replaced with a bowline knot before the same choker line was put back into service, which was a departure from the procedures outlined in the Talleys safe working practice document.

Figure 5
Sample rope with bowline knot on one end and eye splice on the other end

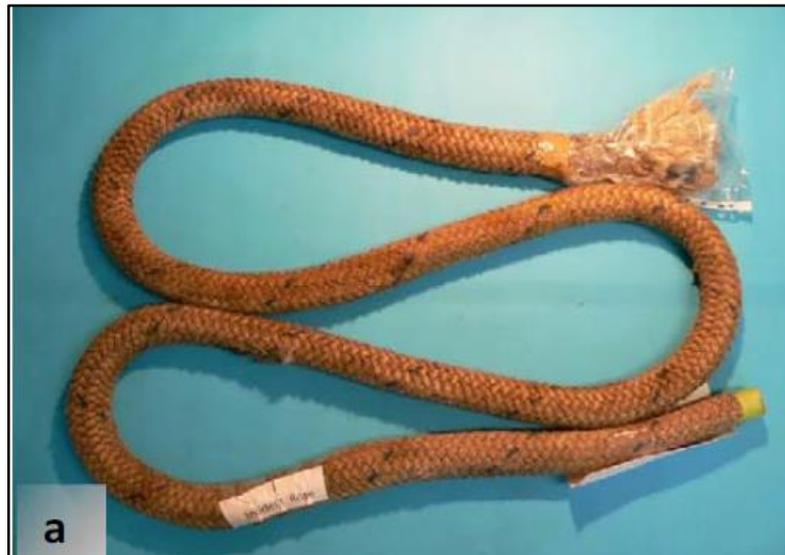
The general damage morphology of the choker line was consistent with predominantly cyclic tension loading, a form of fatigue¹⁵ damage.

It is clear from the evidence that the choker line was in a deteriorated condition at the time it broke. Visual examination of the rope revealed extreme cyclic tension damage and the outer surface also resembled abrasion category 5-6. The ultimate failure was most likely caused by overload of the remaining relatively intact strands, after many fibres had already broken in service. This in service damage substantially reduced the strength of the rope, to the point that it exhibited a small fraction of its original breaking strength.

The cover strands, and core strands, of an untested section exhibited tangled fibres and broken fibres, consistent with cyclic loading damage¹⁶.

Figure 6
Choker line
(Photo courtesy Scrase Metallurgical Solutions)

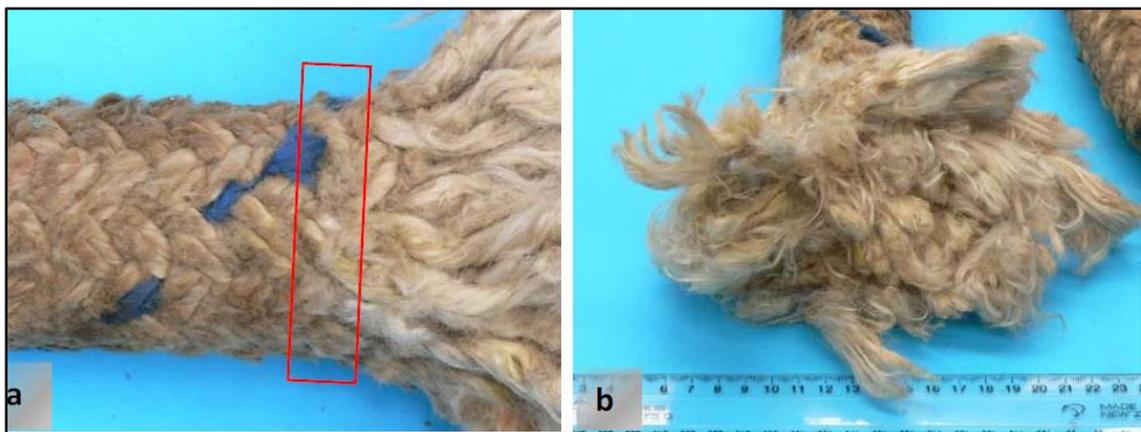
The incident break started at approximately the same axial location all around the circumference of the rope, indicated by the red rectangle in Figure 2a [Figure 7]. No evidence of deliberate cutting, as might have occurred with a knife for example, was observed. No evidence of severe or localised abrasion was observed on the outer strand fibres.

Figure 7
Broken end of choker line
(Photo courtesy Scrase Metallurgical Solutions)

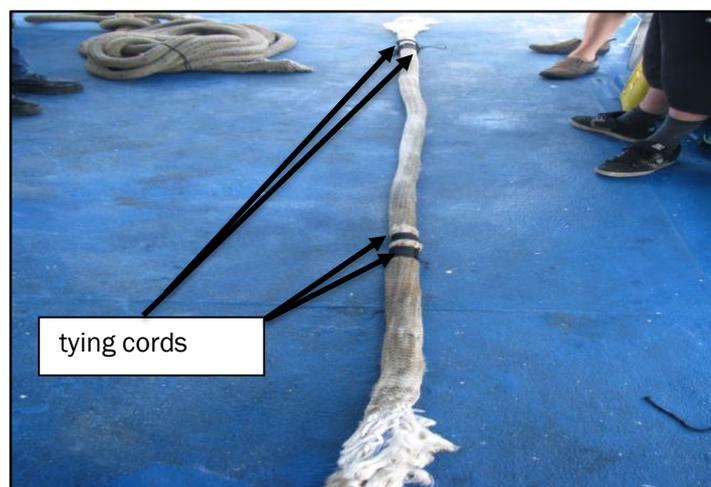
The general outside condition of the rope appeared to be relatively free from damage, compared with the choker line, but exhibited some broken fibres protruding from the otherwise smooth surface. The sling had a very soft and supple feel. It could easily be squeezed in the circumferential direction by hand and move axially.

The rope had 4 tying cords at various locations along its length [refer Figure 8]. Two of these had been made by tightly wrapping and finally tying many turns of black cord around the rope and these two cords appeared to be intact. The other two were loose and did not constrict the rope significantly. The core could easily be pulled out of the cover except where the two tight constrictions held it.

Figure 8
Sling rope core and cover bound by four tying cords

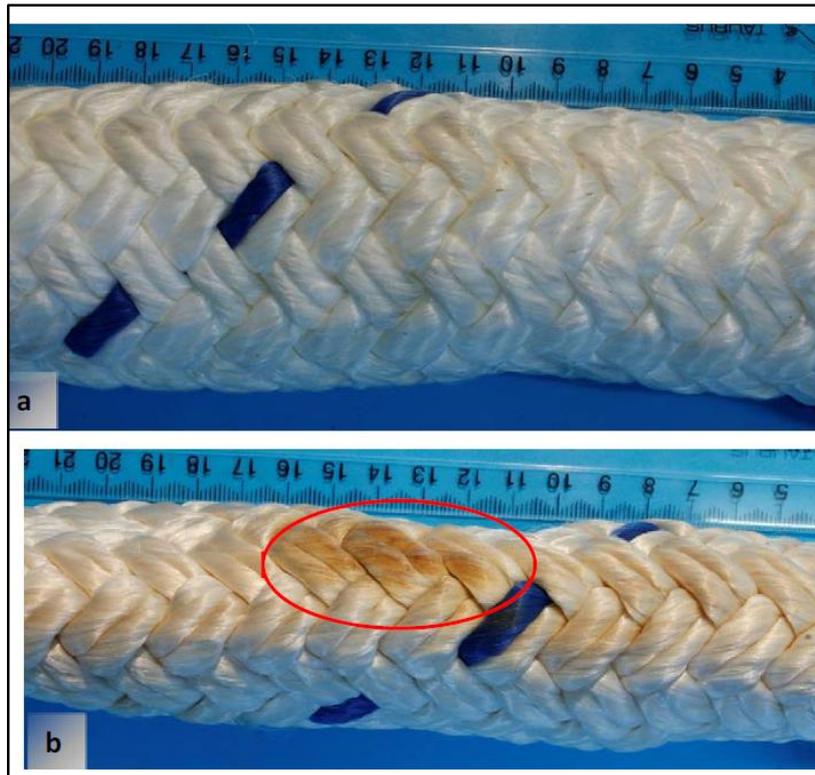
Figure 9

- 3.4.10. The sample rope was 32 metres in length and sourced from on board the *Captain M. J. Souza*. Visually the rope appeared to be in good condition compared with the choker line, but there was some indication of possible crushing and heat damage (see Figure 9). To test it, the rope was cut into five lengths, each six metres long. Two lengths had an eye splice at one end and a bowline knot at the other end. The remaining three pieces had eye splices at both ends.

Reported new rope sample. Red ellipse indicates possible heat damage. (a) and (b) taken at same magnification showing the variation in diameter of the rope due to crushing

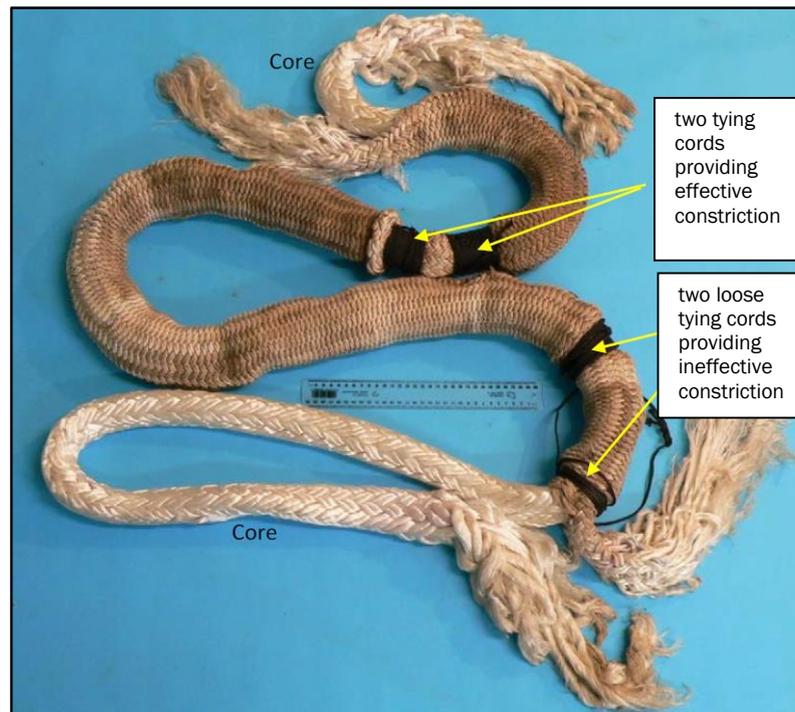
Figure 10
Sling with core pulled out, past two ineffective constrictions but held by two tight constrictions
(Photo courtesy Scrase Metallurgical Solutions)

- 4.2.8. The sling failed at the splice. The SMS report stated that it was difficult to determine whether the splice had been constructed in accordance with general industry guidelines. However, the presence of the tying cords²¹ (see Figure 10) suggested that it had not. The report also stated that there were breaks at both ends, not straight cuts, indicating that a splice might have come apart gradually while in service. The sling then most likely experienced loads sufficient to cause the observed predominantly tensile breaks²².

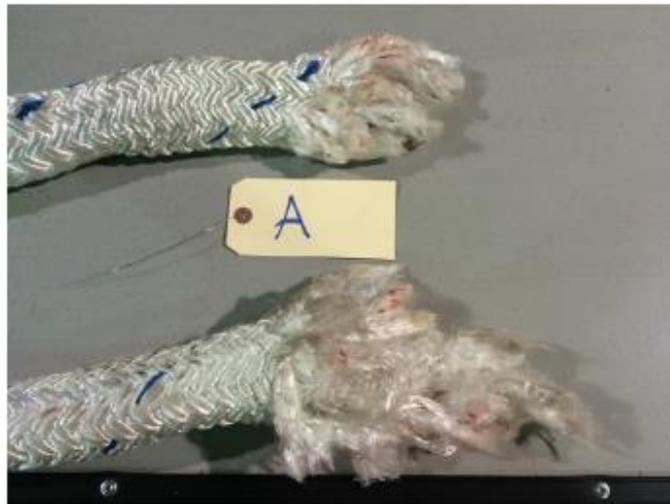
4.1 Sample A

Peak load (breaking Load):	106,100 LBS. (48.13 tonnes)
Location of failure:	At the end of the tapered splice tail.
Elongation:	9" 228.6 mm
Comments:	Test was seen as a successful break and failure was seen at an estimated weak point.

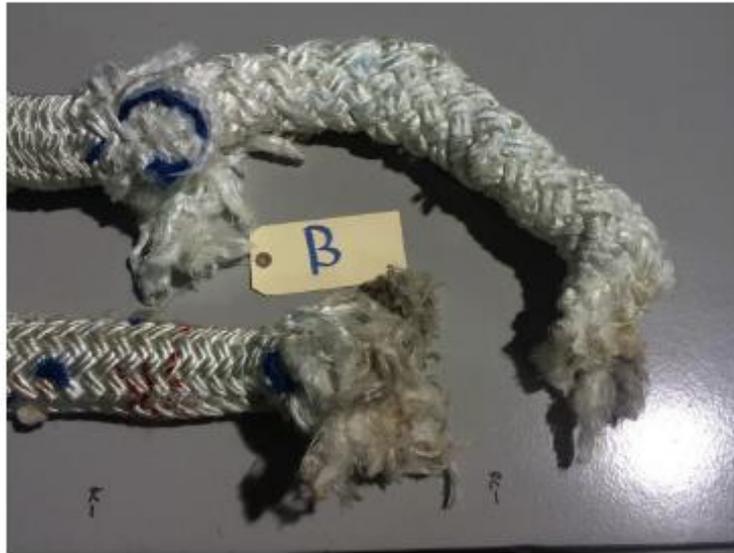
4.2 Sample B

Peak load (breaking Load):	130,700 LBS. (59.28 tonnes)
Location of failure:	At the end of the tapered splice tail.
Elongation:	10" 254 mm
Comments:	Test was seen as a successful break and failure was seen at an estimated weak point.

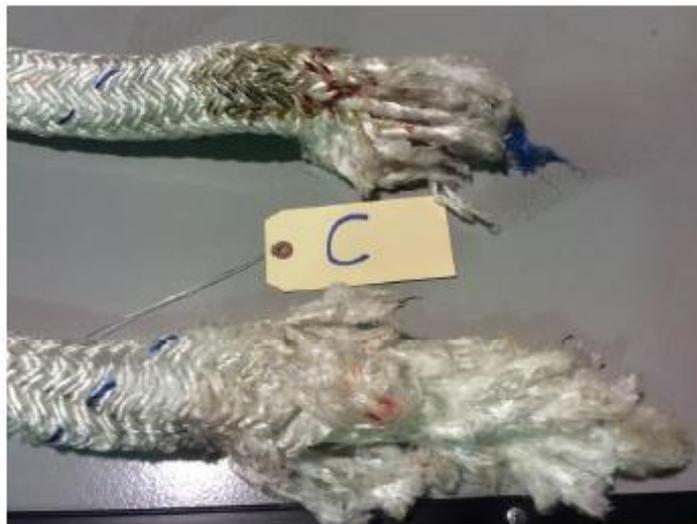
4.3 Sample C

Peak load (breaking Load):	119,5000 LBS. (54.20 tonnes)
Location of failure:	At the end of the tapered splice tail.
Elongation:	9" 228.6 mm
Comments:	Test was seen as a successful break and failure was seen at an estimated weak point.
