Final report AO-2015-003: Robinson R44, Main rotor blade failure,  
Waikaia, Southland, 23 January 2015

Aviation inquiry AO-2015-003  
Robinson R44  
Main rotor blade failure  
Waikaia, Southland  
23 January 2015

Approved for publication: December 2017

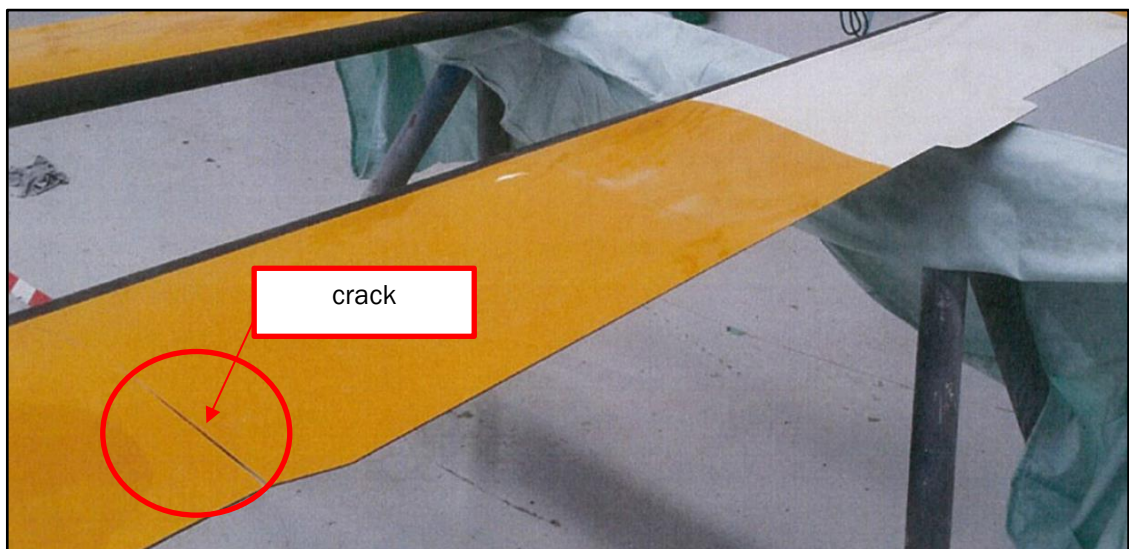
Figure 1  
Cracked blade

- 1.1. While spraying gorse near Waikaia on 23 January 2015, the pilot of a Robinson R44 helicopter felt an unusual and significant vibration. He landed immediately and discovered a large crack in the lower skin of one of the main rotor blades.

- 3.1.3. At the onset of the vibration the pilot was about 200 metres from the landing site so he elected to land there. After landing, ground staff noticed an abnormal movement of one of the main rotor blades, so the pilot shut down the helicopter immediately. He inspected the helicopter and noticed a large crack on the lower surface of one of the main rotor blades, extending from the trailing edge to just behind the 'D spar' leading edge (see Figures 1 and 2).

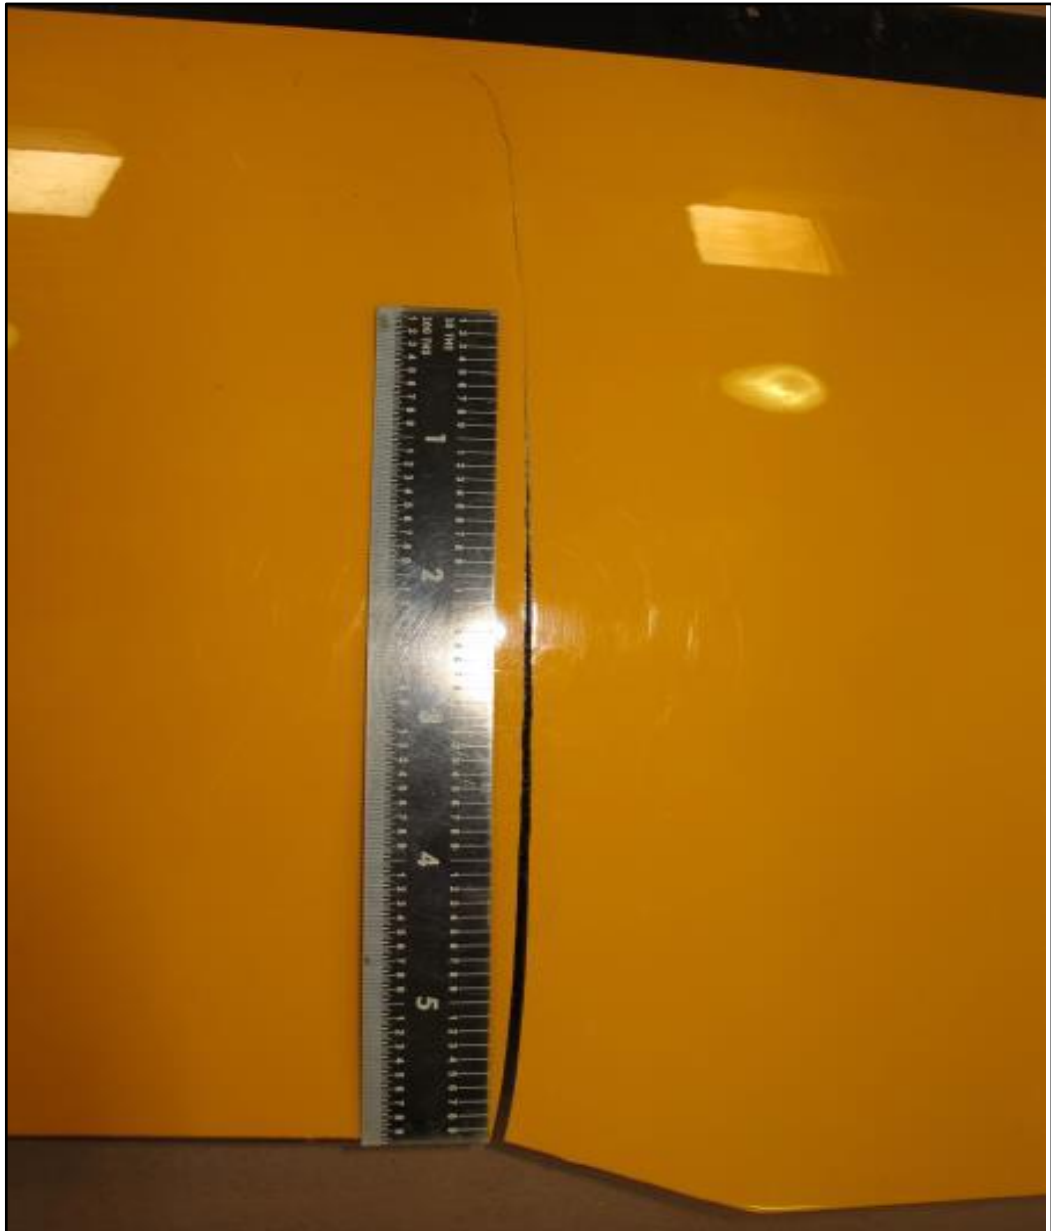
**Figure 2**  
**Blade crack at chord transition**

- 1.2. The crack's origin contained features characteristic of metal fatigue. The crack had started in a radius in the blade trailing edge, known as the 'chord length transition'. Flight testing by the manufacturer found that the stress in this area was higher than had been thought.

- 3.1.4. The helicopter was taken out of service and both main rotor blades were removed. The blades were shipped to the Robinson factory in the United States for detailed inspection. Here it was noted that the crack appeared to have started in a radius in the trailing edge where the chord length<sup>2</sup> of the blade increased, known as the 'chord transition'<sup>3</sup> (see Figures 2 and 3).

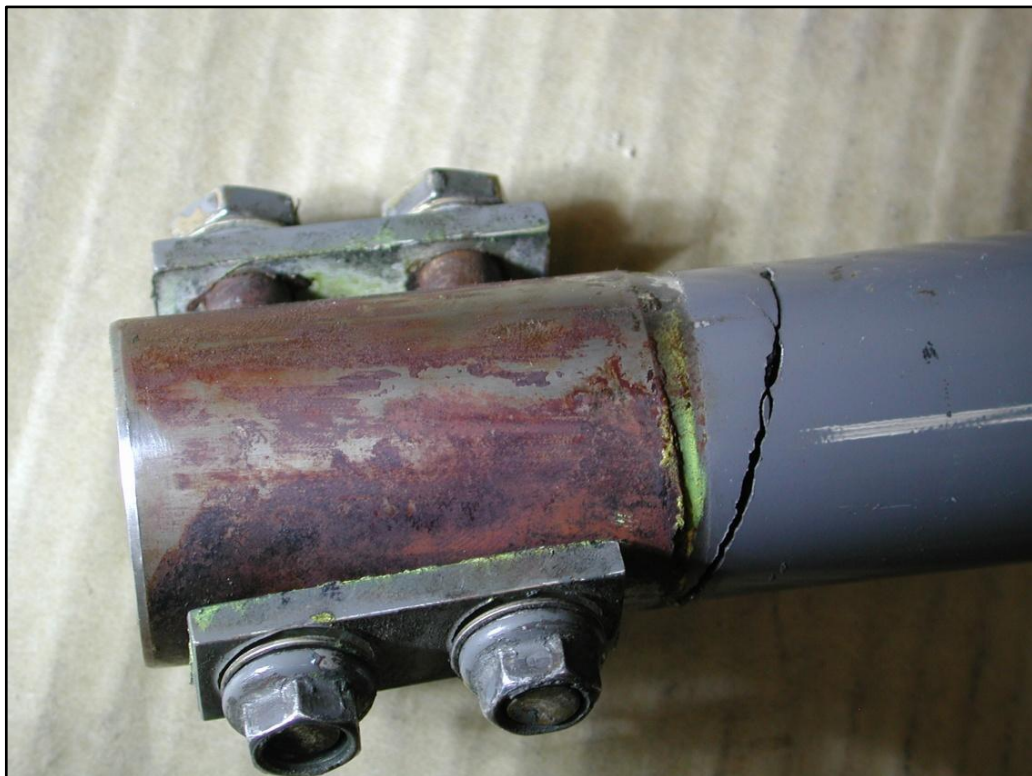
Figure 7  
Cracked clutch shaft

- 3.6.1. On 25 November 2015, a different pilot flying the helicopter for the operator felt a sudden and high frequency vibration accompanied by the clutch<sup>25</sup> light flickering rapidly. He landed immediately and shut down the helicopter. A significant crack was found in the clutch shaft, which was removed and sent to a metallurgy specialist for closer examination.
- 3.6.2. The metallurgist determined the crack was a torsional fatigue fracture,<sup>26</sup> and only 13% of the shaft's circumference remained intact. The fracture had initiated aft of two bolts used to attach the clutch shaft to the main rotor system (see Figure 7).

- 3.6.3. The metallurgist found two maintenance factors that had contributed to the shaft failure: one of two attachment bolts was below its nominal torque value, and an incorrect jointing compound had been used. The CAA subsequently issued Airworthiness Directive DCA/R44/33, which stated, in part, that the torque on the bolt probably reduced due to the

breakdown of the incorrect jointing compound. The CAA also required all R44s in New Zealand to be inspected to ensure the correct jointing compound was used and that there were no cracks or under-torqued bolts.

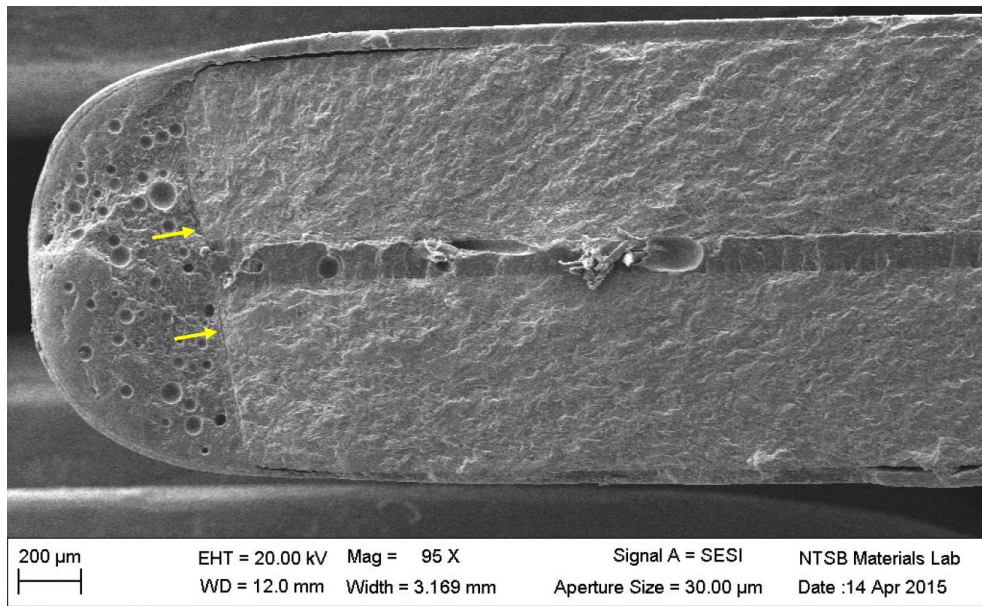
Figure 8  
Crack origin

- 4.2.1. The NTSB laboratory examination determined that the crack initiation site contained features consistent with fatigue failure, and that its point of origin was at the trailing edges of the upper and lower skins, where they were bonded together (see Figure 8). The portion of the fracture surface consistent with fatigue cracking was 3.65 inches in length and exhibited features typical of progressive crack growth. The remainder of the fracture exhibited mixed-mode<sup>28</sup> cracking, then a pure overstress failure (see Figure 9).

- 4.2.2. The examination report concluded that there were no manufacturing defects in the materials, or in the construction of the blade, with all components of the blade meeting the design specifications. The materials experts from the NTSB also stated that the crack may have started in the epoxy sealant that coated the trailing edge, and that it could have spread into the aluminium skin from there. The epoxy sealant was not intended to be a structural or load-bearing component of the blade and is designed to flex with it. However, if the blade was to flex or bend significantly in service under cyclic loads, it is possible the epoxy could have cracked first, creating a further stress concentration at that location.

1. The point of origin of the crack in the main rotor blade trailing edge had features consistent with metal fatigue.
