Final report AO-2016-006: Eurocopter AS350-B2, ZK-HYY, Collision with terrain during scenic flight  
Mount Sale, near Arrowtown, 12 September 2016

Aviation Inquiry AO-2016-006:  
Eurocopter AS350-B2, ZK-HYY  
Collision with terrain during scenic flight  
Mount Sale, near Arrowtown  
12 September 2016

Approved for publication: February 2018

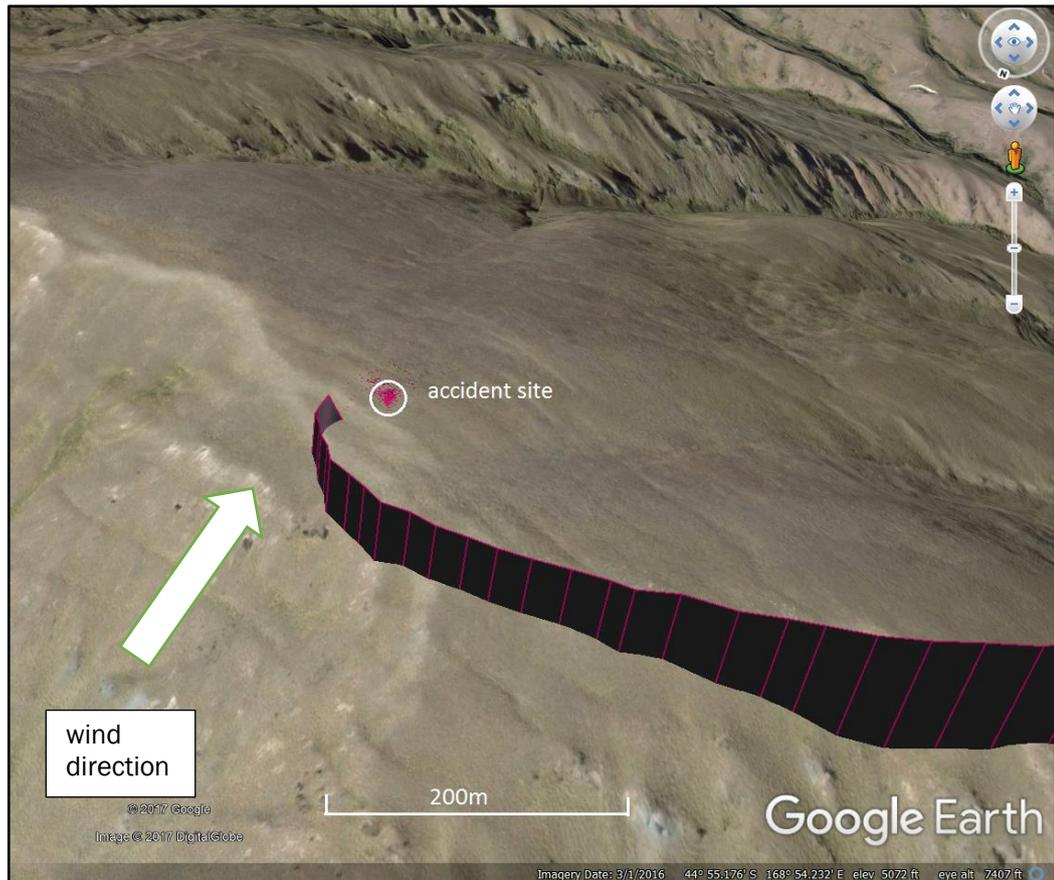
- 3.1.5. The pilot stated that he made a "normal" approach to the ridgeline and landing area (see Figure 2). There was no turbulence and he estimated there was a crosswind from the west at about 10-15 knots (kts). Some of the passengers said that they thought the helicopter was not going to land because of the high (ground) speed as they got closer to the landing area.

**Figure 2**  
Final approach flight path (source: Airways New Zealand surveillance data)

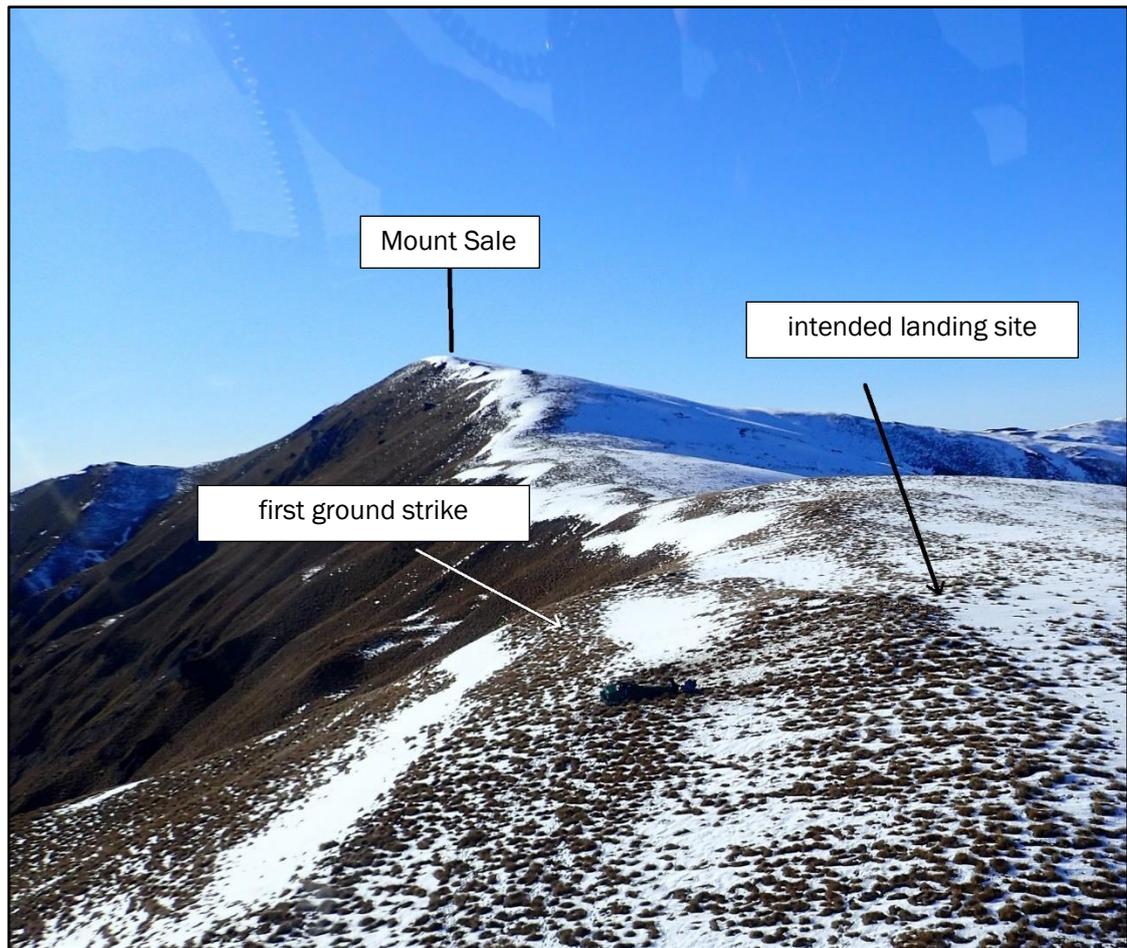
- 3.2.1. The accident occurred on a north-facing slope west of the summit of Mount Sale, a peak 1,700 m (5,576 ft) high, 5 km northeast of Arrowtown. The landing area was on a slightly sloping section of the ridgeline (see Figure 3). The operator used the landing area often, but did not have a dedicated wind marker placed there. At the time there was a light covering of snow on the tussock grass.

Figure 3  
Mount Sale ridgeline and accident site

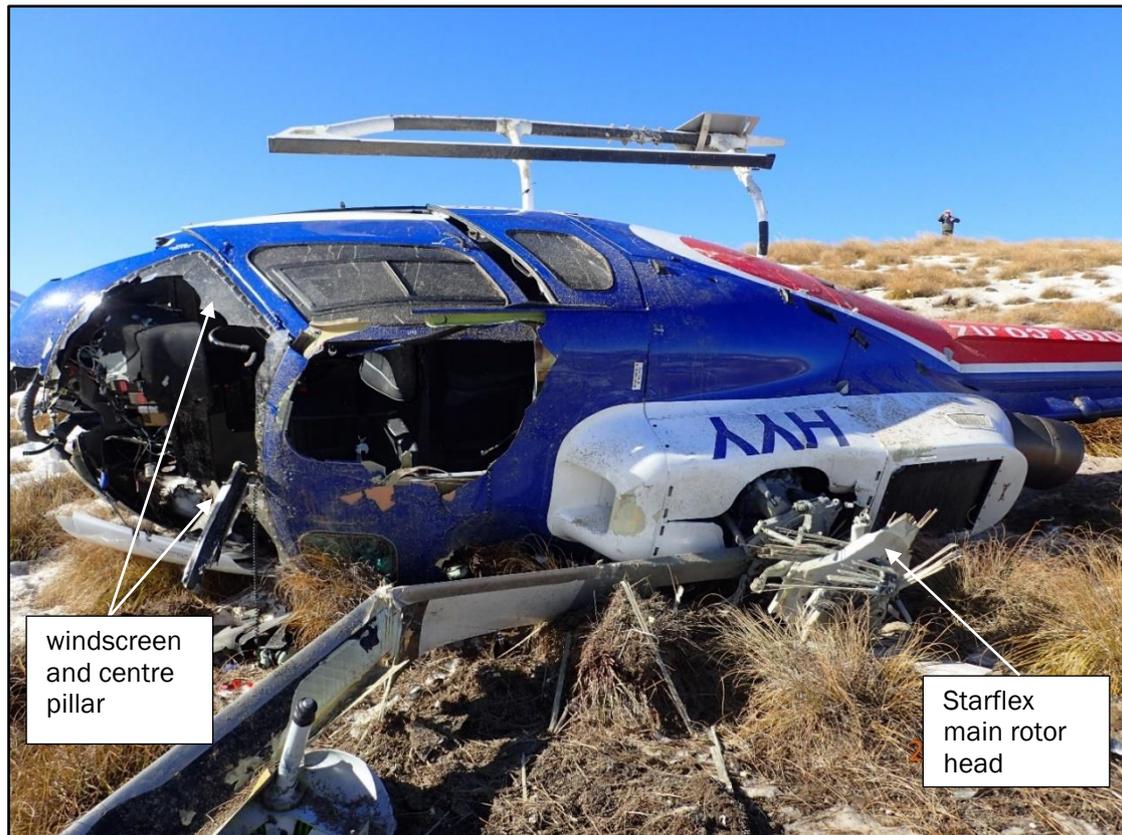
- 3.2.2. The right skid penetrated the snow and made contact with the ground while the helicopter was moving forward, at a point about 35 m to the north of the intended landing point. Shortly afterwards the main rotors struck the ground, which caused the helicopter to reverse direction.
- 3.2.3. The helicopter rolled left through 90 degrees and came to rest on its left side, approximately 20 m from the initial ground strike and 30 m from the intended landing point.
- 3.2.4. The fuselage structure remained largely intact, but the upper-forward cabin structure, windscreen and centre pillar were struck by the main rotor blades and portions of these parts were thrown some distance from the helicopter (see Figure 4).

Figure 4  
Helicopter wreckage

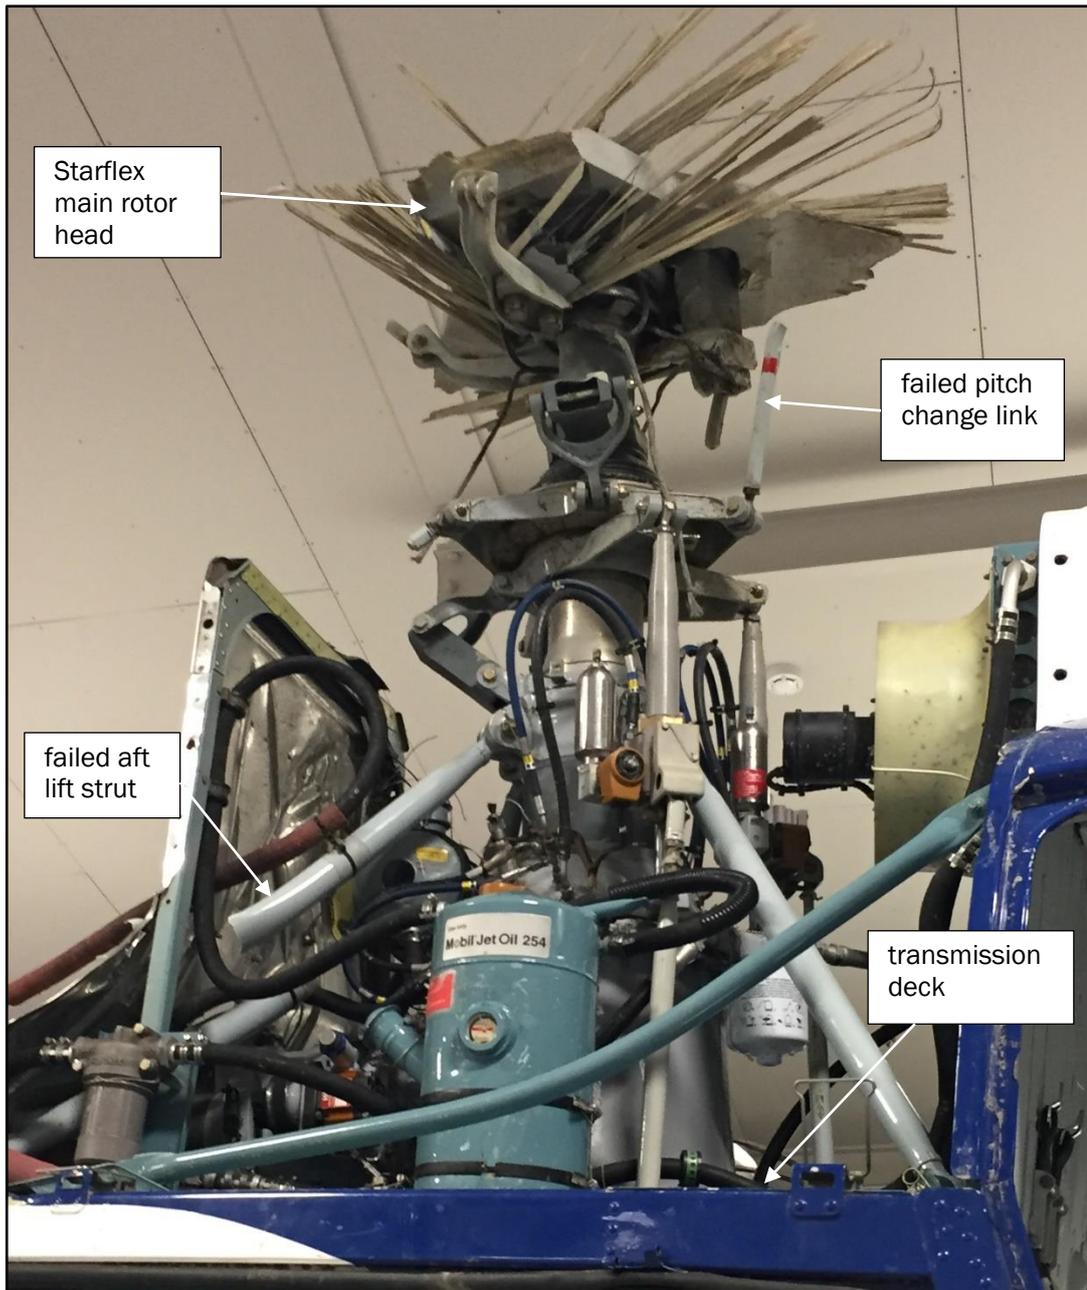
- 3.2.5. All three main rotor blades were destroyed and the arms of the Starflex main rotor head separated. All three pitch change links failed during the break-up of the main rotor (see Figure 5). Pieces of the main rotor blades and main rotor head assembly were found some distance from the helicopter.

- 3.2.6. The left and right aft lift struts on the main rotor gearbox failed and the supporting airframe structure on the main rotor transmission deck was deformed.

**Figure 5**  
Main rotor gearbox with main rotor head damage due to rotation under high power
