Final report MO-2016-204: Bulk carrier, *Molly Manx*, grounding,  
Otago Harbour, 19 August 2016

Marine inquiry M0-2016-204  
Bulk carrier, *Molly Manx*, grounding,  
Otago Harbour, 19 August 2016

Approved for publication: October 2017

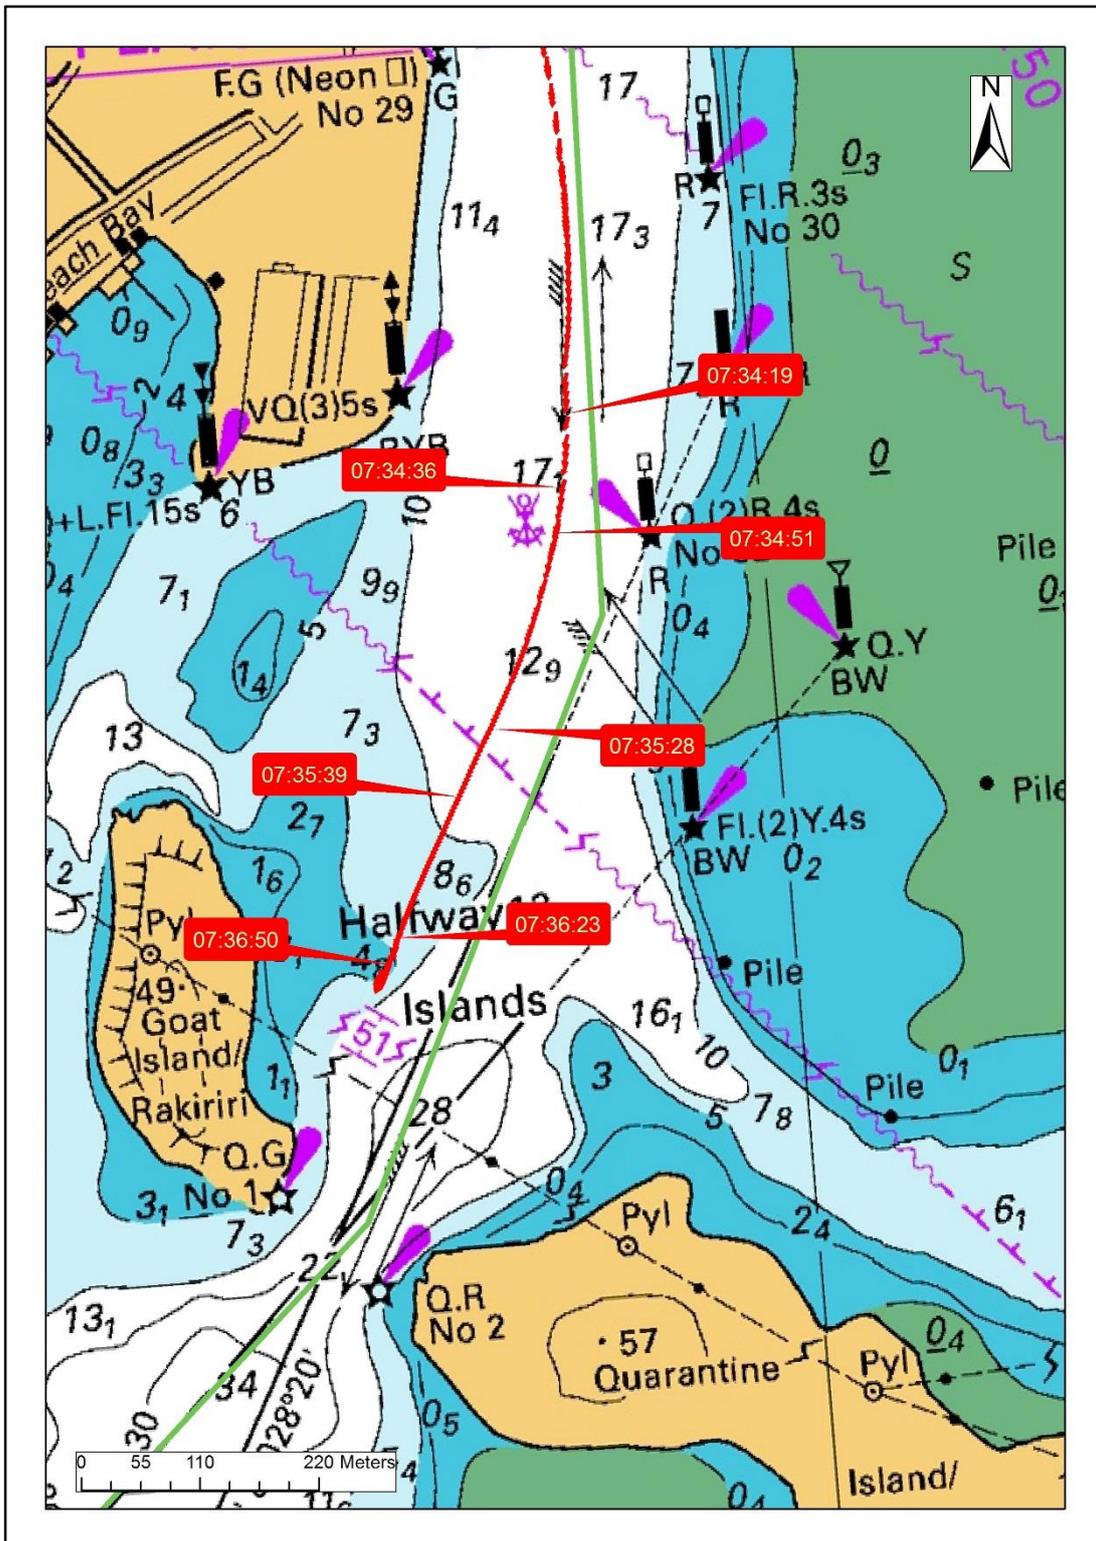
Figure 2

Diagram showing the track, with times, of the *Molly Manx* as extracted from the voyage data recorder

- 3.1.8. The members of the bridge team, including the pilot, then felt a bump that they initially thought was the aft tug bumping the stern of the vessel.
- 3.1.9. The pilot saw that the speed was reducing and he noted that the vessel's head was swinging to starboard despite the 10 degrees of port helm being applied. Both the master and the pilot realised the vessel had grounded, and ordered stop engines, half astern and full astern in quick succession.

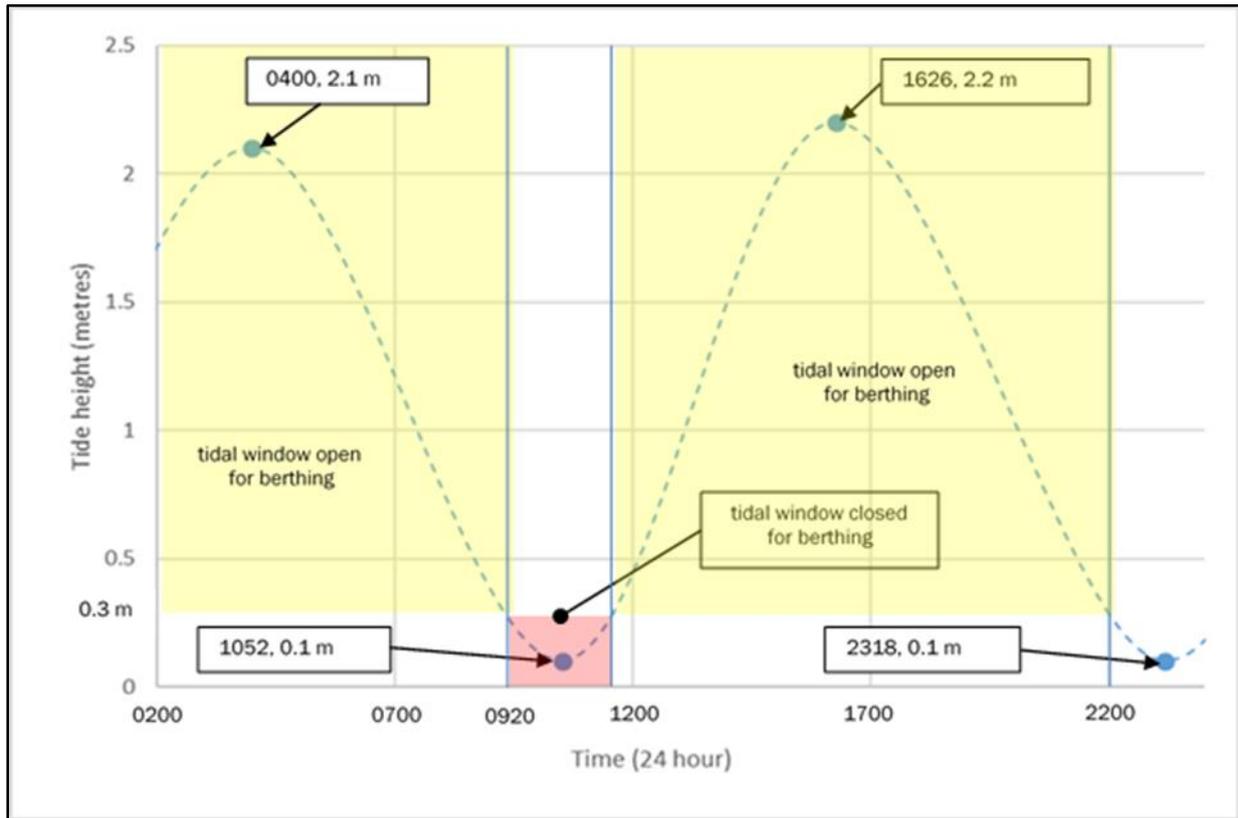
3.2.6. The height of tide at the time of the grounding at the Halfway Islands was approximately 0.7 m based on the port data for Port Chalmers, the nearby standard port. The range of the tide was that of a spring tide.

Figure 3  
Tidal window for the berthing of the *Molly Manx* at Ravensbourne, assuming channel depth of 7.5 m and a static under-keel<sup>12</sup> clearance of 0.7 metre

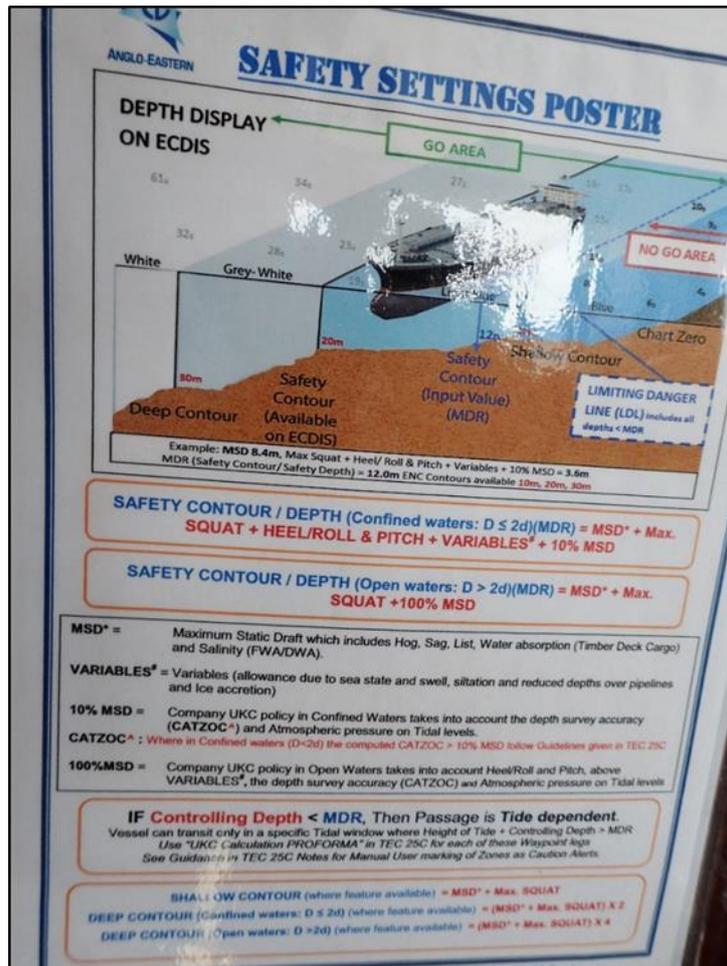
Figure 4  
ECDIS safety settings as supplied in poster format on board the *Molly Manx*

- 4.4.5. The watch vector or predictor was required to be set for two minutes according to the passage plan. At the time of the grounding the ECDIS display showed that the vector was set at 10 minutes rather than two minutes as specified in the vessel's passage plan. In a winding channel such as Otago Harbour, setting the watch vector to 10 minutes would very likely cause the head of the vector to be constantly outside the safe navigable water within the channel, which means it would be in a constant state of alarm. Apart from creating alarm management issues for the officer of the watch (OOW), it was unable to alert the bridge team to any safety hazards ahead.

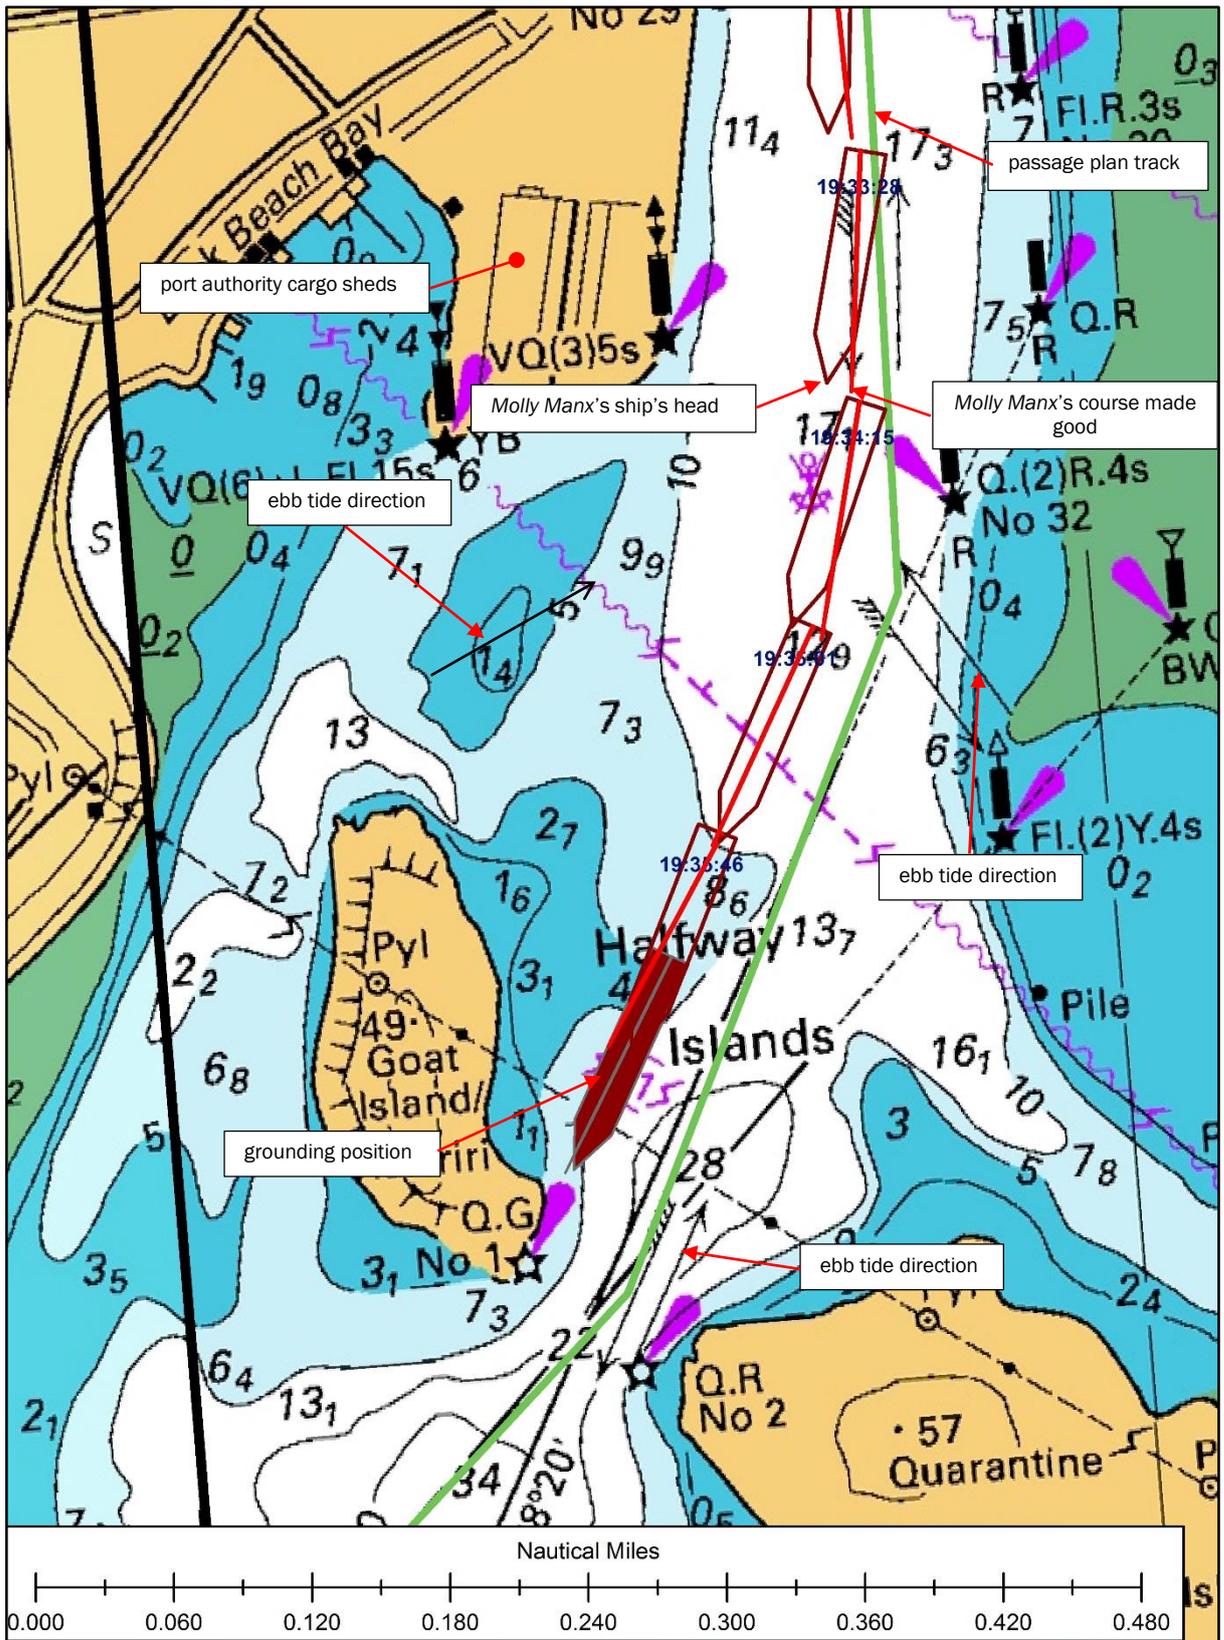
1. The grounding occurred because the bridge team, including the pilot, lost situational awareness and did not realise that the vessel had deviated so far starboard of the intended track.
2. The bridge team, including the pilot, did not realise how far the vessel had deviated from the intended track because they were not monitoring the vessel's progress effectively and by all available means.

Figure 5  
 Passage plan track of the *Molly Manx* (green) and actual track (red)
