Final report MO-2016-206: Capsize and foundering of the charter fishing vessel *Francie*
with the loss of eight lives, Kaipara Harbour bar, 26 November 2016

Marine inquiry MO-2016-206

Capsize and foundering of the charter fishing vessel *Francie* with the loss of eight lives

Kaipara Harbour bar

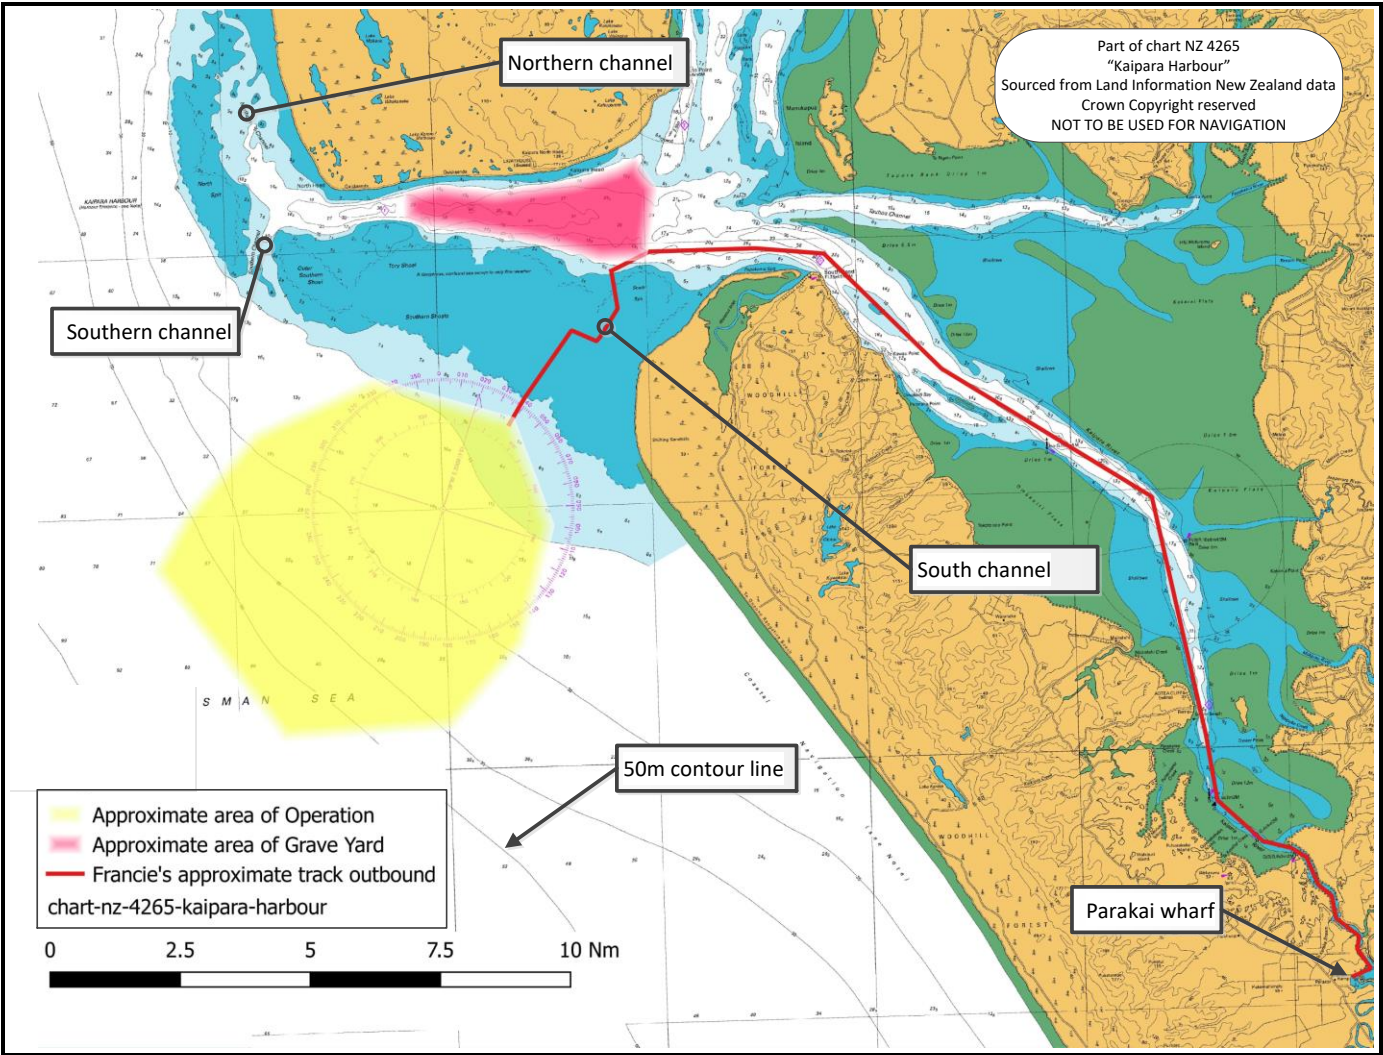
Figure 1
 Extract of chart NZ 4265 showing Kaipara Harbour and the approximate track of the *Francie*

- 3.3.7. Figure 1 shows an excerpt of the Kaipara Harbour chart, with various features pertinent to the *Francie's* operation. Kaipara Harbour is a large estuary, and the bar at its entrance is the largest in New Zealand. The bar is 2-3 nm wide and extends approximately 12 nm across the entrance of Kaipara Harbour to approximately 4 nm offshore.

- 3.3.8. The chart shows two channels at the northern end of the bar: the Northern Channel and the Southern Channel. The Northern Channel is rarely used as it runs predominantly parallel to the swell and can be difficult to navigate. The Southern Channel is more regularly used but is also vulnerable to inclement sea conditions.

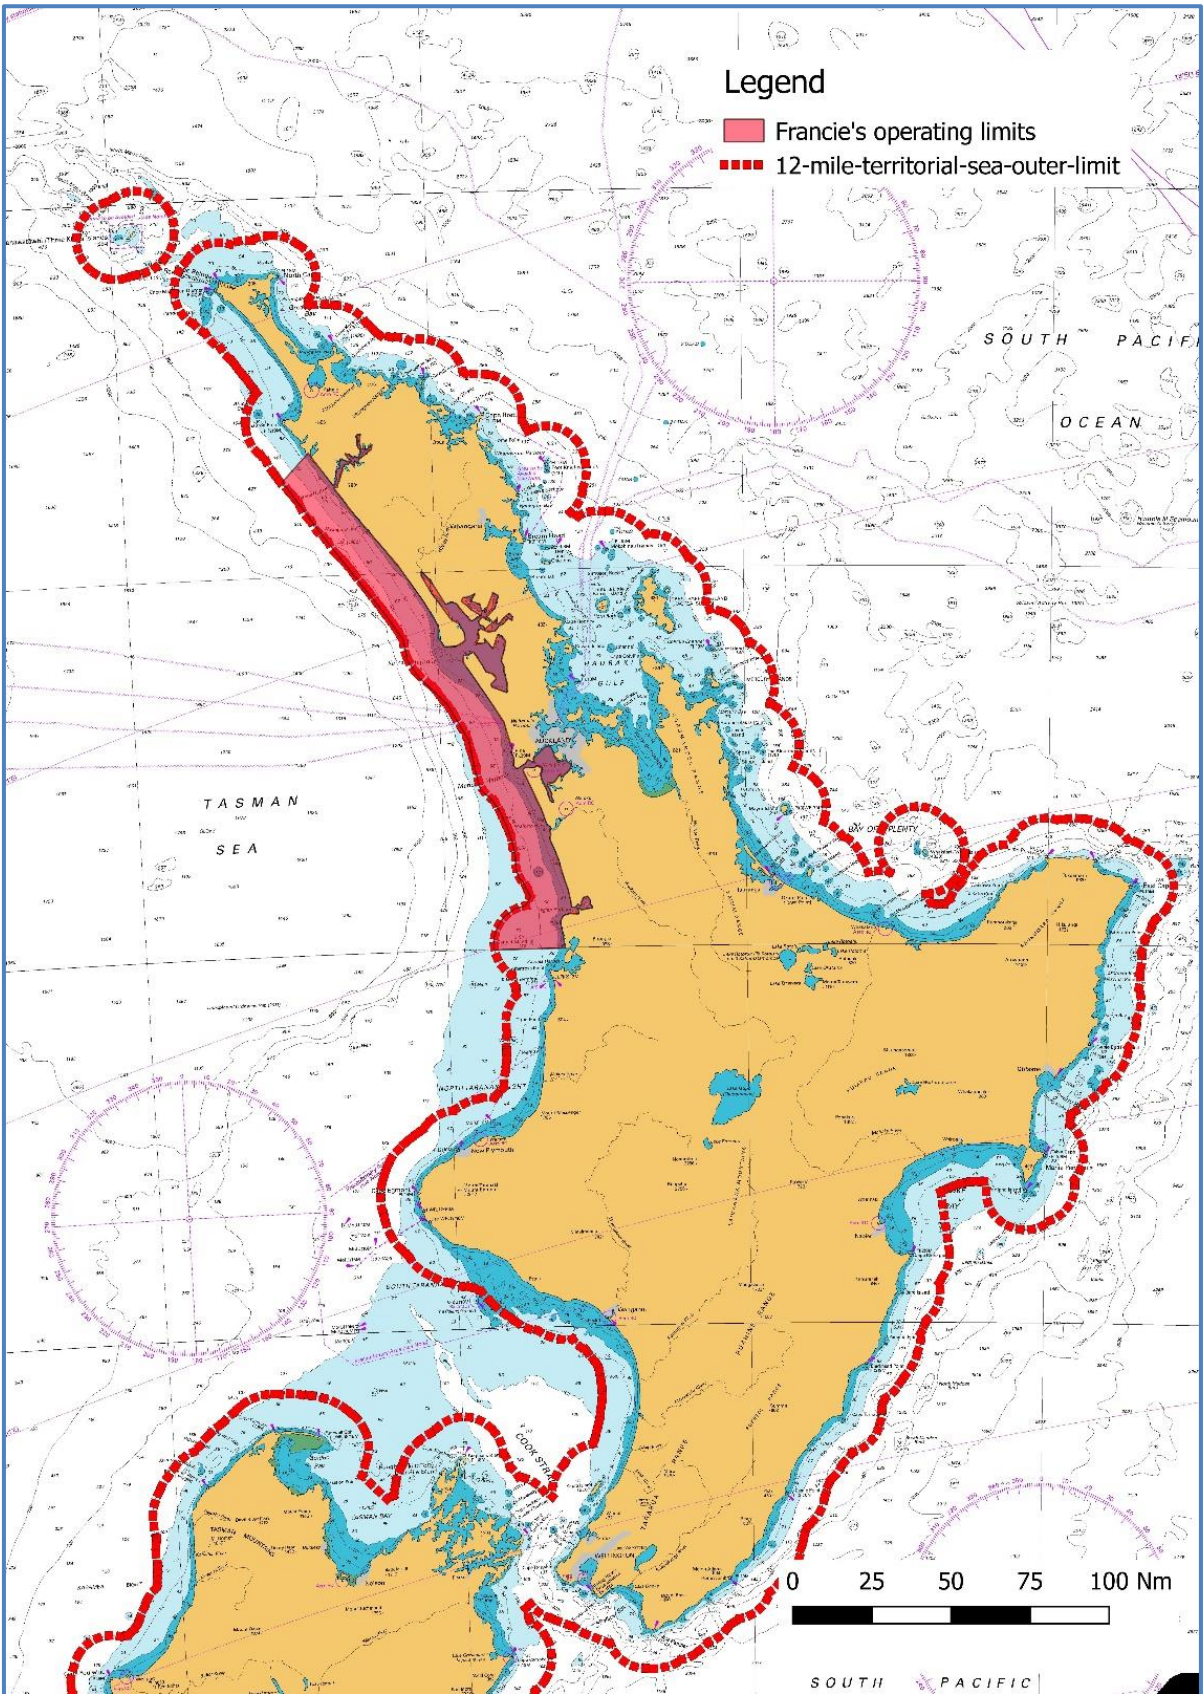
Figure 2
Extract of chart NZ 23 showing the operating limits of the *Francie*

- vessel to be operated over west coast bars in favourable conditions only
 - when operating within west coast limits, this vessel must be operated with a clear weather window for the expected time of the voyage.

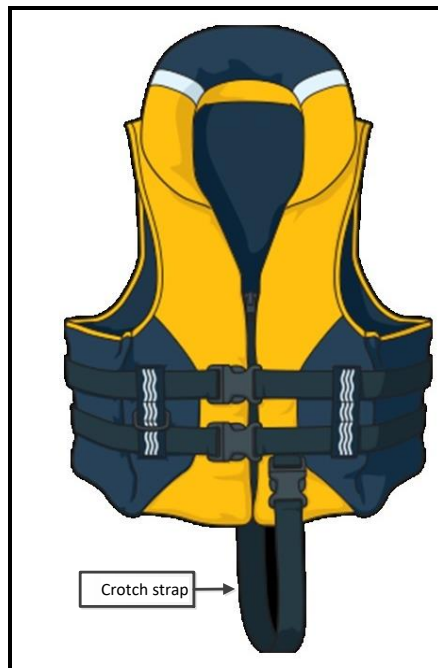
Figure 3
Type 402 lifejacket showing crotch strap

- 4.6.5. Neither of the lifejackets referred to above was fitted with a crotch strap. A crotch strap can be attached to a lifejacket to prevent the lifejacket riding up over the head of the survivor and potentially being lost. The crotch strap is attached at the back of the lifejacket and it passes between the wearer's legs to attach at the front, as shown in Figure 3.

- 4.6.6. In the case of the passenger wearing his own type 401 inflatable lifejacket, if that had been fitted with a crotch strap it very likely would have saved his life. The other deceased passenger was wearing a personal floatation device that was not specifically suitable for supporting a person in rough breaking waters. This was the passenger seen by survivors to be struggling to stay afloat in spite of his wearing such a device. It is likely that he eventually slipped out of the personal floatation device, which would not have happened had it been fitted with a crotch strap. In his case his chances of survival would have increased if a crotch strap had been fitted.
