Interim report AO-2017-004: Forced landing into Porirua Harbour (Pauatahanui Arm),
MBB BK117A-3 Helicopter, ZK-IED, 2 May 2017

Aviation inquiry AO-2017-004
Forced landing into Porirua Harbour
(Pauatahanui Arm)
MBB BK117A-3 Helicopter, ZK-IED
2 May 2017

Approved for publication: April 2018

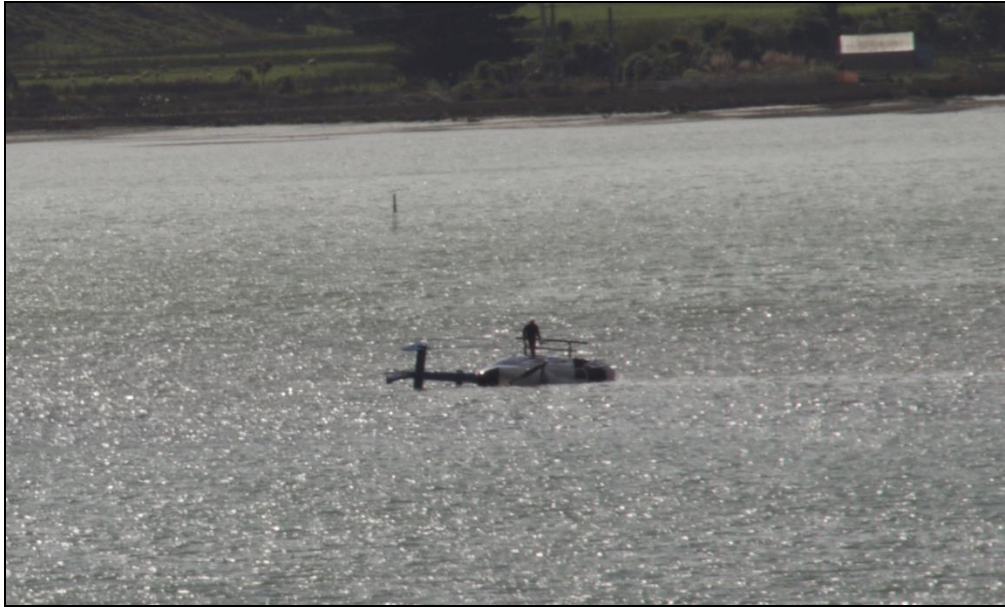
Figure 1
Pilot awaiting rescue

- 2.9. The pilot was wearing a safety helmet. He was able to extricate himself from the wreckage and climb on top of the helicopter (see Figure 1), from where he was rescued and taken to hospital. He suffered minor injuries.

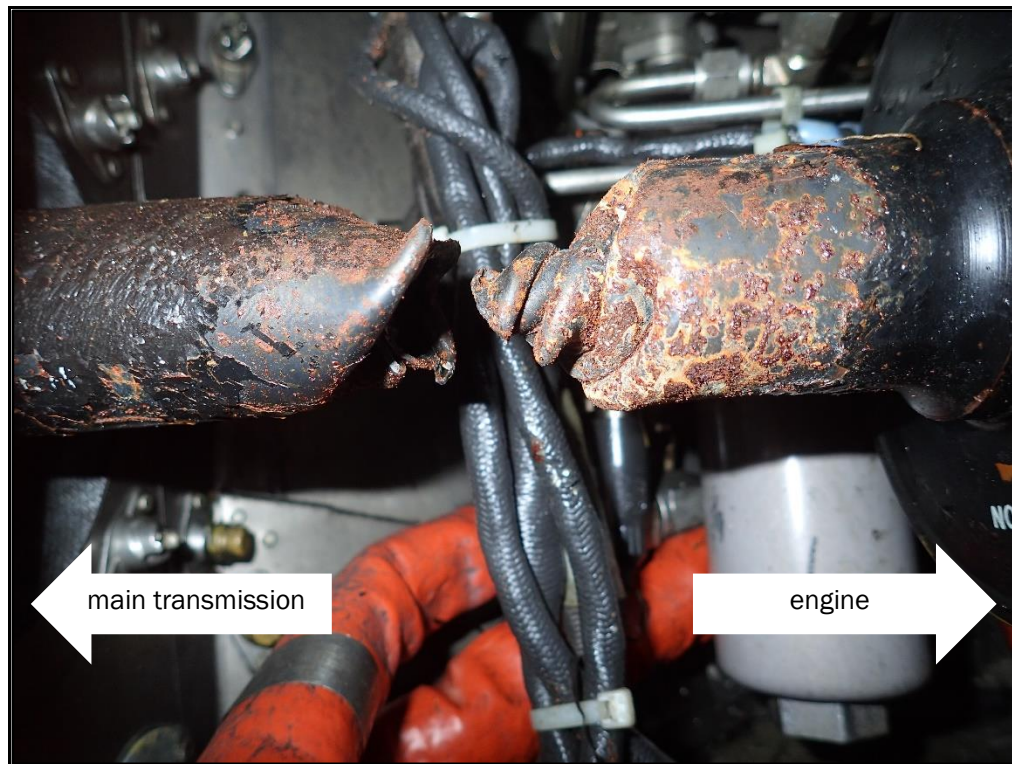
Figure 2
Failure of left-side engine driveshaft

2.21 The left engine drive shaft to the main rotor transmission had failed due to torsional overload (see Figure 2). The associated freewheel assembly had not failed.

2.22 In comparison, the right engine drive shaft to the main rotor transmission was only partially twisted and the freewheel assembly had failed.

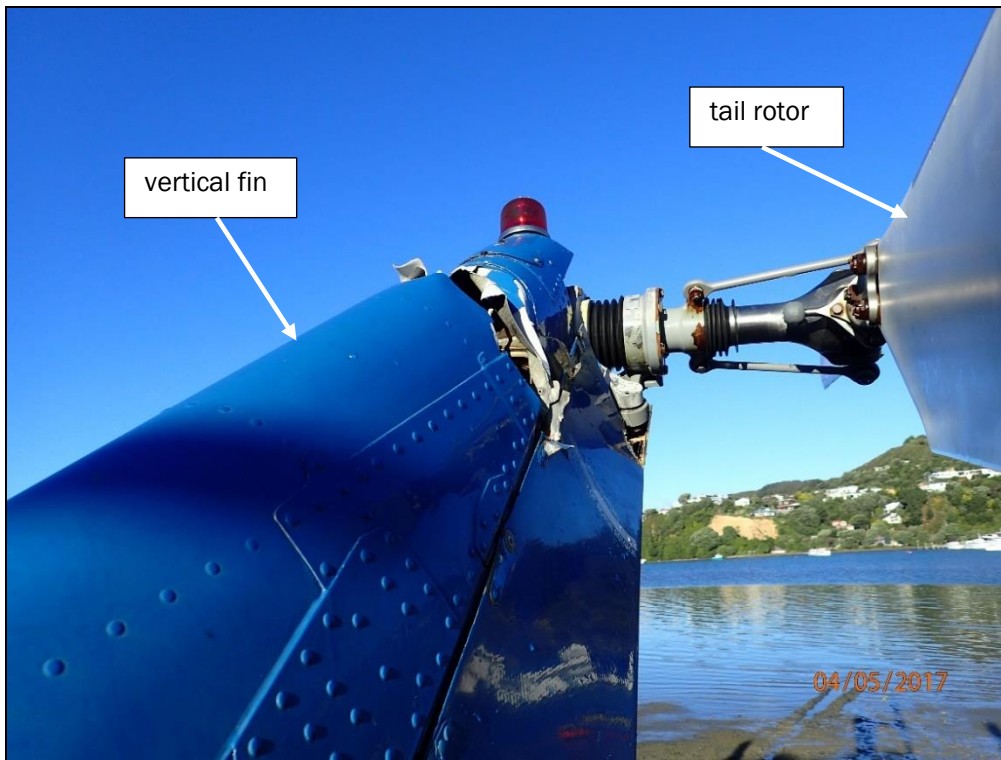
Figure 3
Failed vertical fin

2.23 The tail rotor blades and the tail rotor drive were intact. The primary structure of the vertical fin that supported the tail rotor gearbox had failed on the left side (see Figure 3) and there was a crack running diagonally through the fin spar (see Figure 4).

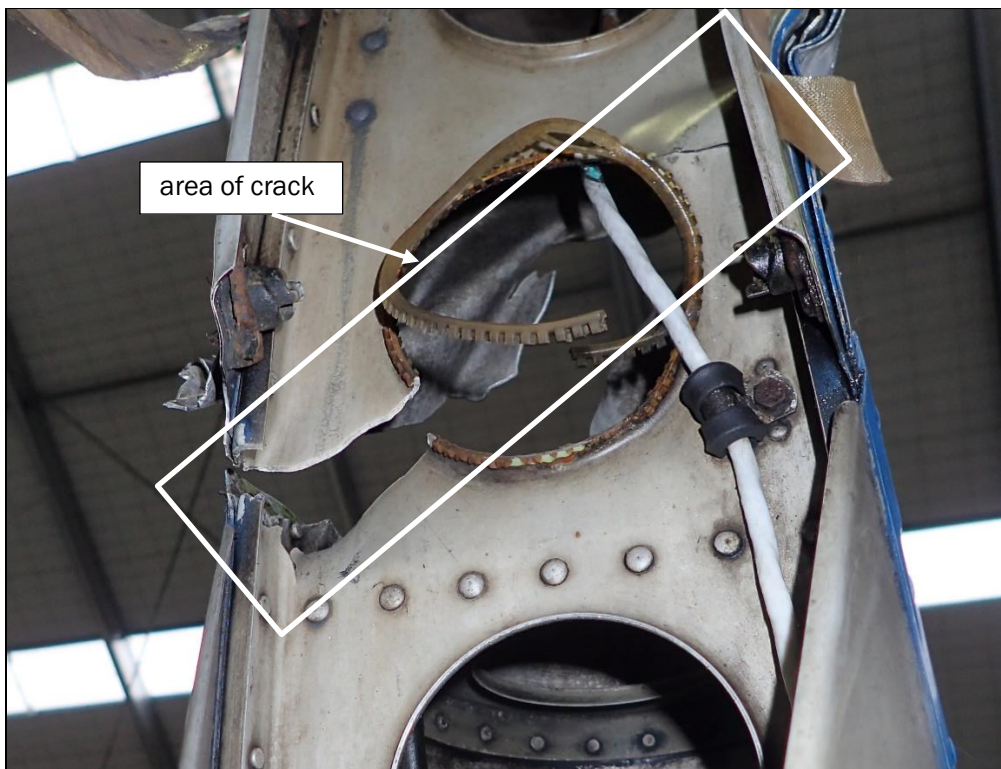
Figure 4
Crack through vertical fin spar

- 2.24 An expert metallurgical examination determined that this failure and associated cracking had occurred as a result of the helicopter's forced landing and had not been present prior to the accident.

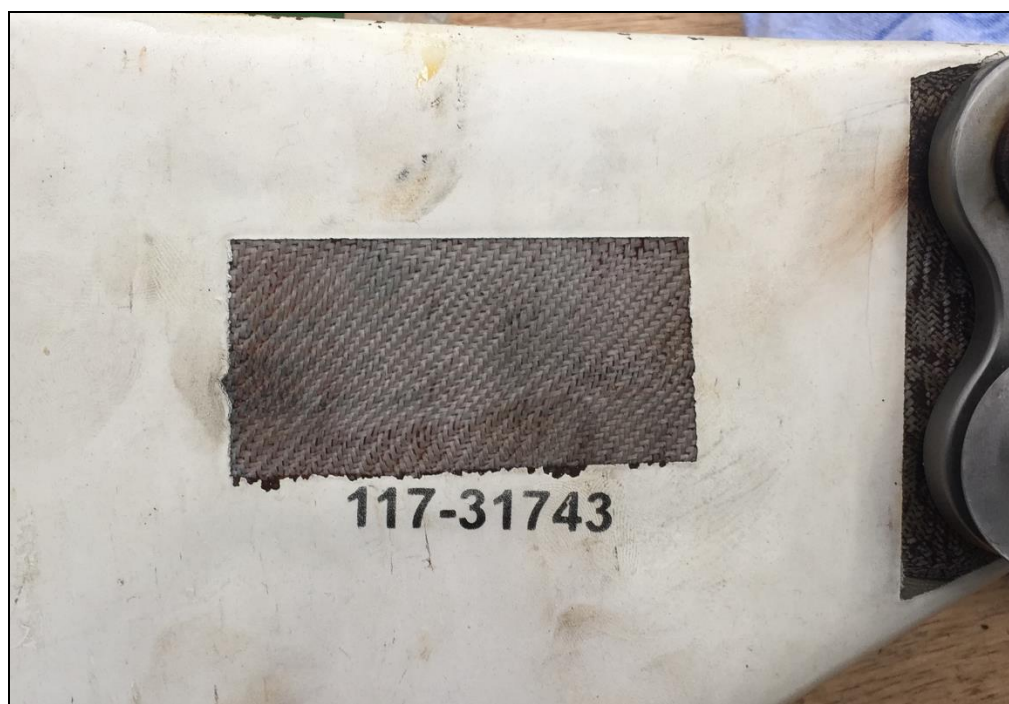
Figure 5
Photograph showing the area of exposed composite structure
where the serial number would normally have been displayed

- 2.27 Additionally, the serial numbers of the tail rotor blades were not visible. Where the serial numbers should have been displayed, the underlying composite structure of the blades had been left exposed without a reapplication of paint or sealing product (see Figure 5).
