Final report RO-2017-102: Signalling irregularity,  
Wellington Railway Station, 3 April 2017

Rail inquiry RO-2017-102  
Signalling irregularity  
Wellington Railway Station  
3 April 2017

Approved for publication: May 2018

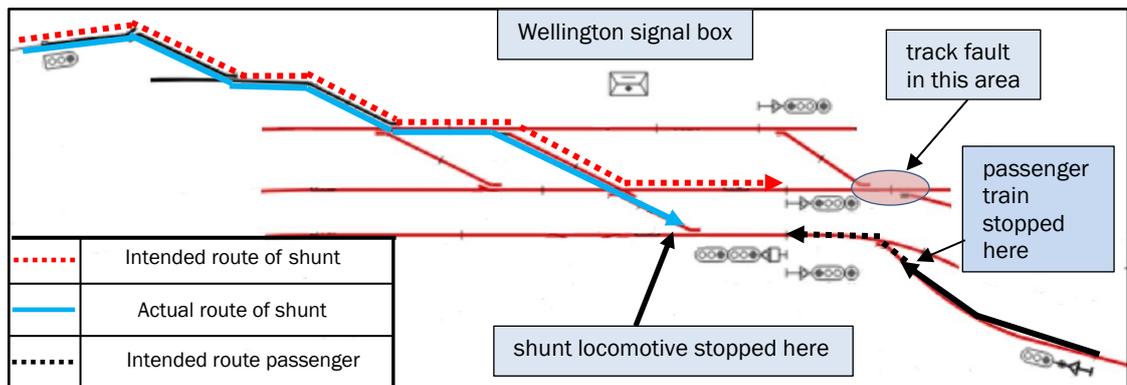
Figure 1  
Route of trains (simplified and not to scale)

- 3.1.1 The incident involved a shunt locomotive travelling southbound from the mechanical repair depot to recover passenger carriages from Platform 9 at Wellington Railway Station. The intended route of the shunt locomotive is shown in red in Figure 1. The actual route taken by the shunt locomotive is depicted by the blue line.

- 3.1.2 At around the same time, a passenger train was scheduled to depart from Platform 6 and travel to Upper Hutt. The intended route of the passenger train is shown in black in Figure 1.

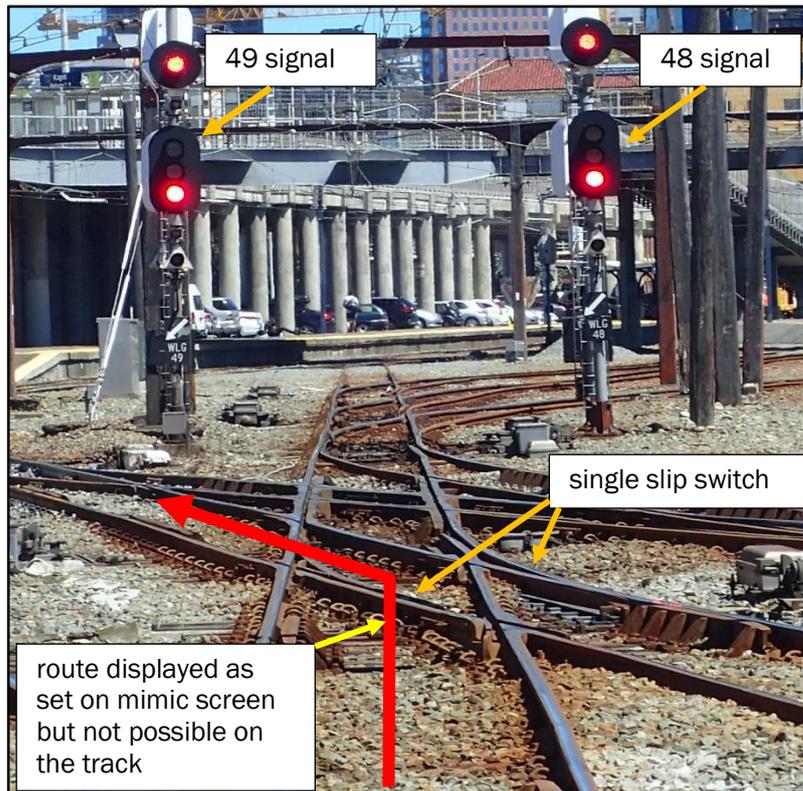
**Figure 3**

Rail traffic cannot move in the above direction because there is no method of switching tracks

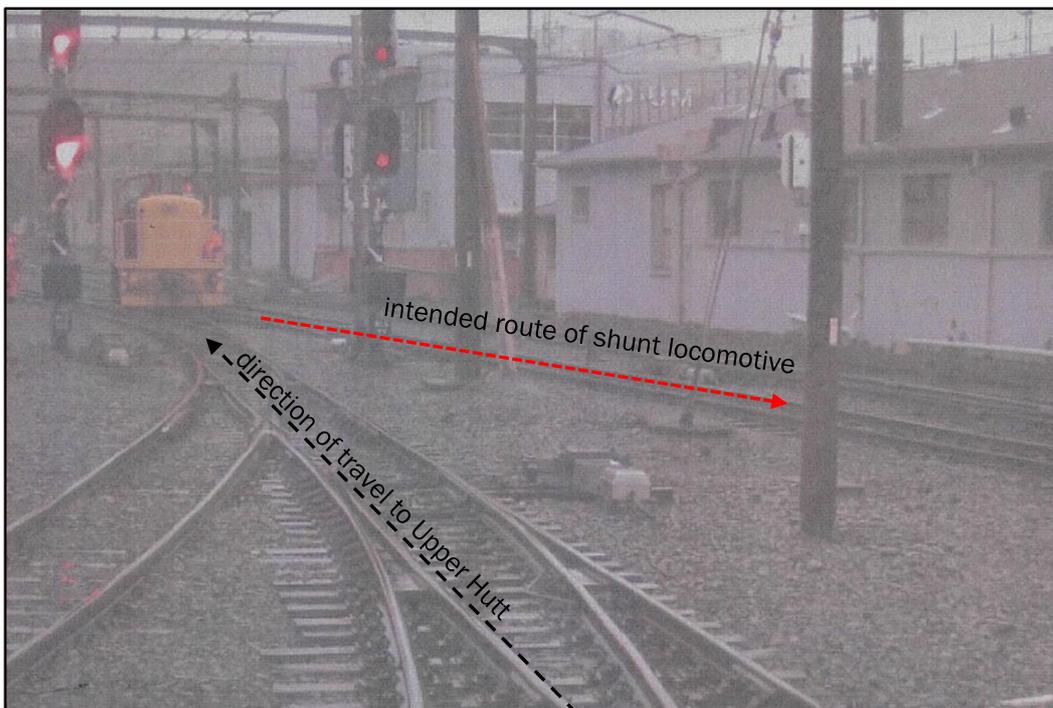
**Figure 4**

3.2.13 At 0936:32 the Upper Hutt passenger train began moving away from Platform 6 under a proceed signal. Eleven seconds later the driver stopped his train as he observed both a stop aspect on the next signal and the shunt locomotive encroaching onto his track ahead (see Figure 4).

CCTV<sup>5</sup> footage from the front of the passenger train. Both trains are stopped

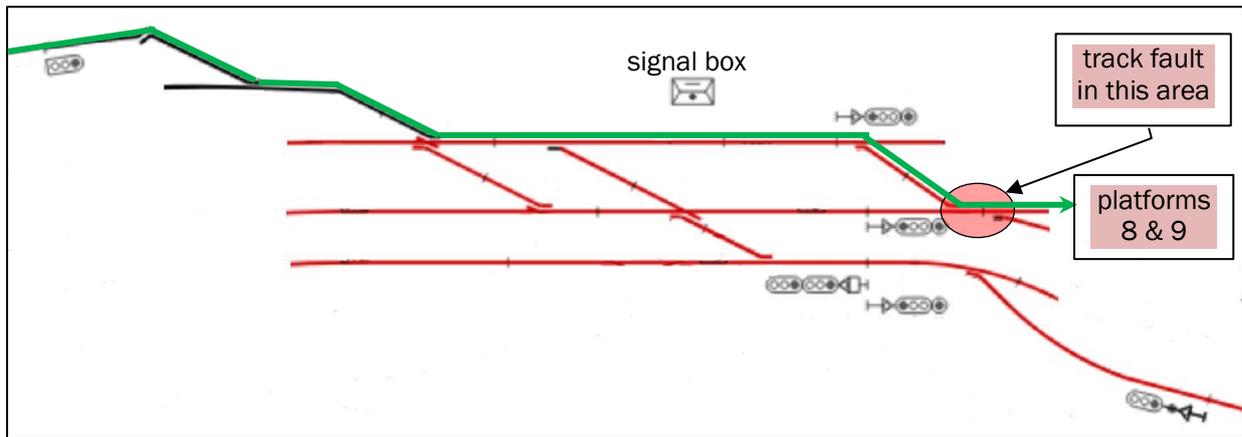
**Figure 5**  
Normal route of shunt locomotive towards platforms 8 and 9

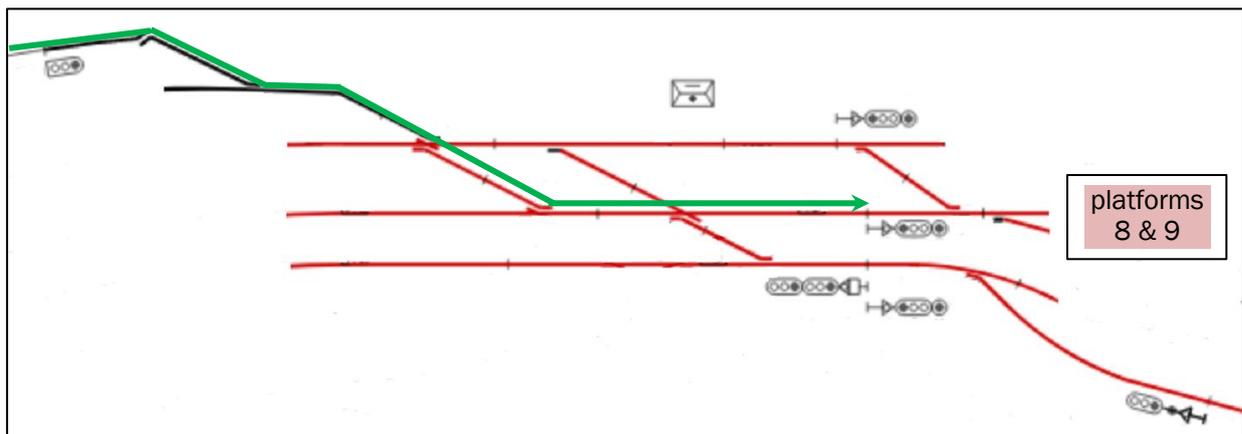
4.2.5 An alternative route existed that would have placed the shunt locomotive at the intended location. However, the alternative route utilised the main passenger running lines, and for this reason the signallers were in the habit of avoiding it if possible (see Figure 6). If this route had been set the signalling system should have been able to provide a proceed indication on the first signal facing the shunt locomotive, thereby negating the need for signaller A to give verbal authority to the RCO for the shunt locomotive to proceed past a red signal.

**Figure 6**  
Alternative route available towards platforms 8 and 9

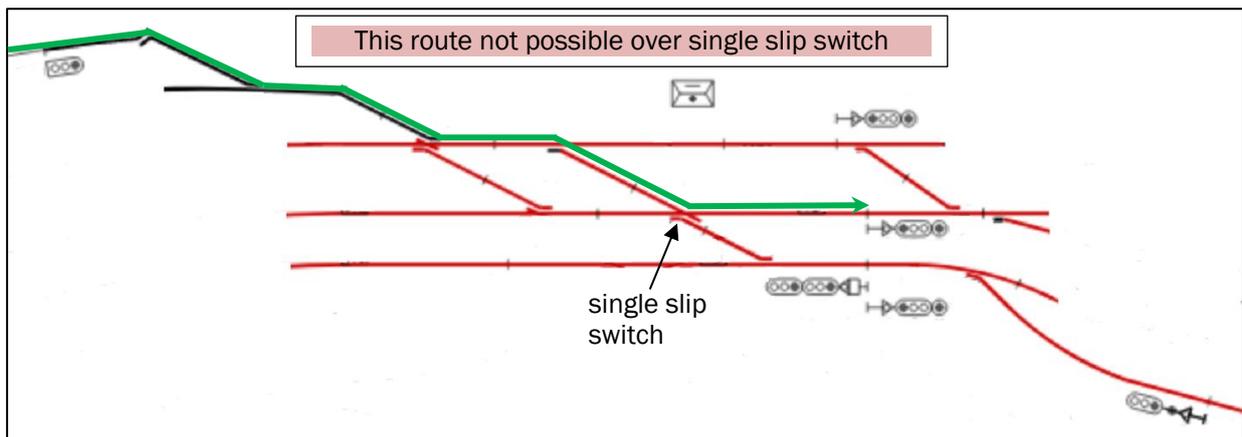
4.2.6 Instead, the route shown in Figure 7 was selected. However, because of the single slip switch design it was not physically possible for trains to travel over this route and there was no interlock fitted to the levers in the signal box to prevent it being selected. Furthermore, an inaccuracy in the mimic display allowed a valid route to be displayed. These two failures are discussed further in the following sections.

**Figure 7**  
Route displayed on mimic screen as being a valid route

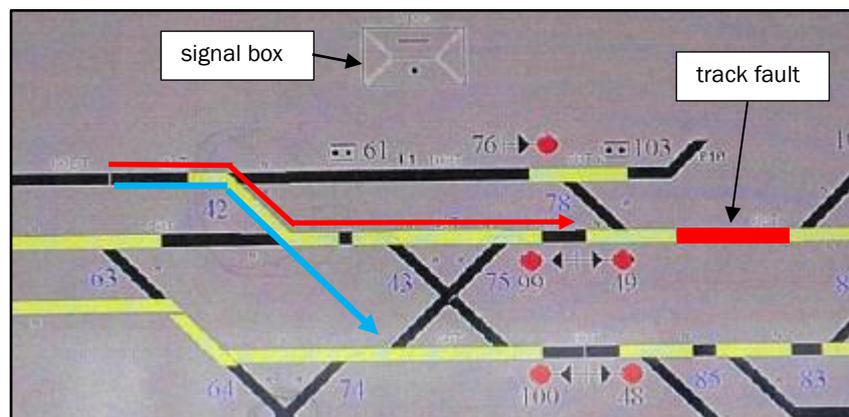
4.3.2 Figure 8 shows a screenshot of the mimic display in the Wellington signal box as it was observed by the signallers at the time of the incident. Based on the information displayed, they were led to believe that the shunt locomotive would follow the path of the red arrow, when really the route was set for the shunt locomotive to follow the blue arrow, towards the path set for the passenger train.

**Figure 8**  
Mimic screen as seen by signaller

4.3.3 The display error had been a latent failure lying dormant in the system for seven years, and as far as could be determined it had never been noticed or reported.

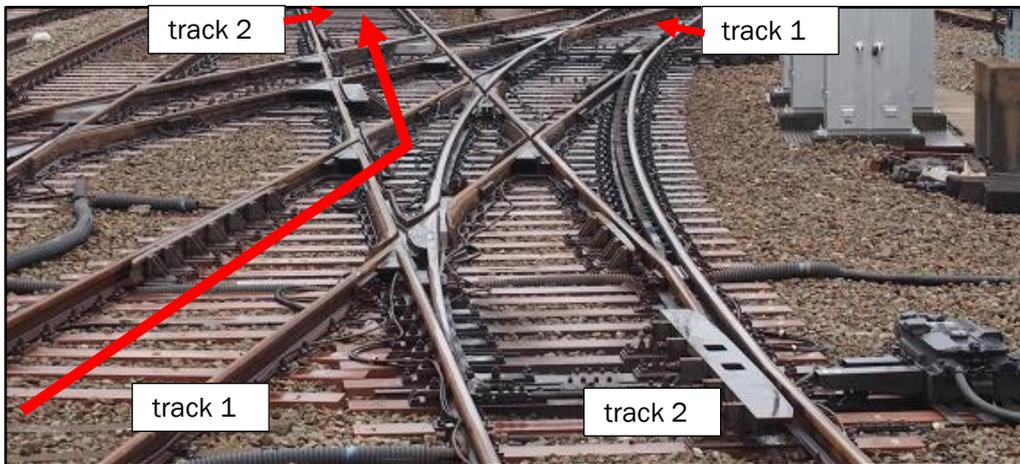
**Figure 13**  
**Single slip switch. Impossible route (displayed as valid on mimic screen)**

Rail traffic cannot move between track 1 and track track 2 in the direction of travel shown, as there is no switching equipment to change tracks
