# AIRGRAFT ACCIDENT REPORT

**No. 90-012T**

**BELL 206B ZK-HZX**

**Transport Accident Investigation Commission  
Wellington - New Zealand**

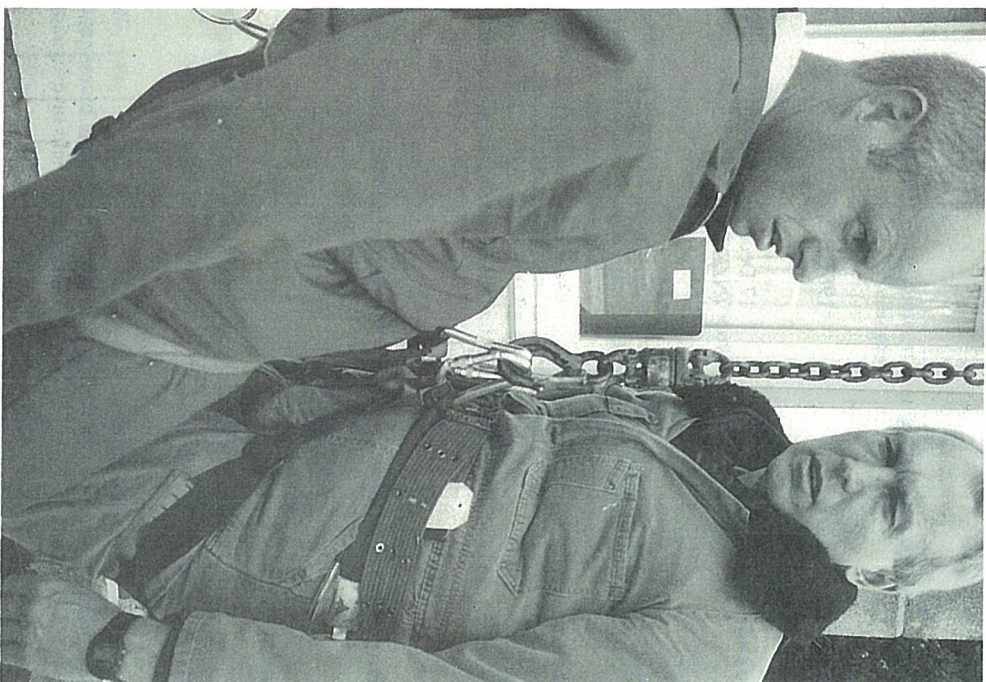
*FIGURE 1*

1.2 Each man wore a sit harness which was attached to a hook on the end of the chain with a mountaineering, screw-lock, karabiner (See Fig. 1).

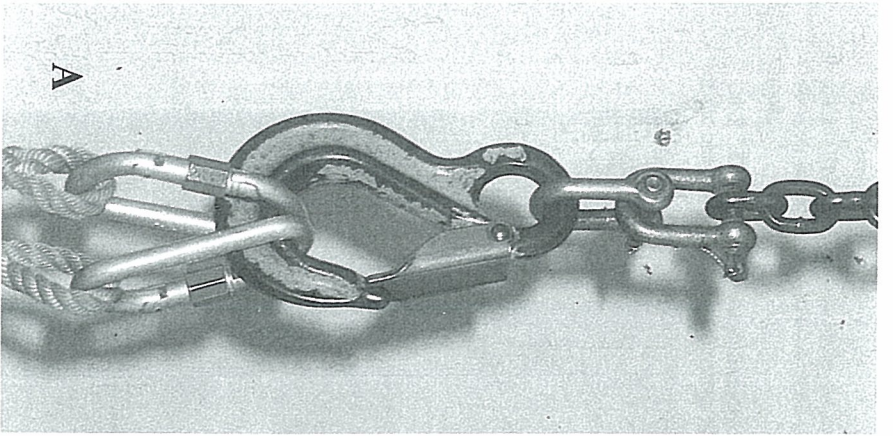
a. Two karabiners securely in hook.

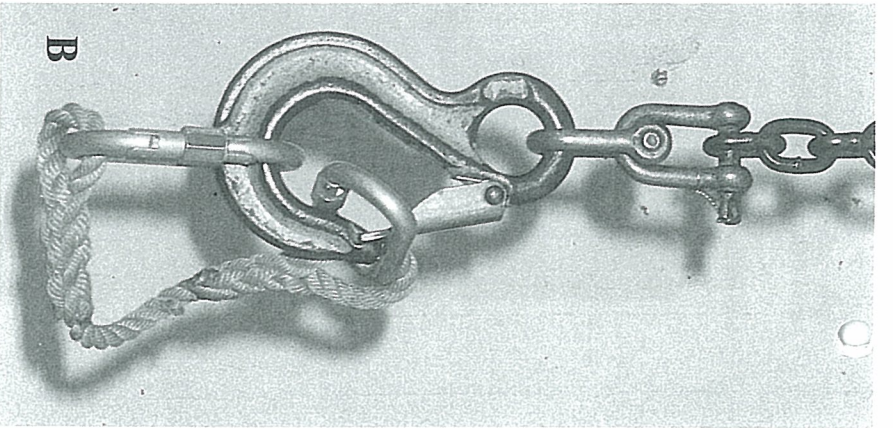
b. Karabiner mispositioned across jaw of hook.

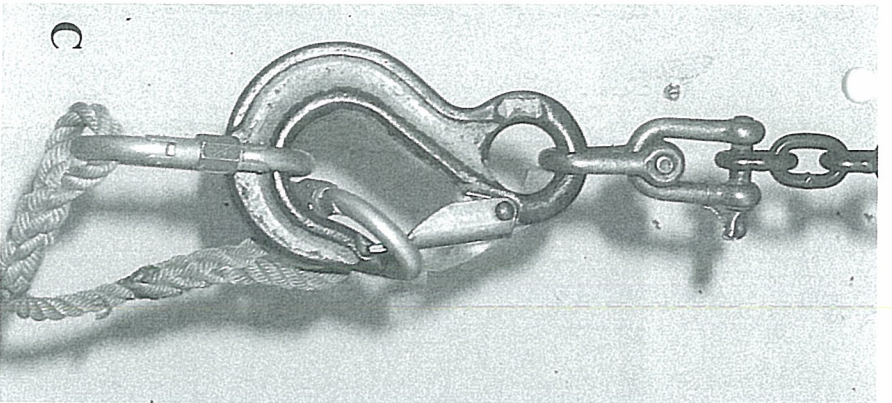
c. Load on karabiner applied between keep and lip of hook.

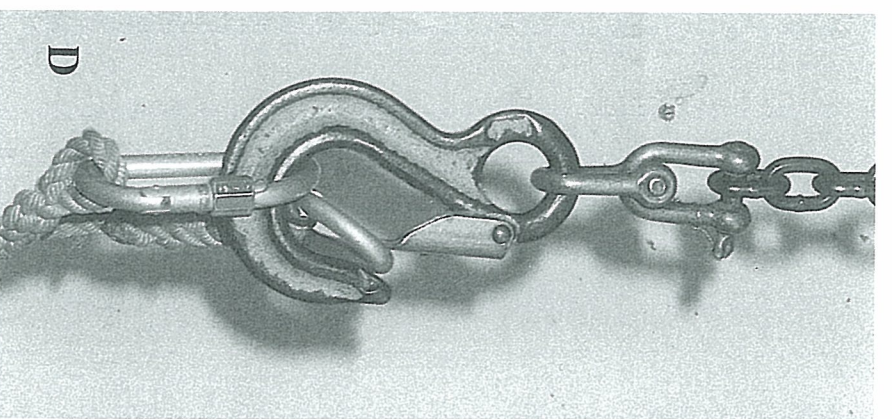
d. Keeper pushed back by karabiner.

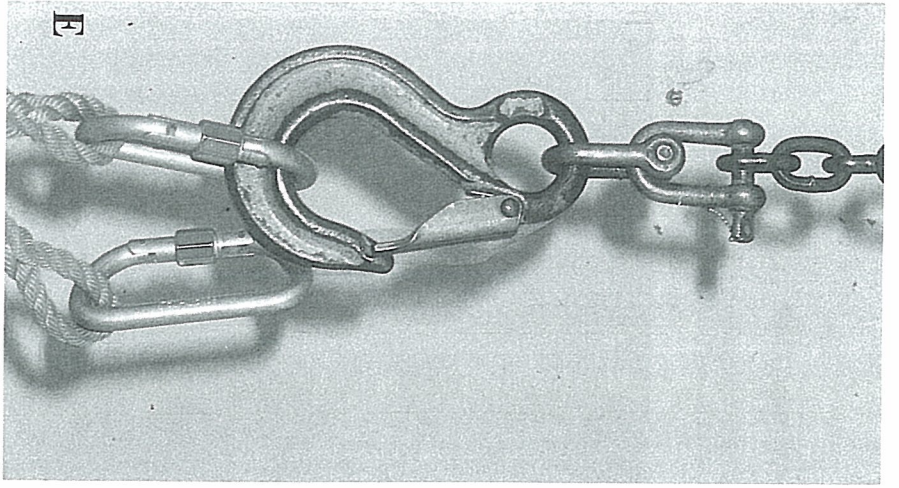
A simulation of the sequence of events which has resulted in a karabiner separating from a hook provided with a keeper.

e. Karabiner falls free.

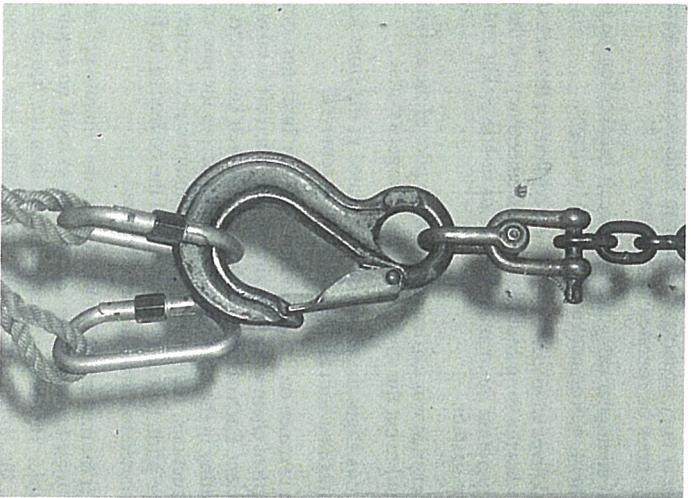
FIGURE 21

1.19 In such a situation a karabiner could separate from the hook by twisting in such a way that the portion of the karabiner outside the hook bore down on the keeper and allowed the inner portion to fall free (See Fig. 2). With two persons on the hook the second person to hook on was at greater risk because his was the karabiner closer to the "keeper" over the gap in the hook and the other man's weight kept the hook under load and relatively stationary.

1.25 An attempt to replicate the conditions which lead to the accident was not conclusive but each item of the equipment was intact and the process by which karabiners have been released from hooks with similar keepers was well known in several fields which used such equipment. As a result hooks have been designed with additional safeguards which prevent the keeper from moving under the influence of the karabiner once it is in place (See Fig. 3). As the man had checked the karabiner was in place on the hook prior to lift off it could not have come off by whatever means had a lockable keeper been available and used correctly.

1.32 The probable cause of this accident was the carriage of two men on a single hook, the lack of a keeper which was proof against a known hazard, the last man on the hook inadvertently applying a twist to his karabiner which secured his webbing harness as he placed the karabiner on the hook and the
