# AIRCRAFT ACCIDENT REPORT

**No. 91-014**

**ROBINSON R22 BETA ZK-HYN**

**Dart River, Near Glenorchy, Otago Province**

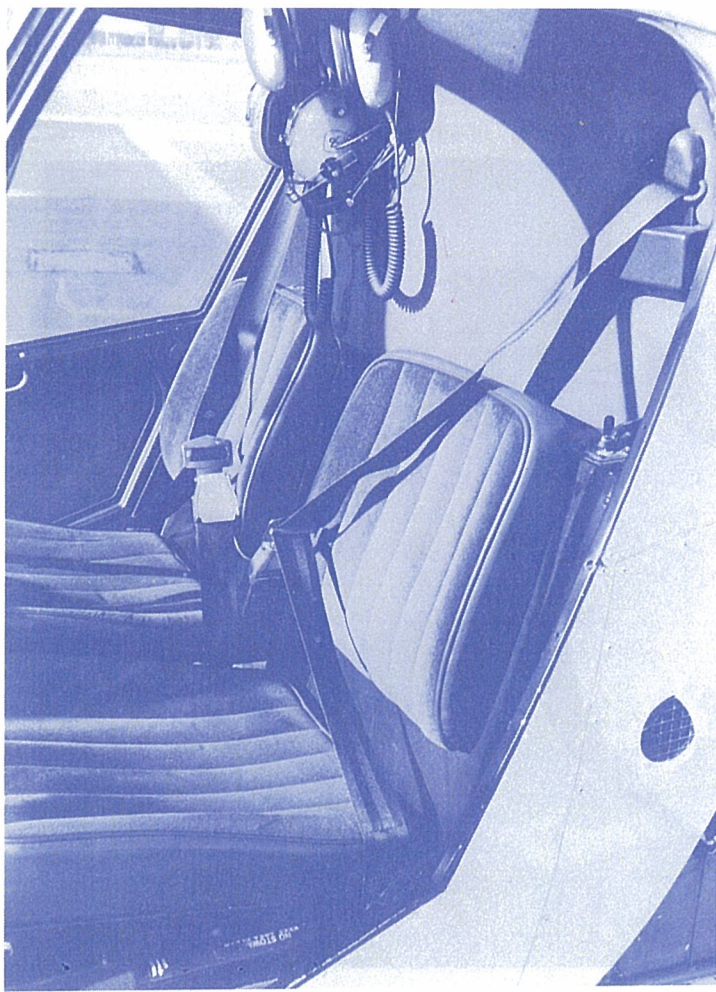
*Figure 1.*

**ROBINSON R22  
STANDARD SEATBELT  
INSTALLATION**

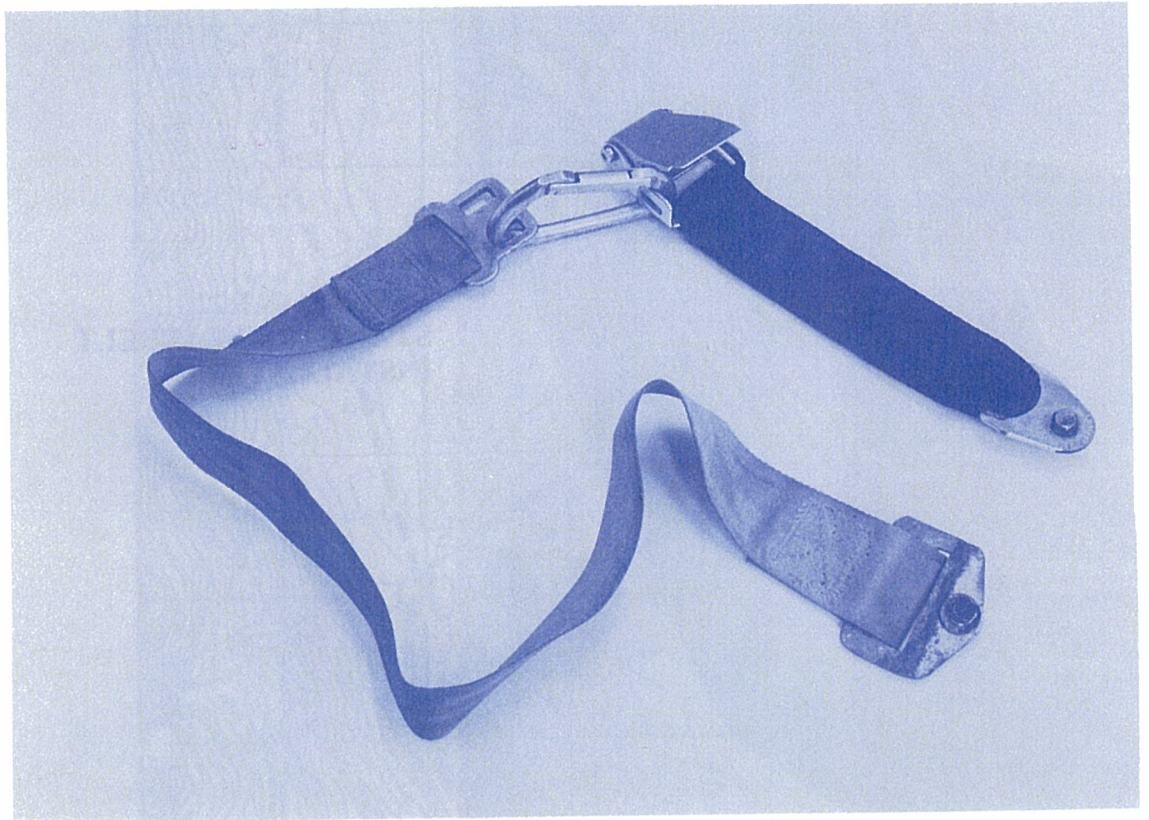
1.17.2 In the event, in order to permit maximum freedom in upper body movement for the “shooter”, who occupied the left (passenger) seat, the lower attachment plate of the combined diagonal/lap belt assembly had been removed and a plain lap belt installed. The existing short belt and flap-type buckle assembly on the right side of the harness installation was left in place.

1.17.3 The lap belt which had been installed had a metal tongue at its free end with two square holes. To utilise the seat belt a karabiner, inserted through one of these holes, was clipped through the “slot” in the buckle assembly which was accessible when its flap was lifted. The use of the karabiner between the two sections of the lap belt assembly was intended to provide a secure link, obviating any risk of inadvertent disengagement and release of the lap belt during shooting operations. During the accident sequence however, the side of the buckle fractured as a result of the load applied to it by the karabiner (See photographs).

1.17.4 The alterations to the manufacturer installed seatbelt/harness arrangement constituted a modification to the helicopter and required the approval of the Airworthiness Section of the Air Transport Division of the Ministry of Transport. No application for modification of ZK-HYN in this manner had been received by the Airworthiness Section as at the time of the accident.

*Figure 3. Improvised Lap Belt Installation*

The hazards of altering the configuration of a seatbelt installation. The proper approval process should be followed as it is intended to ensure that any modified seatbelt or harness installation will serve the purpose for which it is to be used with due regard to the loads which may be placed upon it and will not compromise other safety aspects.

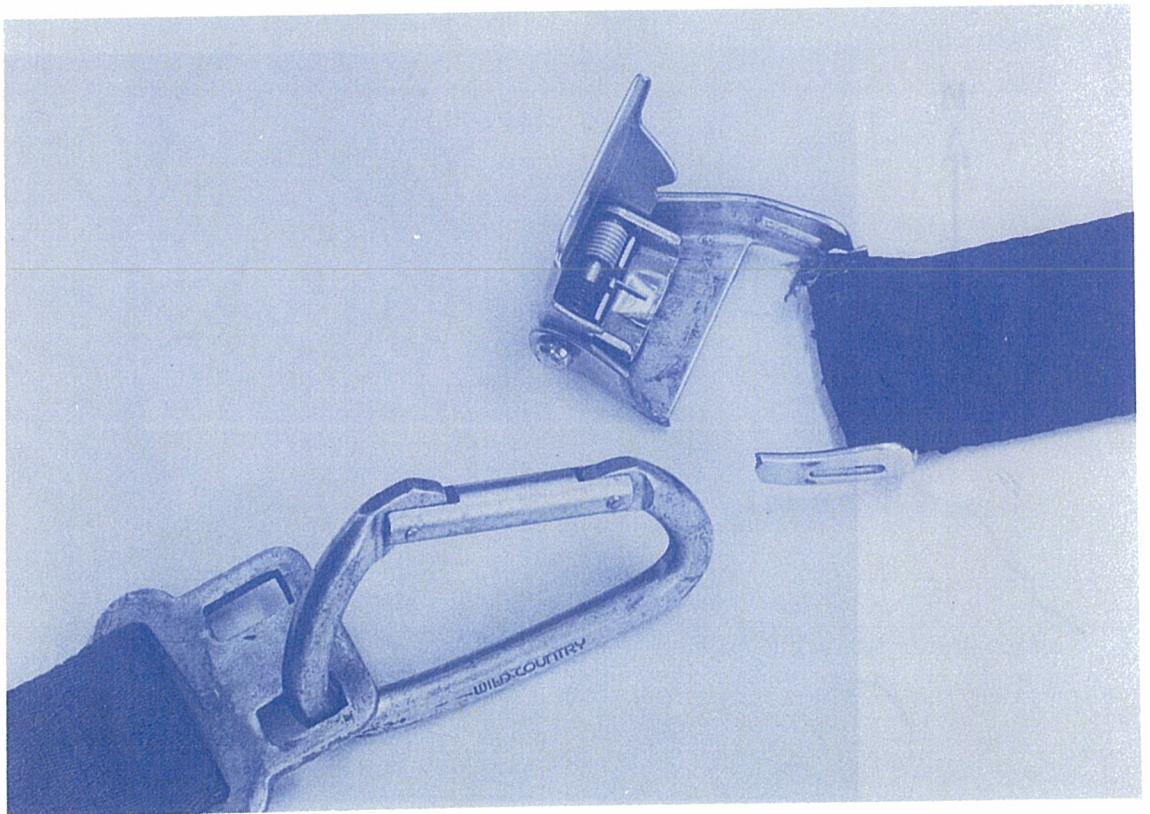
1.15.3 Examination of the wreckage showed that the short metal "strap" which comprised the structural attachment for the left side of the pilot's safety harness had failed in overload, releasing the harness. The buckle of the passenger's lapbelt had failed as a result of side loads applied by the karabiner which formed part of the improvised lapbelt installation.

*Figure 4. Failed Buckle*
