AIRERAHI ACCIDENT REPORT

No. 91-019

Hawker Siddeley HS748

ZK-CWJ

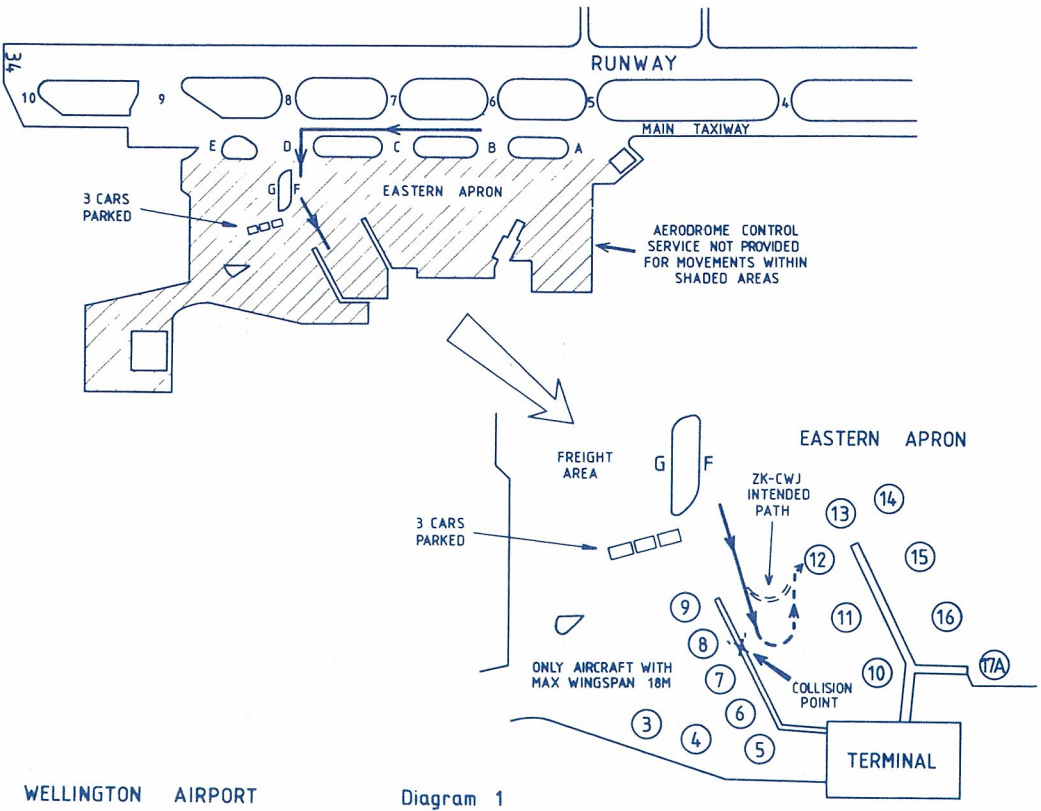
Diagram 1

1.2 Because of the early arrival the aircraft was not given a gate number before landing. The pilot was informed, after landing, that all gates at the passenger terminal were full but he would be allocated Gate 12 (see Diagram 1) when it became free.

1.4 He turned left off the main taxiway onto Stub-way Delta (See Diagram 1) which was the normal access to the gate which he had been allocated. This taxiway lead onto an apron area which was bounded by a covered walkway on the aircraft's right and a series of airbridges and the associated building on the left. Prior to the covered walkway was a grass area and a sealed access for aircraft to taxi to the other side of the walkway. Normally this sealed area would have provided a holding bay for the aircraft but on this occasion there was a VIP car and two escort vehicles parked on the western side of this access.
