# ALPERAFTACCIDENT REPORT

**No. 92-019**

**Westland Wasp**

**20 November 1992**

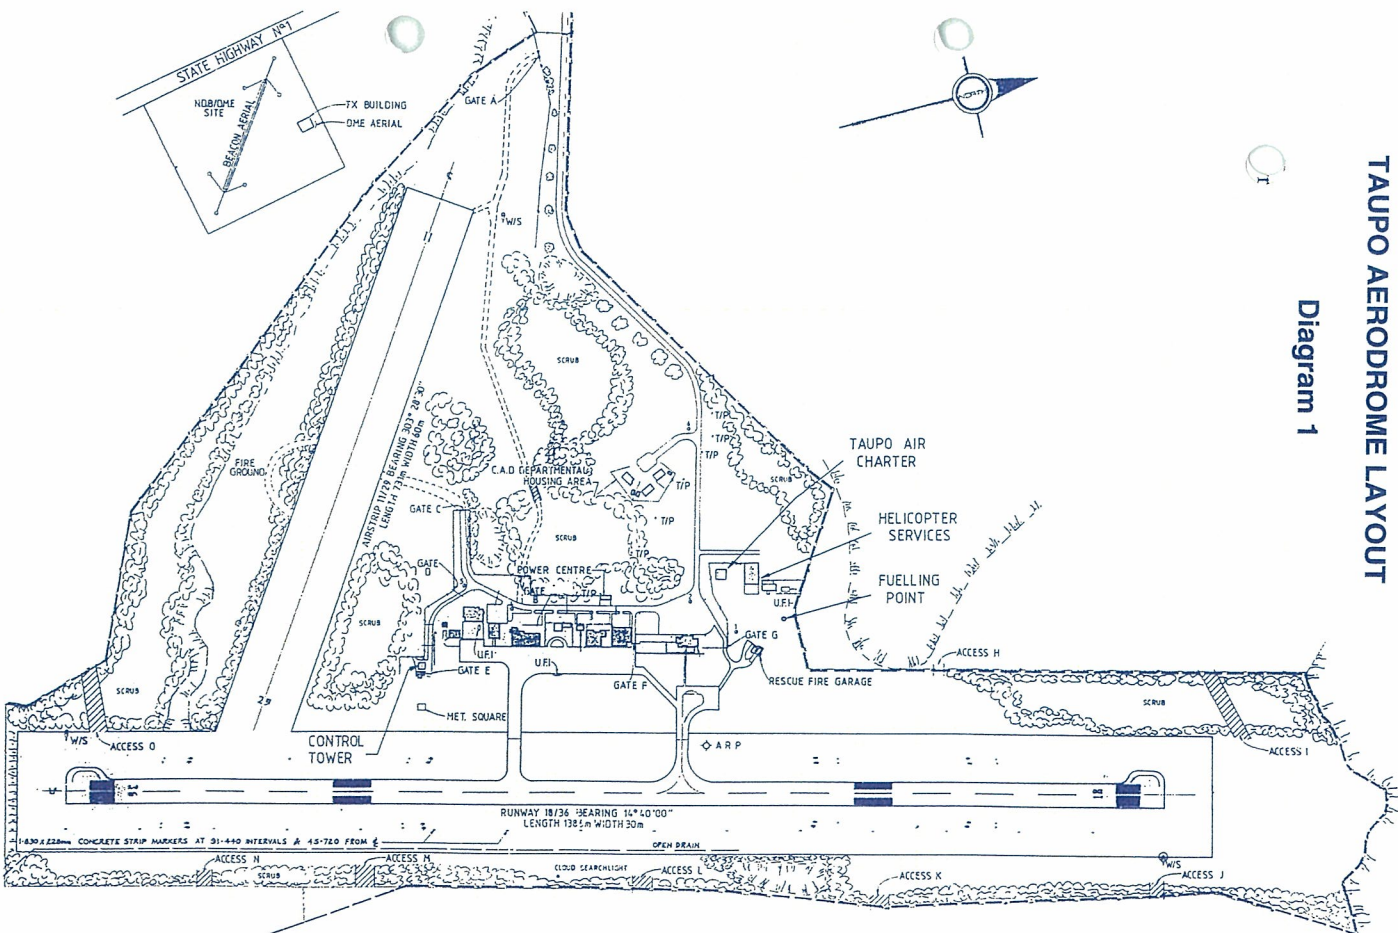
**Diagram 1**

2.1 Two RNZAF "Wasp" helicopters called at Taupo Aerodrome to refuel. They descended to hover height over the runway as a pair, then one aircraft went to the control tower to get the key to the fuel pump, while the second hover-taxied to the fuelling point (see Diagram 1: Layout of Taupo Aerodrome).

2.9 The fuelling point at which the Wasp was about to land was commonly called "the Air Force pump" but was in fact a common-user outlet. Originally the fuelling point was adjacent to the helicopter hangars (Diagram 2) but some years ago it was moved to its present position. When this was done, it was in the middle of an open space which was, de facto, the helicopter operating area, though it was never officially designated as such.

- (a) About seven years previously a lease of land adjacent to the helicopter hangars was granted to a firm flying aeroplanes (ie. fixed-wing aircraft) on charter. This firm, which previously occupied rented space beside the apron (see Diagram 1) built new accommodation on its leasehold land, and subsequently parked its aircraft in the area shown in Diagram 2.

- (c) Consider moving the fuelling point for visiting helicopters to a less cluttered location.

- (c) The refuelling point would be relocated,

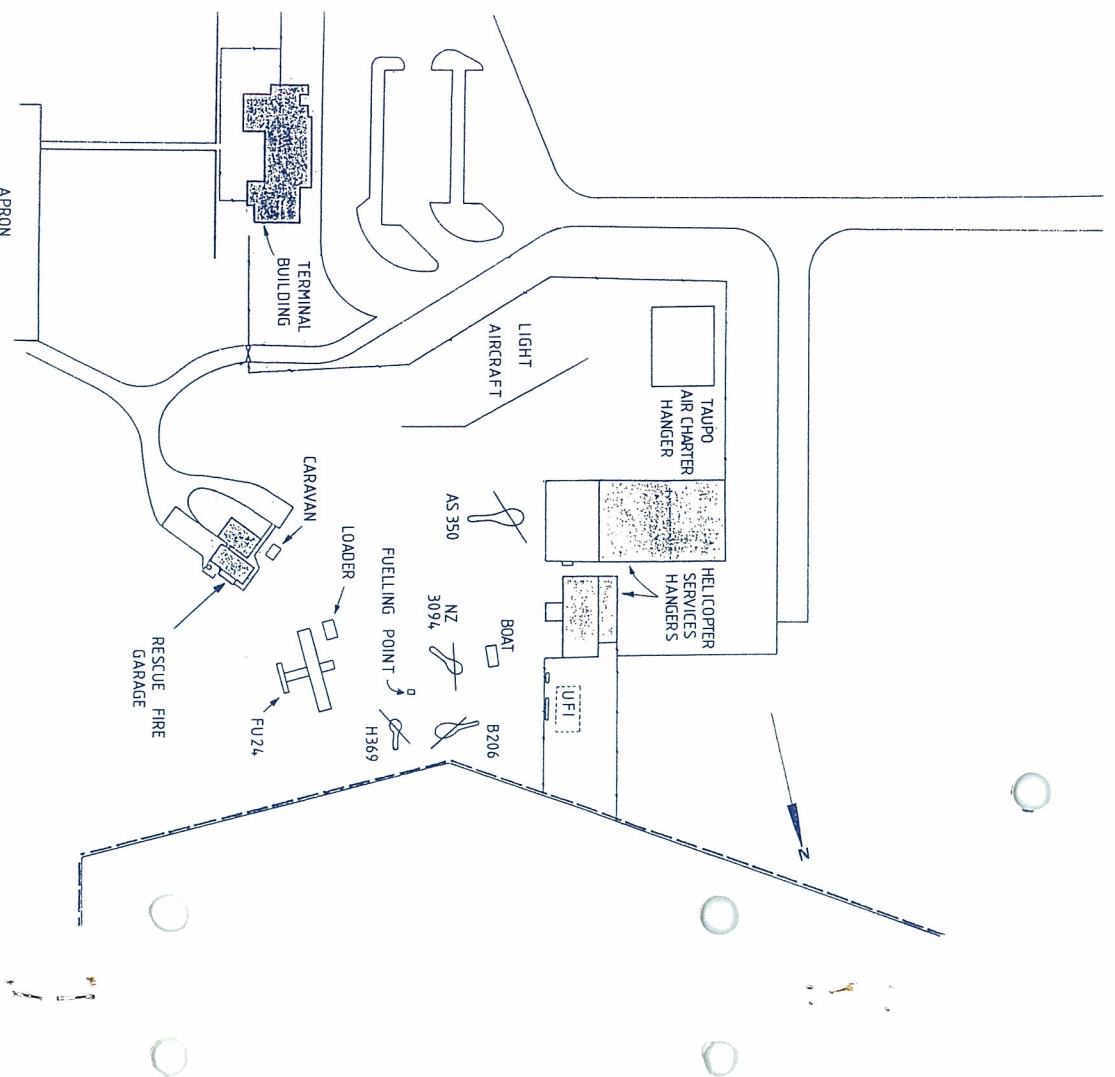
**Diagram 2**

2.3 Adjacent to the fuelling point were two civil helicopters (a Bell 206 and a Hughes 369) which had landed there shortly beforehand and refuelled, and a large powerboat (about 11 m long) which had been put there ready to be towed away (see Diagram 2 : Accident Site). The Wasp commander was unconcerned about the powerboat as it was sufficiently large as to be unaffected by the Wasp's downwash, but he was concerned about the civil helicopters, because they were much lighter than the Wasp, and because it was necessary to ensure clearance between them and the Wasp's tail rotor. The second pilot who was the pilot flying (in the right hand seat) therefore brought the Wasp to the hover close to the powerboat, while the commander released his harness and ducked down so that he could see the tailrotor.

2.16 The civil helicopters flew in from the north and landed in the positions shown on Diagram 2. They refuelled, and their pilots went to the nearby terminal building for refreshment.

2.19 No aspect of the operation was regarded by the participants as being out of the ordinary and all used their best endeavours to make it safe. The question thus arose as to how unsafe circumstances came about. The essence of the situation was that, over the years, the area around the common user fuelling point had become cluttered to the extent that it was hazardous for visiting pilots.

- (d) Consider removing the former Rescue Fire Service building.

- (e) Include the inspection of helicopter operating areas in the normal inspection of the manoeuvring area.
