A V I A T I O N O C C U R R E N C E R E P O R T

NO. 93-005

AEROSPATIALE AS 350D

ZK-HGV

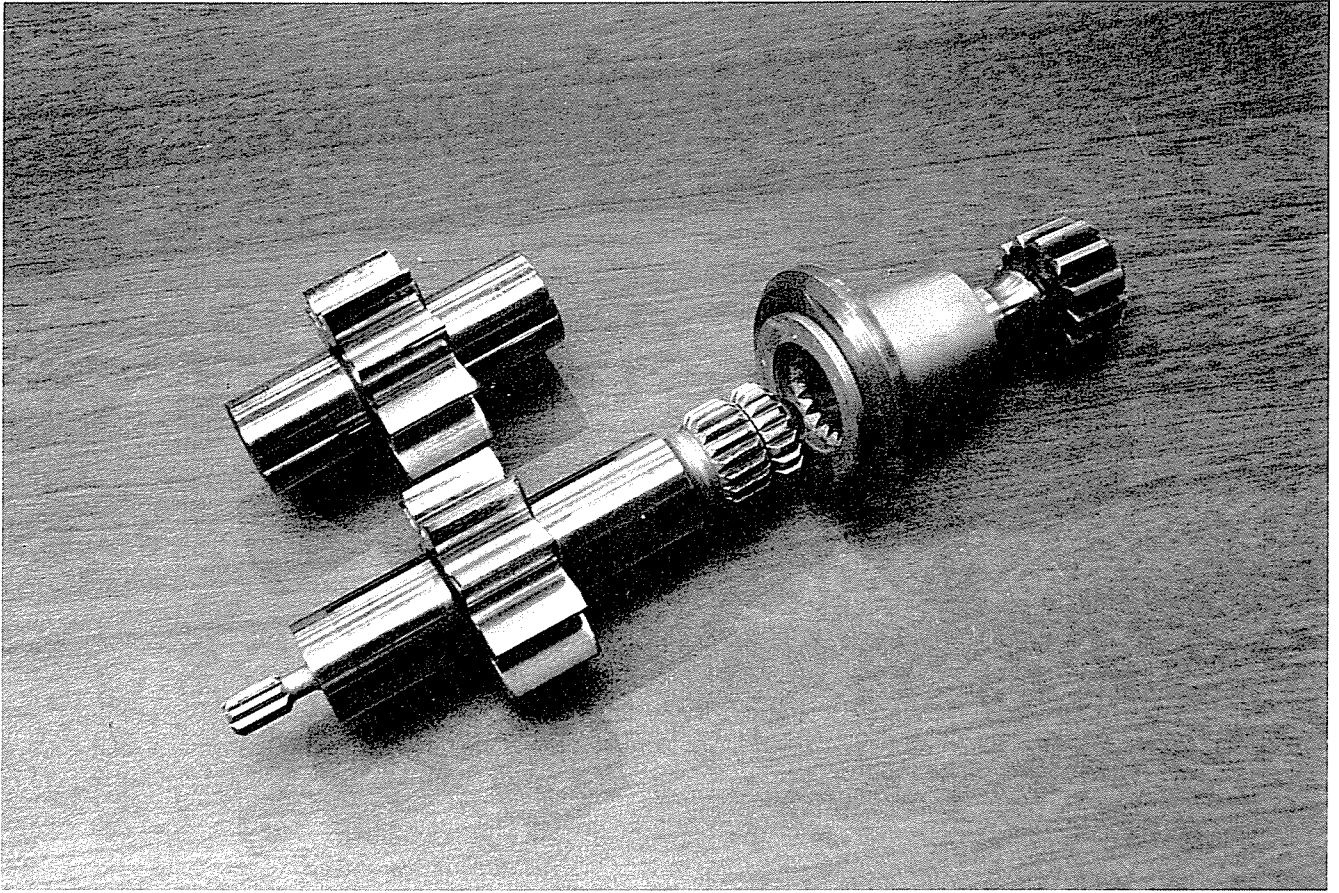
1. *General arrangement of Fuel Pump Components and Drive Assembly*

1.16 Examination of the fuel pump disclosed that the drive failure had occurred due to wear of the drive shaft internal spline (see figure 1 and photographs 1 and 2). No significant metallic contamination was present, suggesting that wear had occurred over a long period. The fuel pump and the fuel control unit were returned to Textron Lycoming USA for specialist investigation of the failure.

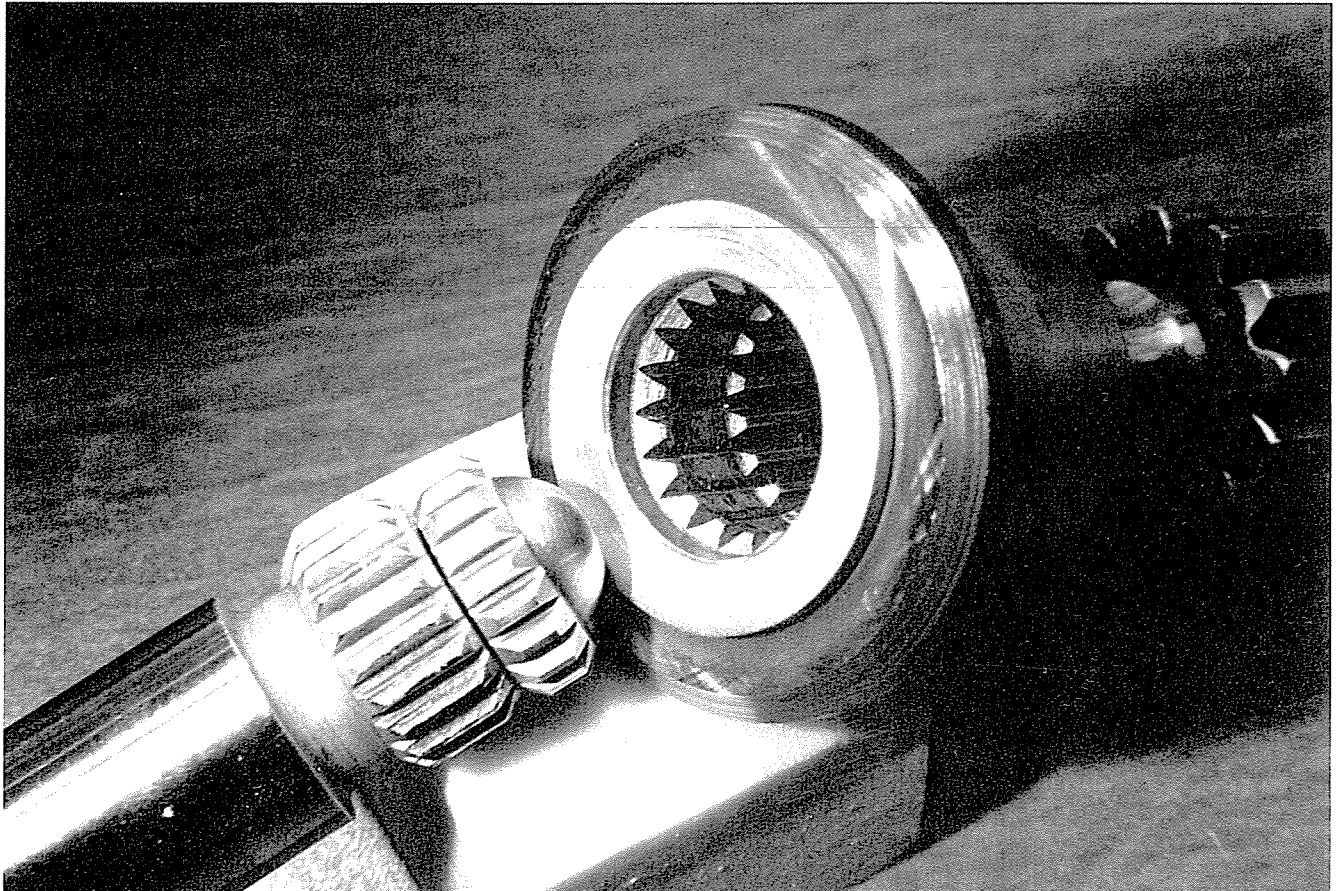
2. *Fuel Pump Drive Shaft internal spline wear, wear on loaded side of driver gear teeth and circumferential scoring.*

The fuel pump was received in a disassembled condition. Visual examination of the individual components revealed that the drive shaft internal spline had been completely worn away in the area that meshes with the driver gear. Examination of the driver gear external spline revealed circumferential scoring on the outer diameter and wear on the loaded side of the spline teeth. There was no evidence of lubricating grease on either the drive shaft internal spline or the driver gear external spline.

- The engine power loss was caused by the de-coupling of the fuel pump drive shaft from the driver gear.
- The de-coupling occurred due to heavy spline wear on the fuel pump drive shaft.
- The heavy spline wear occurred because the grease had leaked out of the spline shaft cavity.

- Textron Lycoming Commercial Service Letter (CSL) number 102, released 23 June 1992 informs operators of modifications and improvements that can be made to existing fuel pumps to improve their reliability. Specifically, vendor Service Bulletin 73-9, which introduces improved internal spline lubrication to reduce spline wear and extend pump service life. Compliance with CSL 102 will eliminate the heavy spline wear which caused this engine incident.”

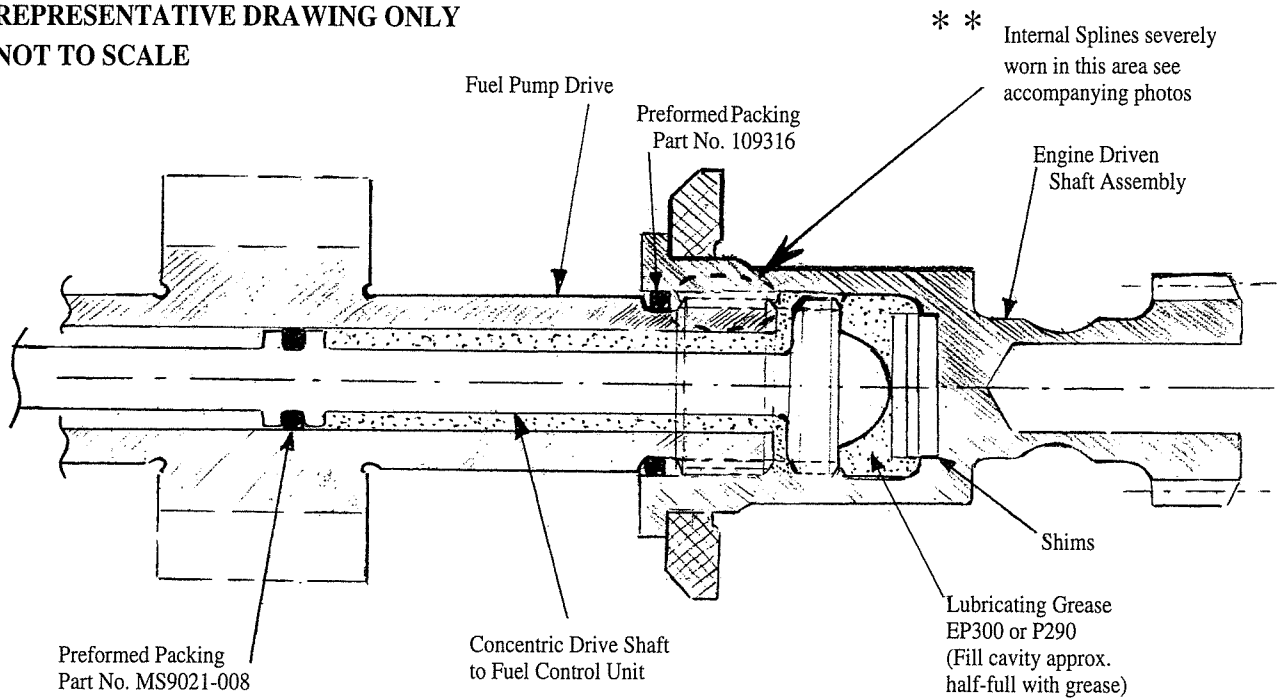
Fig 1. Cross-sectional view of affected fuel pump components, also showing fuel pump improvements per vendor service bulletin 73-9. These improvements include the addition of preformed packing P/N 109316 and the application of additional lubricating grease in the shaft cavity to eliminate spline wear.

Draw the attention of owners/operators to TextronLycoming Commercial Service Letter 102 [dated 23 June 1992] to inform or remind them of the series of modifications and improvements that may be made to existing fuel pumps with particular reference to Chandler Evans Service Bulletin (SB) 73-9 "Improved internal spline lubrication resulting in reduced spline wear and extended pump service life" (061/93), and
