NO. 93-017

BELL 212

ZK-HNO

AIRCRAFT ACCIDENT REPORT NO. 93-017

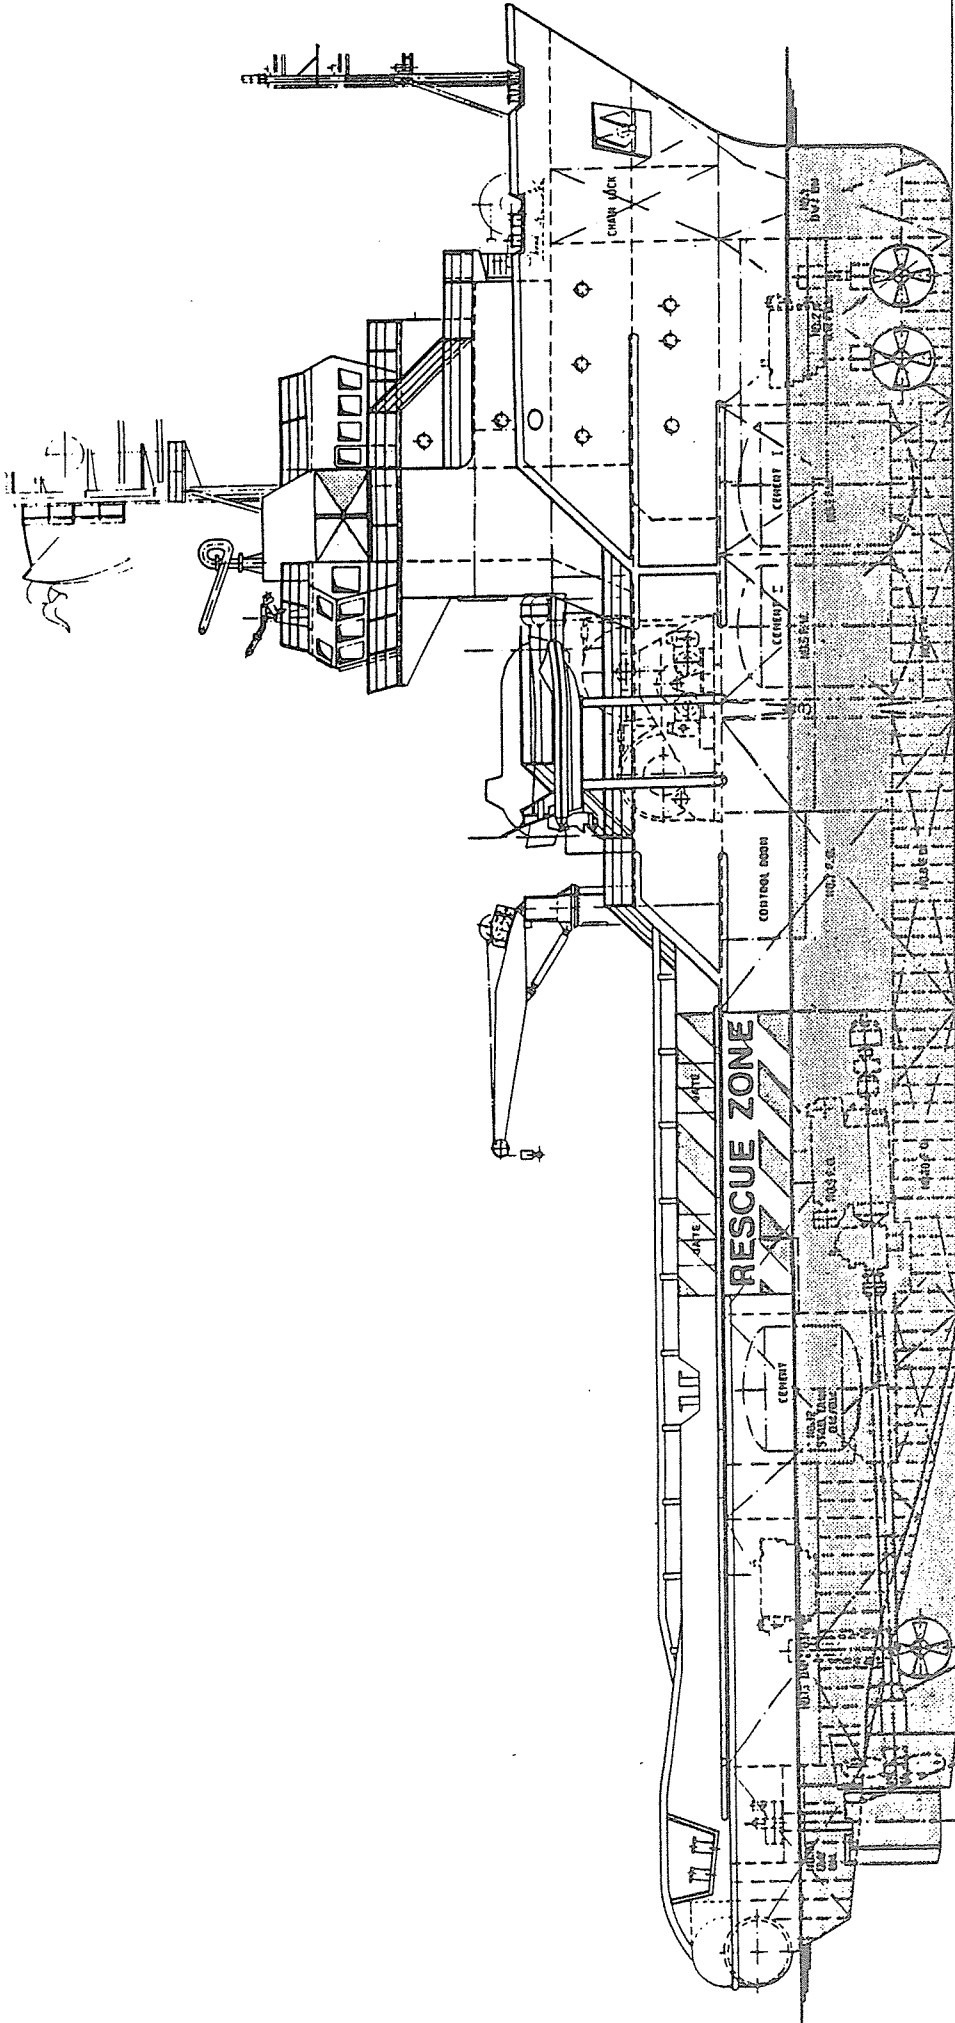
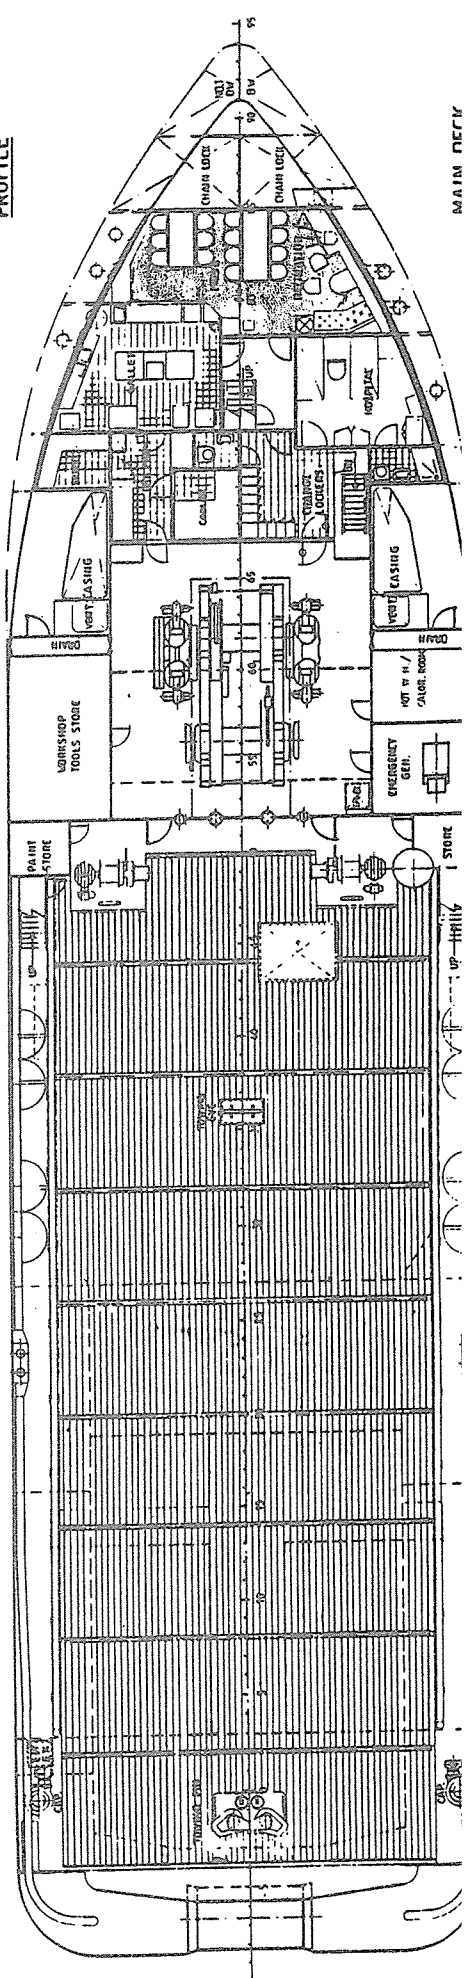
1.11 The first manoeuvre was to lower the winchman and "survivor" to the middle of the deck, some 10 m from the stern of the Pacific Ariki (see Figure 1). Here the "survivor" was unhooked and remained on the deck while the winchman was winched in and the helicopter pilot flew a circuit about the ship.

1.19 The "survivor" and the winchman fell onto the deck brushing the safety rail near the capstan on the ship's starboard quarter and sustained fatal injuries.
