NO. 93-020

**MID-AIR COLLISION
AEROSPATIALE AS 355 F1 HELICOPTER
PIPER PA 28-181
ZK-HIT/ZK-ENX
AUCKLAND CITY
26 NOVEMBER 1993**

This report explains the mid-air collision of a AS 355 helicopter with a PA 28 aeroplane, both on Police patrol flights over Auckland City on 26 November 1993. Safety issues discussed include the limitations of the "see and avoid" concept of collision avoidance, the use of radio contact between aircraft and the variety of radio frequencies in use.

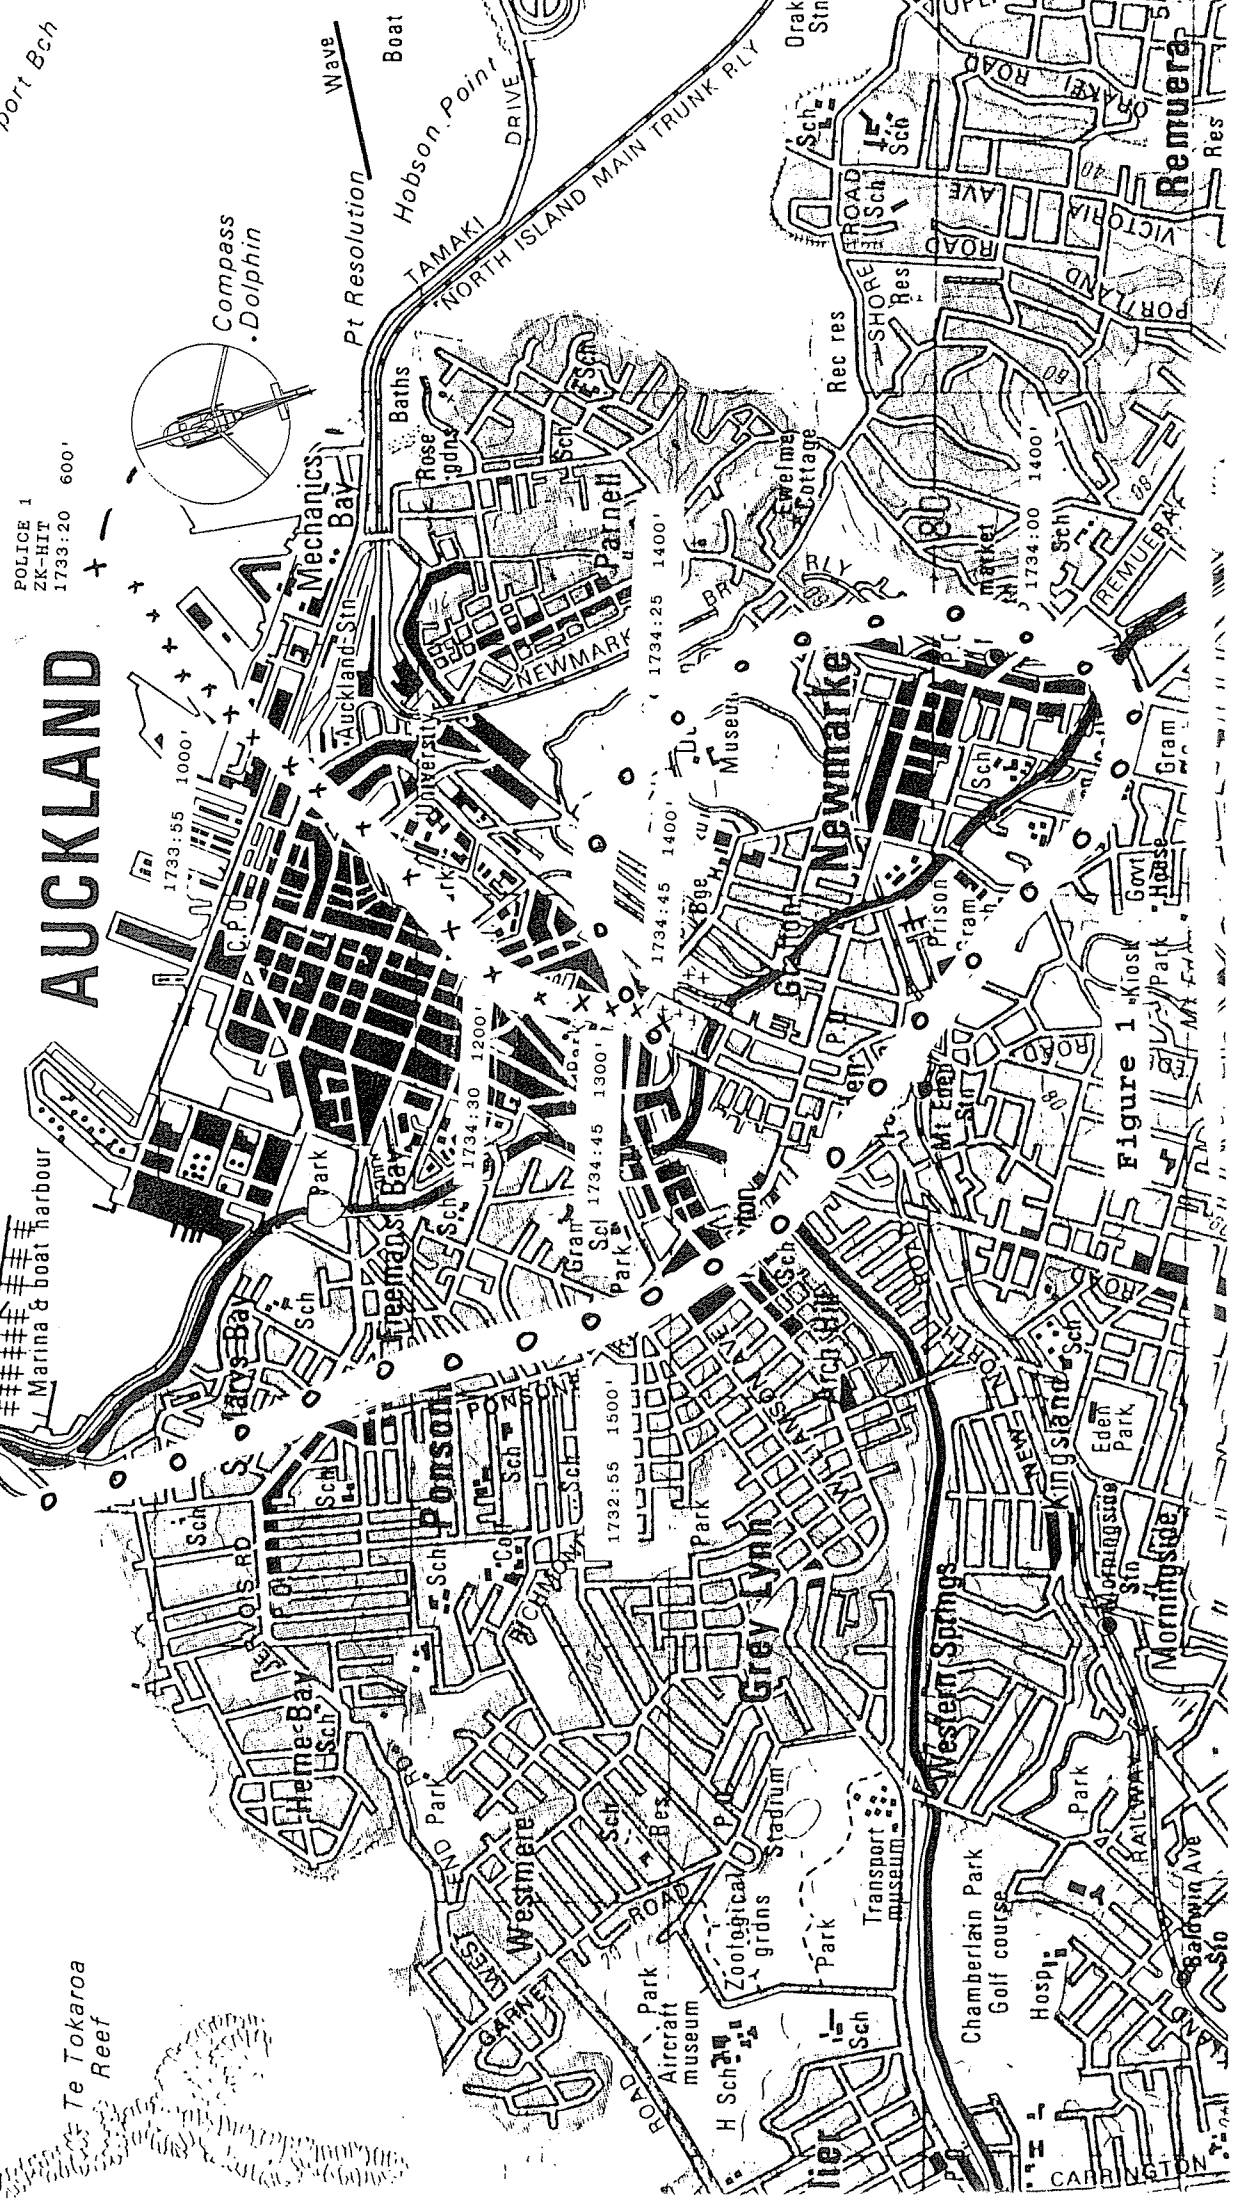
Figure 1

1.16.4. Some smoothing and interpolation was used to produce the track plots derived from the primary and secondary radar plots, which are shown overlaid on a map of Auckland (Figure 1). A few secondary radar returns for each aircraft were missing, either as a result of terrain masking, or the aircraft turning and thus shielding its transponder aerial from the radar. The altitude information shown was that derived from each aircraft's encoder by ATC. The first radar return of Police 1 was at 600 feet, heading south-west, so the flight path to that point is an estimate only.

1.16.5. Each radar return occurred at 5 second intervals, and the plots indicated an intersection of the two flight paths at 1734:48 hours, the estimated time of the collision.

1.16.6. Measurement of the distances travelled on the plot over a 60 second period gave a ground speed for the PA 28 of 110 knots, and for the AS 355 of 65 knots.

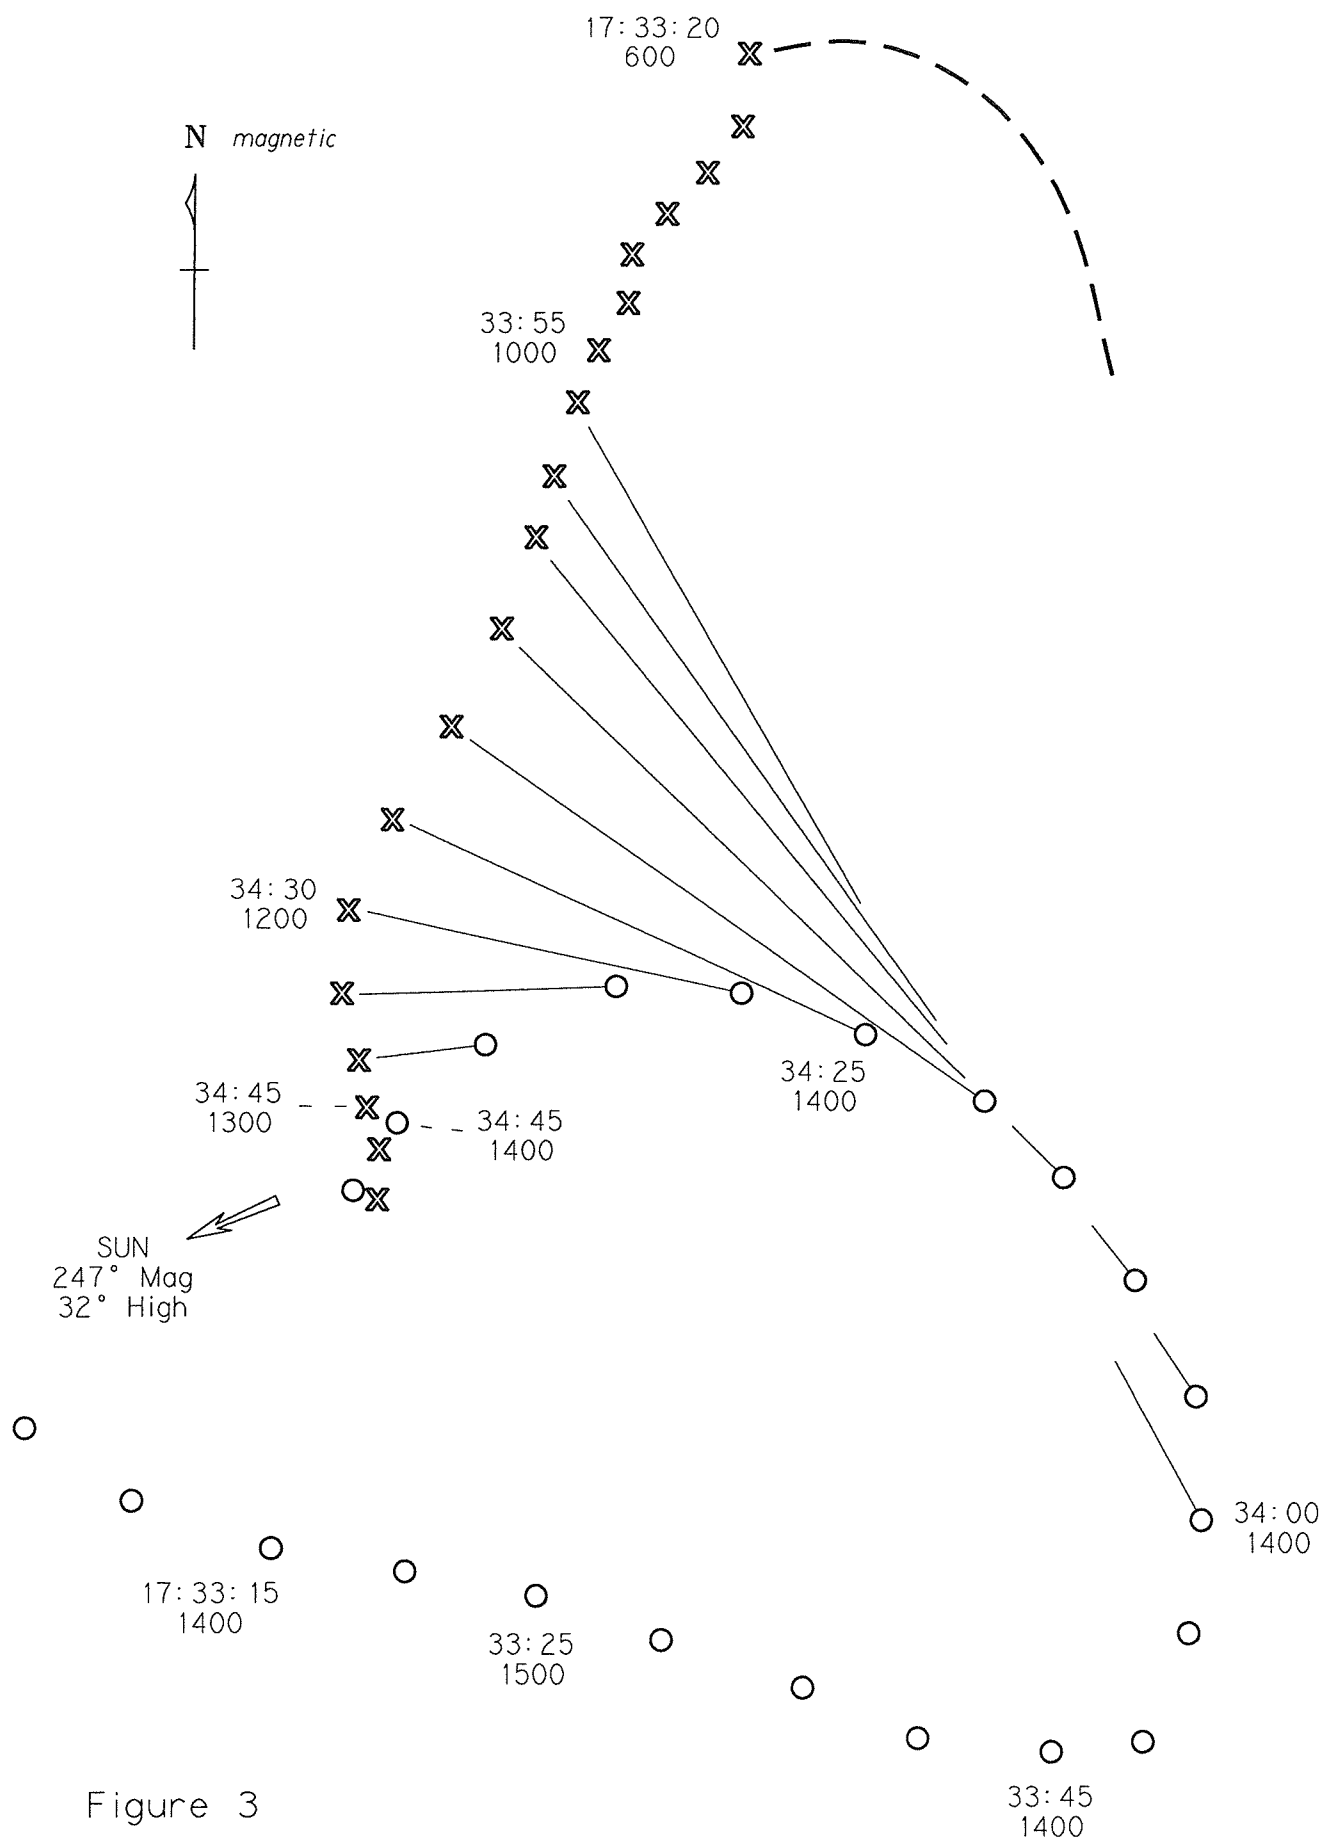
1.16.8. Figure 3 shows the relative bearings of each aircraft for the last 45 seconds, as well as the bearing of the sun. Separation distances measured show that the closing speed was initially about 150 knots, reducing to about 80 knots just before the collision.

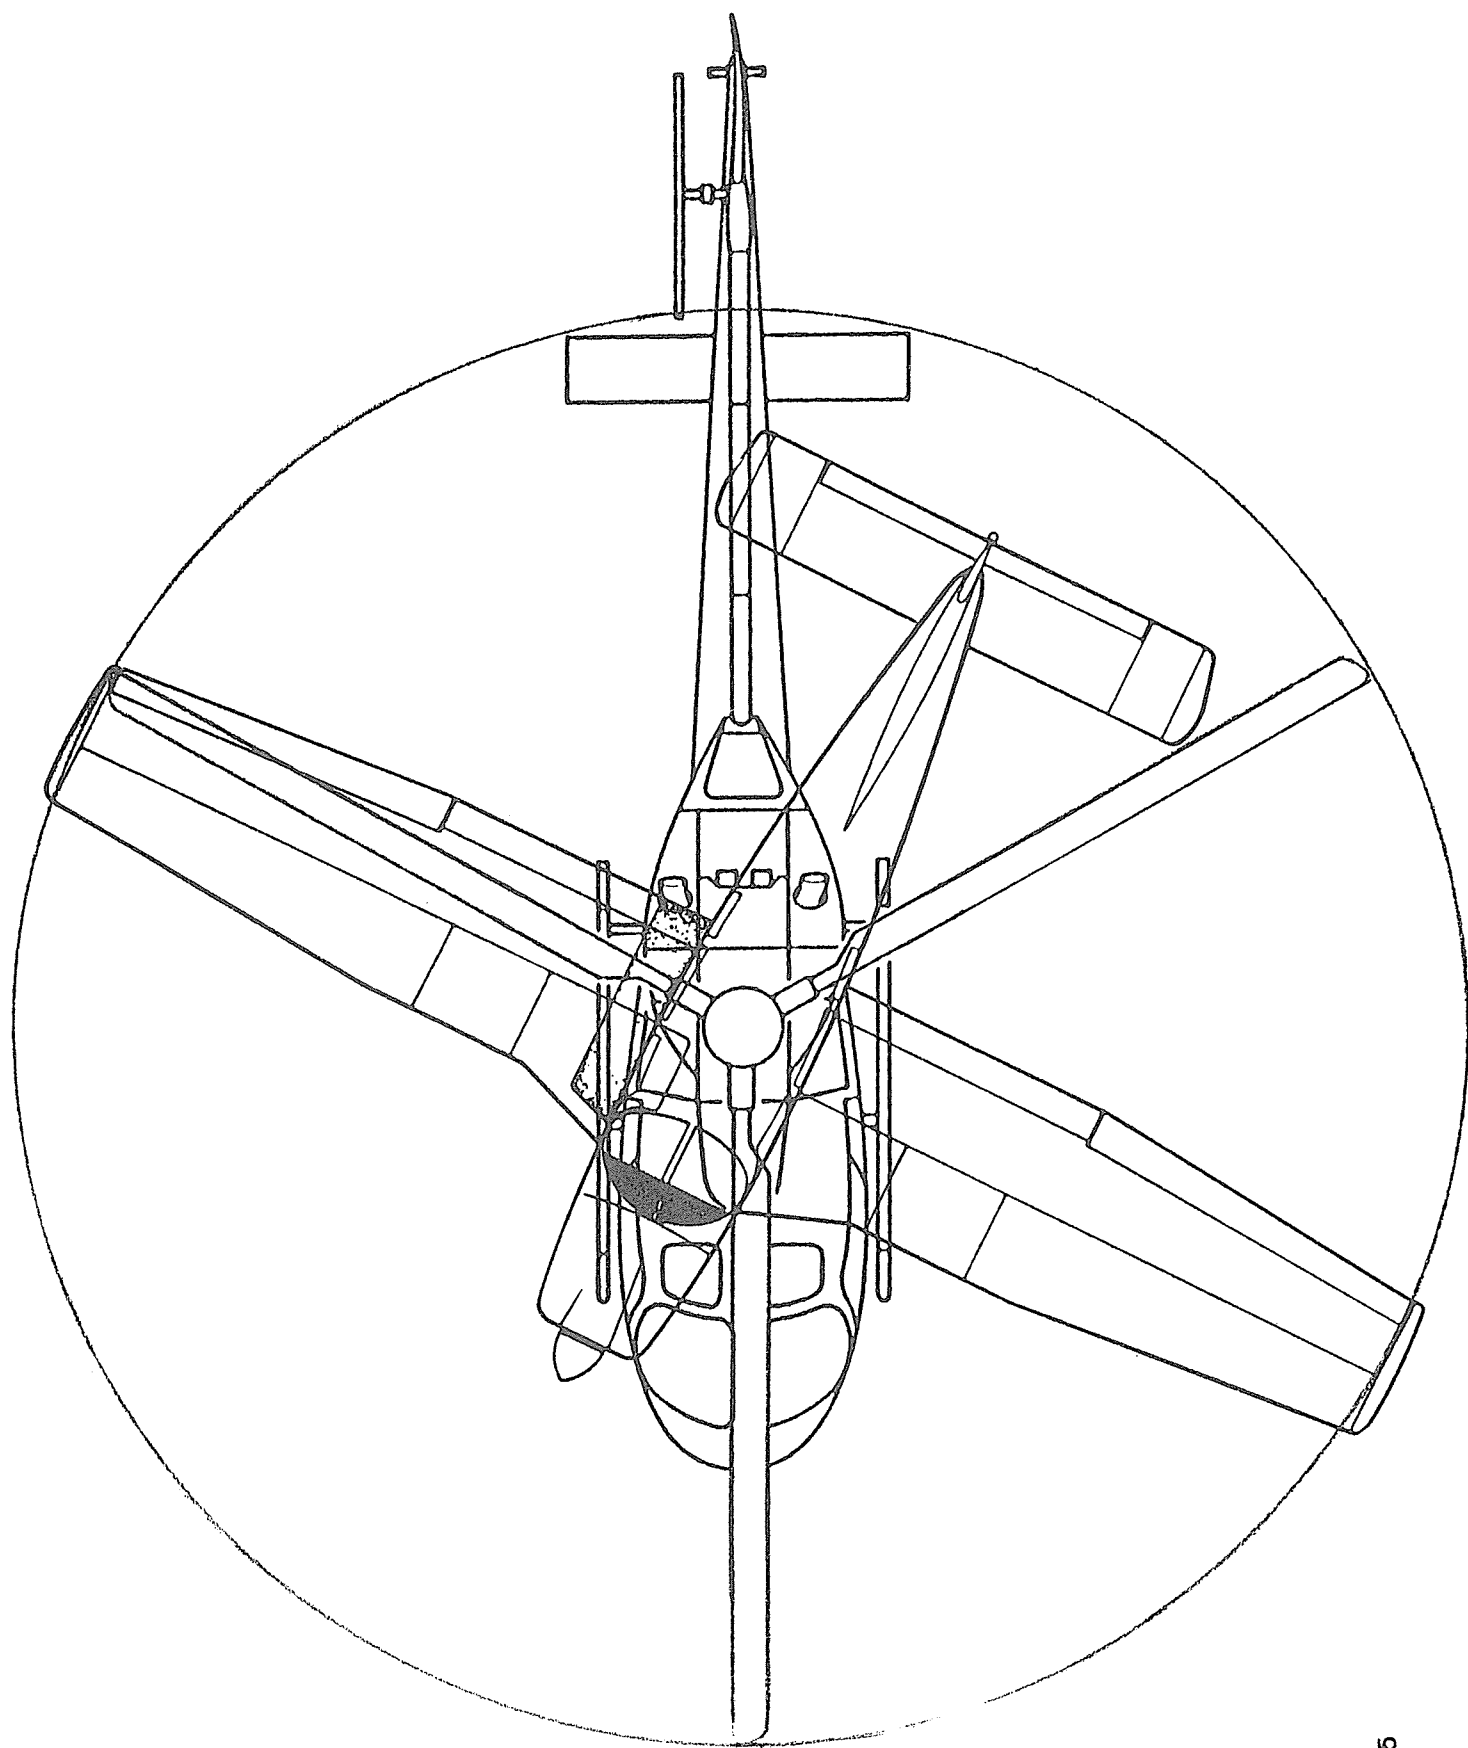
Figure 5

1.16.9. Figures 4 and 5 show the relative positions of each aircraft at the collision.

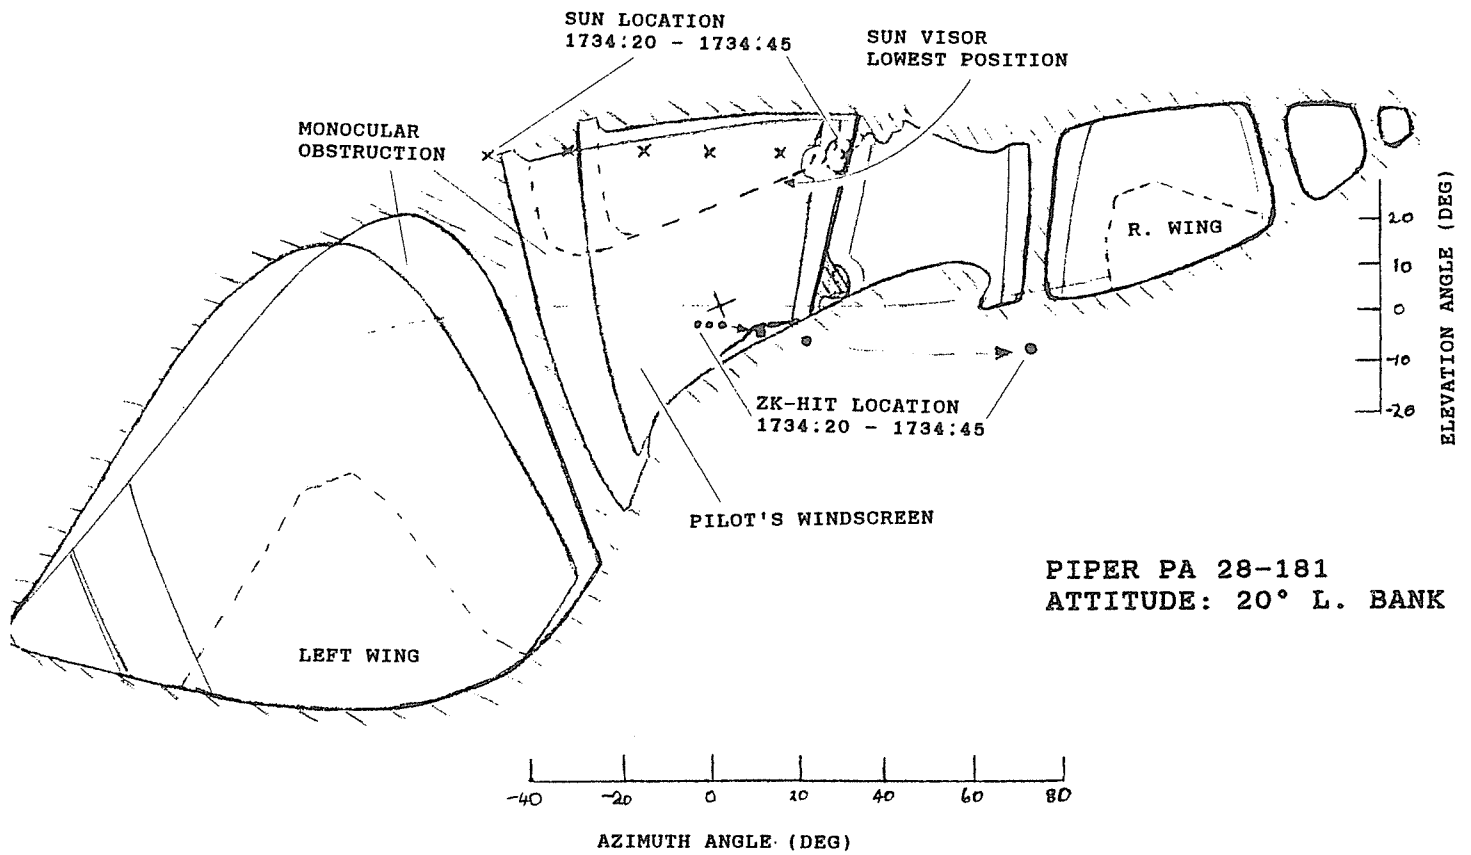
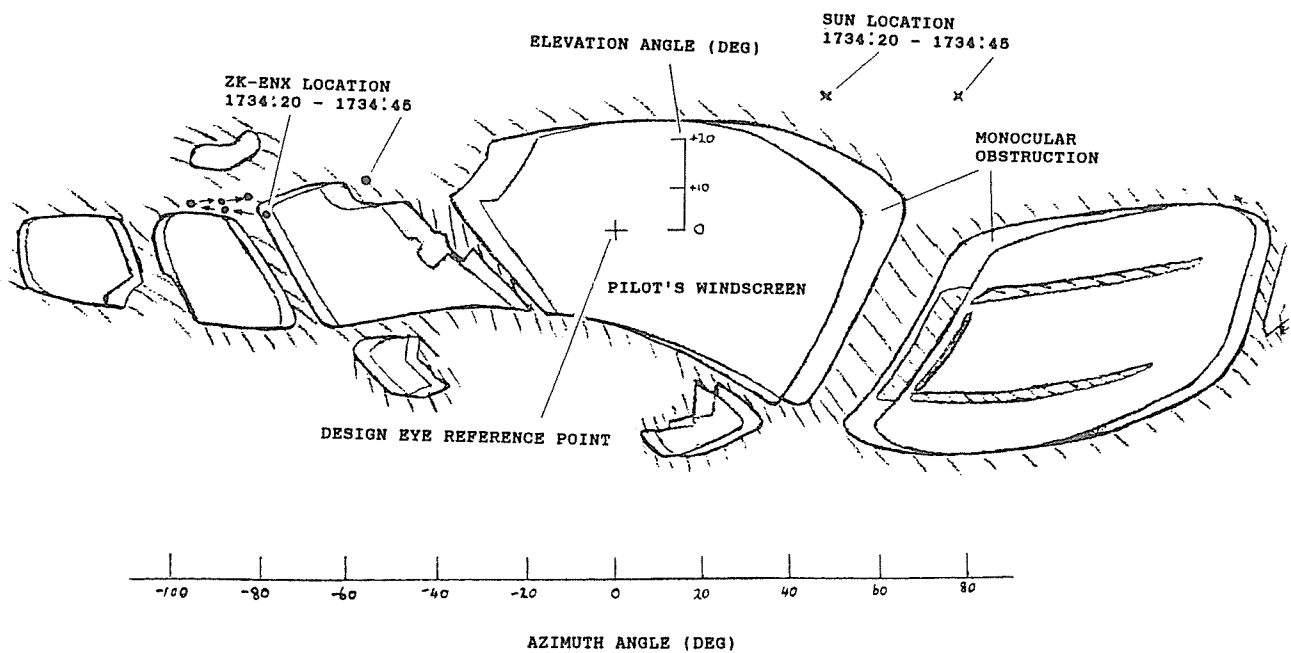
AEROSPATIALE AS 355
ATTITUDE: LEVEL

2.12. From the pilot's viewpoint in ZK-ENX, the helicopter was just left of straight ahead, in his 12 o'clock position, low in his windscreen and just above the nose of his aircraft. It was some 3° below his horizon, and would have had a background of the predominantly built-up area of North Shore, across Waitemata Harbour. His view would have been of the left side of the helicopter. The study showed that the lowering afternoon sun appeared in his field of view at about the same time, in the top left of his windscreen. If his sun visor had been raised, the resulting dazzle would have impaired his ability to discern the helicopter. If the visor was lowered, the effects of dazzle would have been mitigated, but the helicopter would not have been easily distinguished from such a background
