NO. 94-018

CESSNA A185E

ZK-JEM

AIRCRAFT ACCIDENT REPORT NO. 94-018

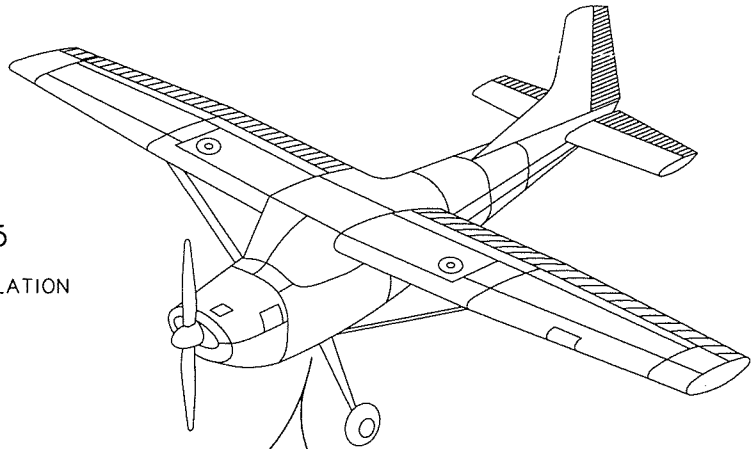
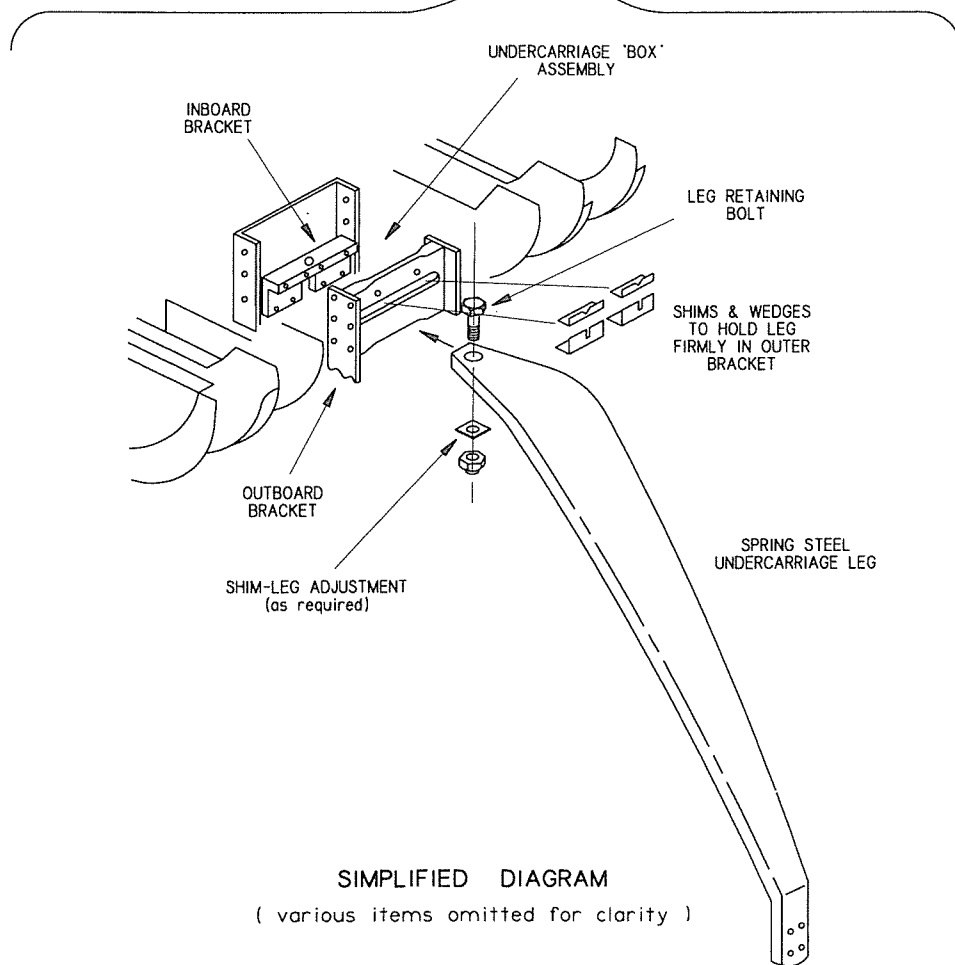
Figure 1

1.5 The left undercarriage leg had been forced rearwards and folded inwards during the occurrence. Damage to the forward bulkhead and bending of the retaining bolt was consistent with such a sequence. The upper section of the outer bracket, through which the undercarriage leg passed and in which it was normally held firmly by a pair of wedges, had failed as a result of overload. Some distortion of the bolt hole in the inboard bracket had occurred, probably during the undercarriage collapse. However, step marks on the bolt and a wear pattern on the upper face of the bracket indicating that fretting had taken place between the leg and the bracket suggested that the retaining bolt had been loose for some time prior to the mishap.

1.6 The undercarriage leg retaining bolt specified by the aircraft manufacturer was AN7-20A (This designated a standard aircraft bolt of given diameter and length). Measurement of the damaged bolt recovered from the aircraft showed that, although it was of the correct diameter, its length corresponded to that of an AN7-23A. This meant that the "grip" of the bolt (the length of the unthreaded portion of the shank) was some 0.375 inches in excess of that specified by the manufacturer. Measurement showed that the thickness of the undercarriage leg and the inboard bracket conformed to standard. There was therefore no special circumstance requiring the use of a longer than normal bolt.

1.7 The use of a retaining bolt with excess “grip” to secure the undercarriage leg to the inboard bracket held potential for incorrect assembly. If insufficient packing washers were initially employed, or if one of a series of washers was inadvertently omitted at some later stage such as if the leg was removed and re-installed, there was a risk that the nut could become threadbound when tightened. This could result not only in undetected damage to the threads but a consequent impression could be gained that an appropriate torque had been applied without a guarantee that the bolt was, in fact, in tension, and the leg and bracket properly clamped together. In addition, the use of excessive ‘packing’ increased the possibility of loss of torque due to ‘bedding-in’, or ‘crushing’, of the packing as a result of service loads. The fluctuating loads to which the undercarriage legs were subjected in day to day operation were likely to have induced relative movement between the leg and the bracket once a loss of torque occurred. The extent of wear on the bracket of ZK-JEM indicated this had occurred.
