Report 95-004

**Beech 65-A80-8800 Queen Air
(Excalibur Conversion)**

ZK-TIK

29 March 1995

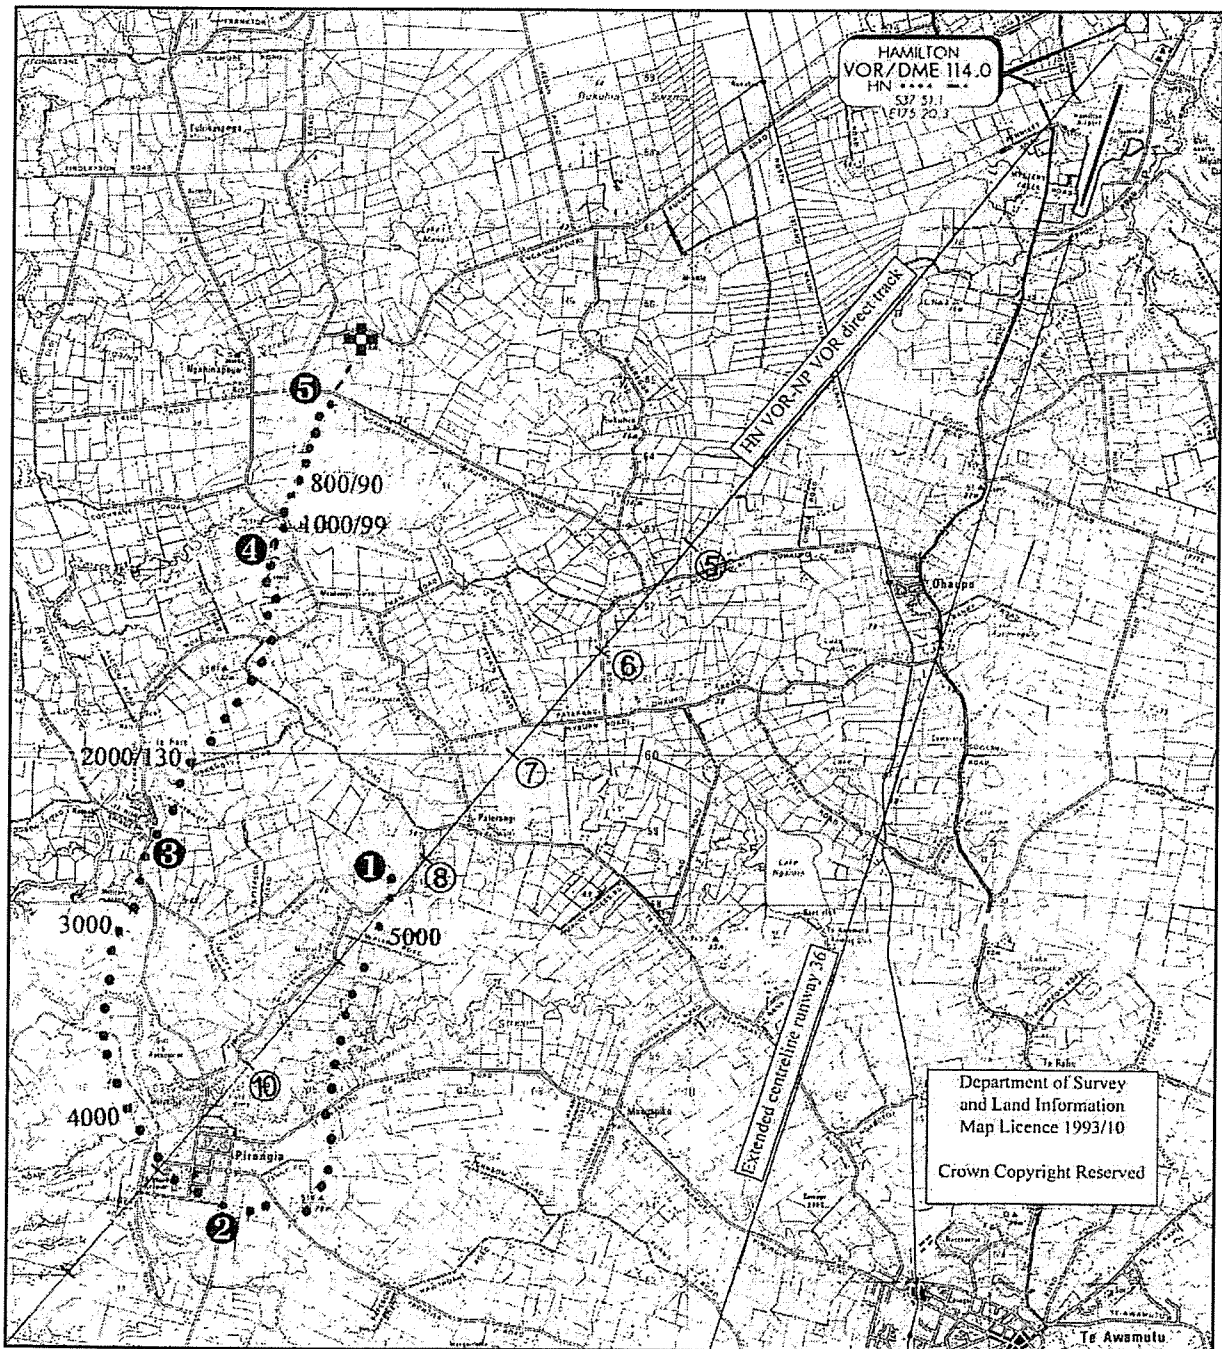
Figure 1
Radar plot of ZK-TIK's flight path
subsequent to first engine failure

- ② Approximate point of second engine failure (witness observations)

- ✚ Final impact point

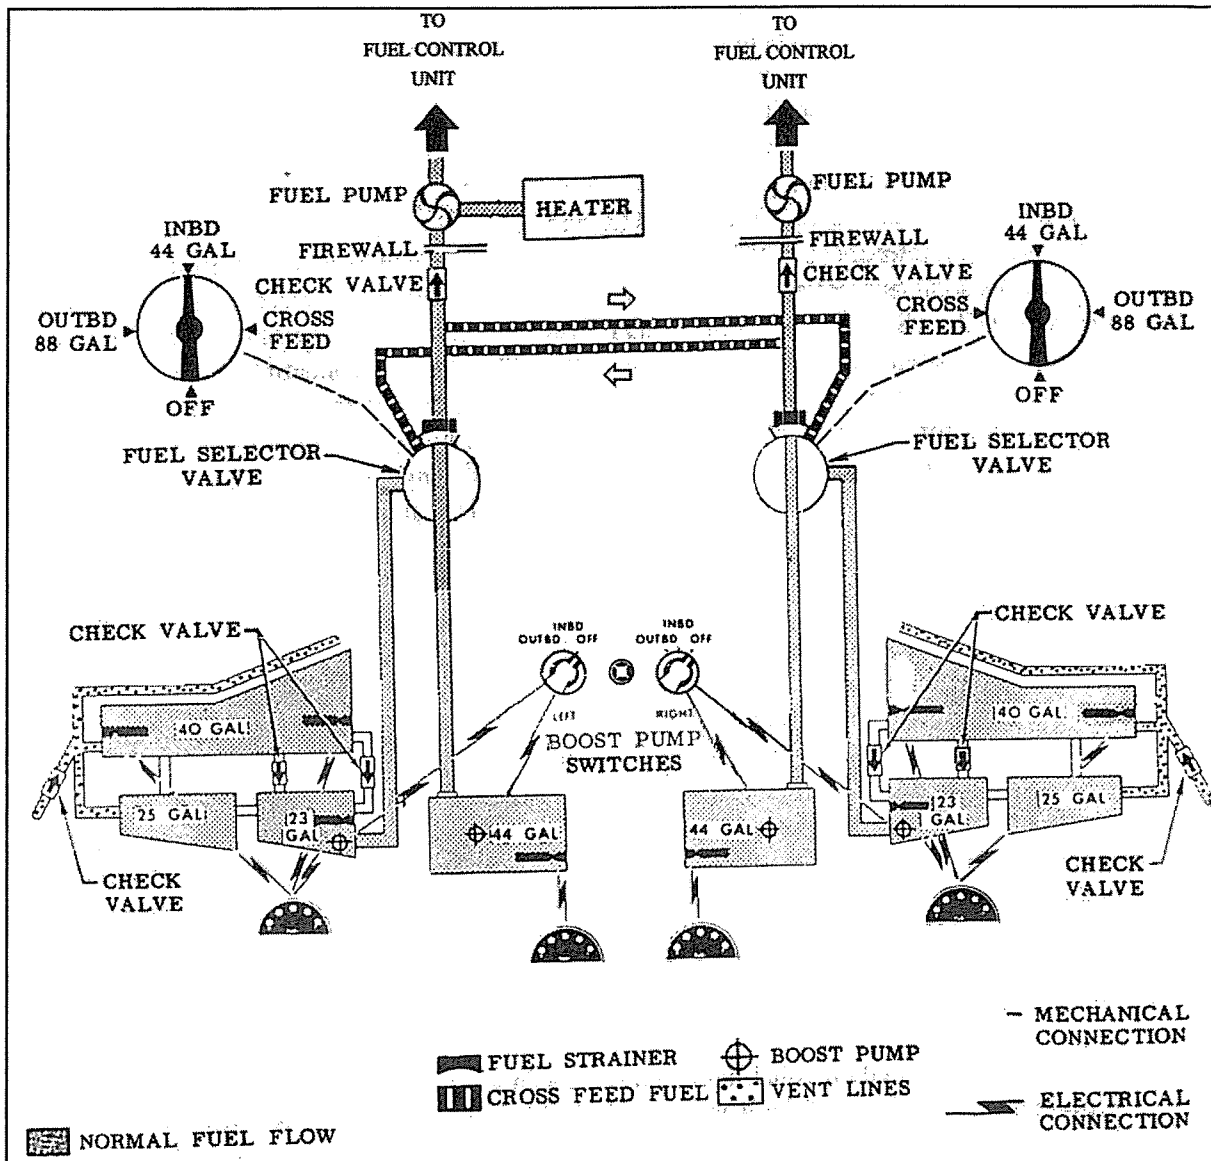
Figure 2
ZK-TIK (A80) fuel system

- 1.6.12 The Queen Air A80 fuel supply system as applicable to ZK-TIK is shown schematically in Figure 2. From the diagram, it can be seen that the inboard tanks and the outboard tanks are selected independently. On each side, the three outboard cells are interconnected to form, in effect, a single outboard tank. Further reference to an “outboard tank” means the group of three considered as one. The cells themselves are flexible rubberised fabric units.

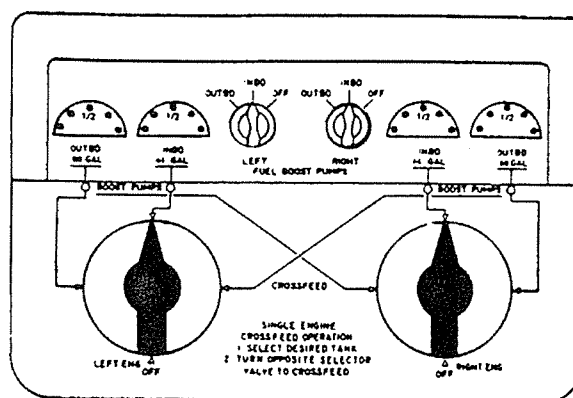
Fuel panel ZK-TIK in take-off configuration

- 2.9 There was sufficient evidence to point to a take-off with the fuel selectors set to the inboard tanks. The quantities available in the inboard tanks were compatible with the time taken from take-off until the engines failed, the nature of the second failure in particular suggested that it was due to a tank being run dry, the position of the right fuel selector at impact was considered to be its pre-impact setting, and no evidence could be found of any other cause for the engine failures. There was sufficient fuel on board for the planned return flight, with reserves, and this was all carried in the outboard tanks. There was no impediment to this fuel's availability to the engines. The sequential, rather than simultaneous, engine failures can be attributed to slightly different fuel levels in the inboard tanks.
