No. 95-010

Fletcher FU24A-954

ZK-EMU

Aircraft Accident Report No. 95-010

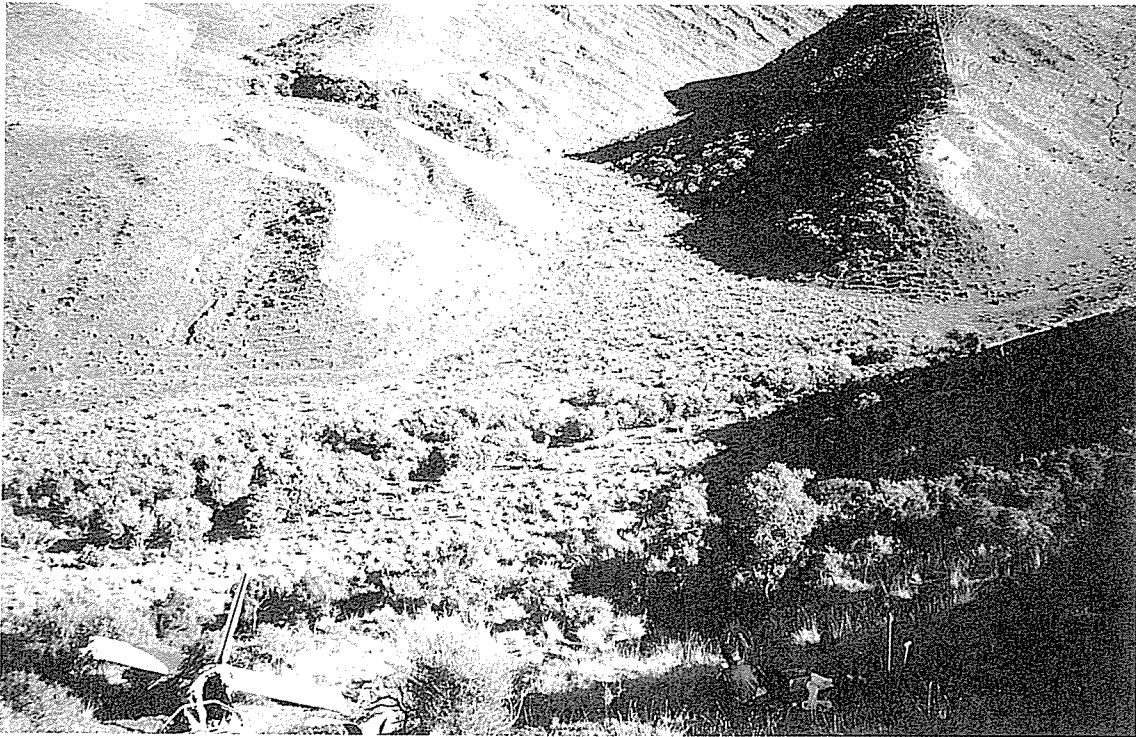
Figure 1

- 1.13 The aircraft had collided with the western face of a hill on the eastern side of a wide valley which ran in a north-west to south-east direction. The aircraft had been flying in an easterly direction away from the valley and along a boundary fence, which ran up the hill face toward the east. The collision occurred about halfway up the 26° slope. The aircraft had squashed onto the ground with its nose raised to approximately the angle of the slope. The ground strike marks showed that the left wing was about 16° down at the time of impact. About one quarter of the load remained in the hopper and there was no evidence that the pilot had attempted to jettison this load. The aircraft had struck the ground heavily and slid up the slope for 41 m before coming to rest in an upright attitude. An intense fire broke out shortly afterwards and consumed most of the aircraft.

- 1.15 The topography of the surrounding area was such that it would have presented few problems for the pilot during his sowing, especially at the altitude he had been flying. The valley he had been sowing prior to the accident was relatively wide and there were no obstructions to the flight path such as trees, poles or wires. Had an engine failure or loss of power occurred, the valley floor would have been suitable for a forced landing. There was no evidence that the pilot had attempted to position the aircraft for a forced landing and examination of the wreckage suggested that the flaps were in the up position. (See Figure 1)
