No. 95-017

Robinson R22 Beta

ZK-HKM

Aircraft Accident Report No. 95-017

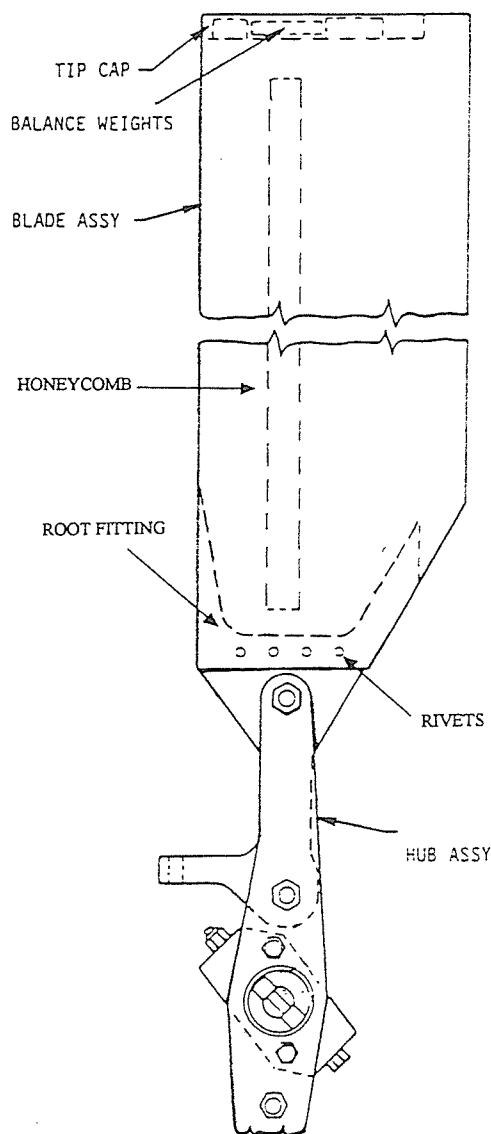
Figure 1
Tail Rotor Assembly

- 1.23 Each tail rotor blade consisted of a root fitting, aerofoil section, tip cap and balance weights. A length of honeycomb material was bonded internally along the complete length of the aerofoil. The tip cap contained the balance weights and was bonded to the outer end of the aerofoil. The aerofoil was bonded together along its trailing edge and to the root fitting, and eight non-load bearing rivets helped secure the aerofoil to the root fitting. The rivets were not designed to carry the load of the aerofoil section. A data plate with the serial number and part number was secured to the arm of the root fitting, and the serial number was also mechanically etched to the tip cap. (See Figure 1.)

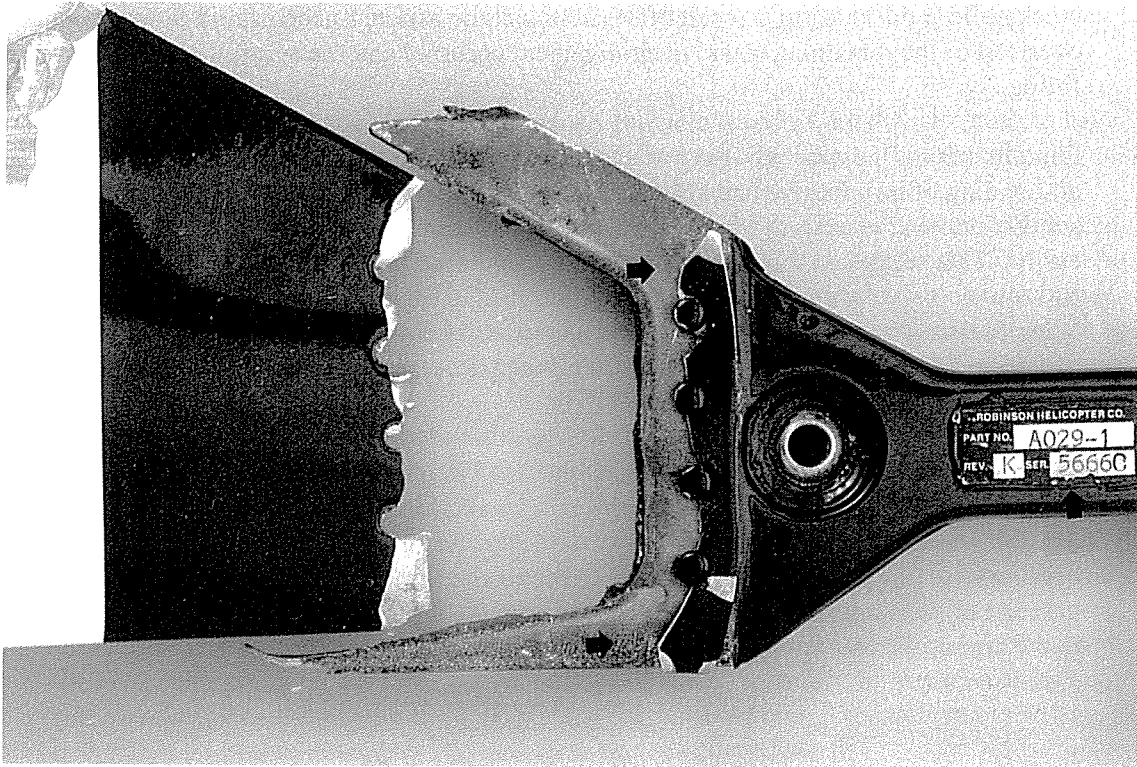
- 1.19 The rest of the helicopter was accounted for and nothing additional was found that might have contributed to the accident.
- 1.20 The empennage attachment fitting and the tail rotor blades and their root fittings were taken to Industrial Research Ltd for analysis. It was found that the empennage attachment fitting had failed in overload. However it was established that the separated tail rotor blade, serial number 5666C, had failed as a result of de-bonding at the adhesive to metal aerofoil interface. Once the de-bonding occurred the load was transferred to eight non-load bearing rivets. Despite the centrifugal and torsional loads induced during tail-rotor rotation the non-load bearing rivets evidently held the aerofoil to the root fitting for a period of time, but the aerofoil eventually

cracked from the rivets as a result of environmentally assisted (corrosion) fatigue. Final overload of the remaining sound metal ligament occurred and the aerofoil separated from its root fitting.

Figure 2a
The root fitting and detached aerofoil from blade 5666C.

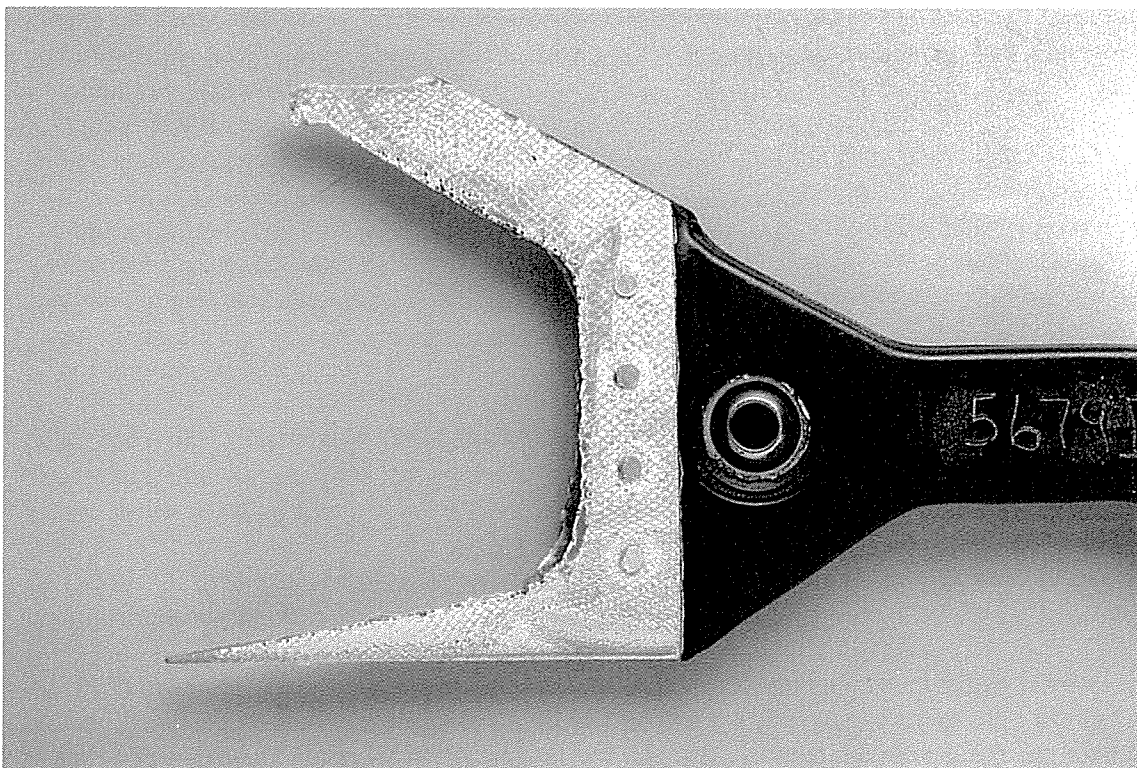
Figure 2b
The blade root from a sample blade, showing a light brown adhesive and knit carrier.

- 1.26 Two sample Robinson R22 tail rotor blades that had been removed from service were examined. One blade had been manufactured five days after the failed blade. Its aerofoil skin section was removed from the root fitting and the aerofoil section exposed internally. The other blade was cut through adjacent to the root fitting and the trailing edge of the aerofoil section separated. The two sample blades were similar in appearance and had been fabricated as described by the manufacturer. No purple coloured adhesive was present in the sample blades, only a “yellow to butterscotch brown” coloured adhesive with a knit carrier. The colour and texture of the adhesive used on the failed blade and its matching blade, and the internal skin preparation, were very different from that on the sample blades. (See Figures 2a, b, c, d.)

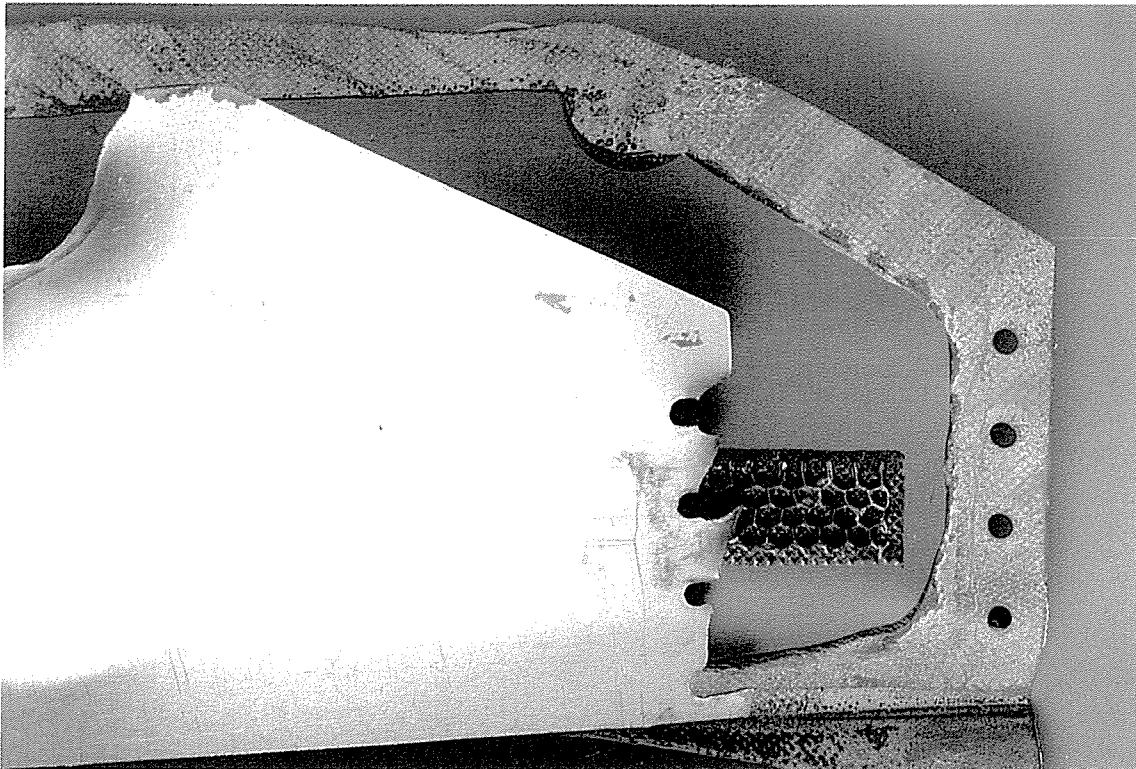
Figure 2c

- 1.25 Further examination of the failed tail rotor blade and the other blade from ZK-HKM, showed that a purple coloured adhesive had been used to bond the aerofoils along their trailing edges, honeycomb inserts, tip caps, and to the root fittings. The internal skins of the aerofoils had not been treated or prepared by any process and were bare metal. At the root fittings the purple coloured adhesive had been layered over and alongside a “yellow to butterscotch brown” coloured adhesive. There was no knit carrier present in the purple adhesive.

A comparison of the inside of the aerofoil from blade 5666C, showing the bare metal and the inside of a sample blade showing the correct surface preparation and adhesive colour.

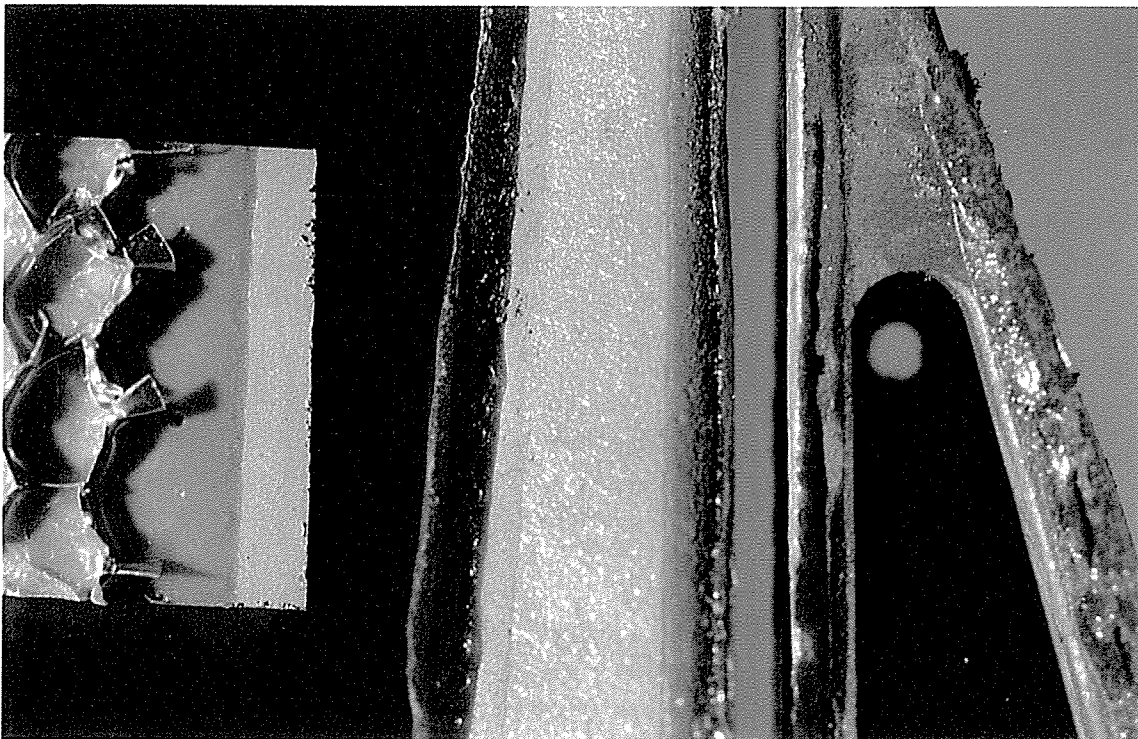
Figure 2d

The blade root and tip cap of blade 5666C, showing the purple coloured adhesive layered over tan brown coloured adhesive.
