No. 95-020

Robinson R22 Beta

ZK-HDD

Aircraft Accident Report No. 95-020

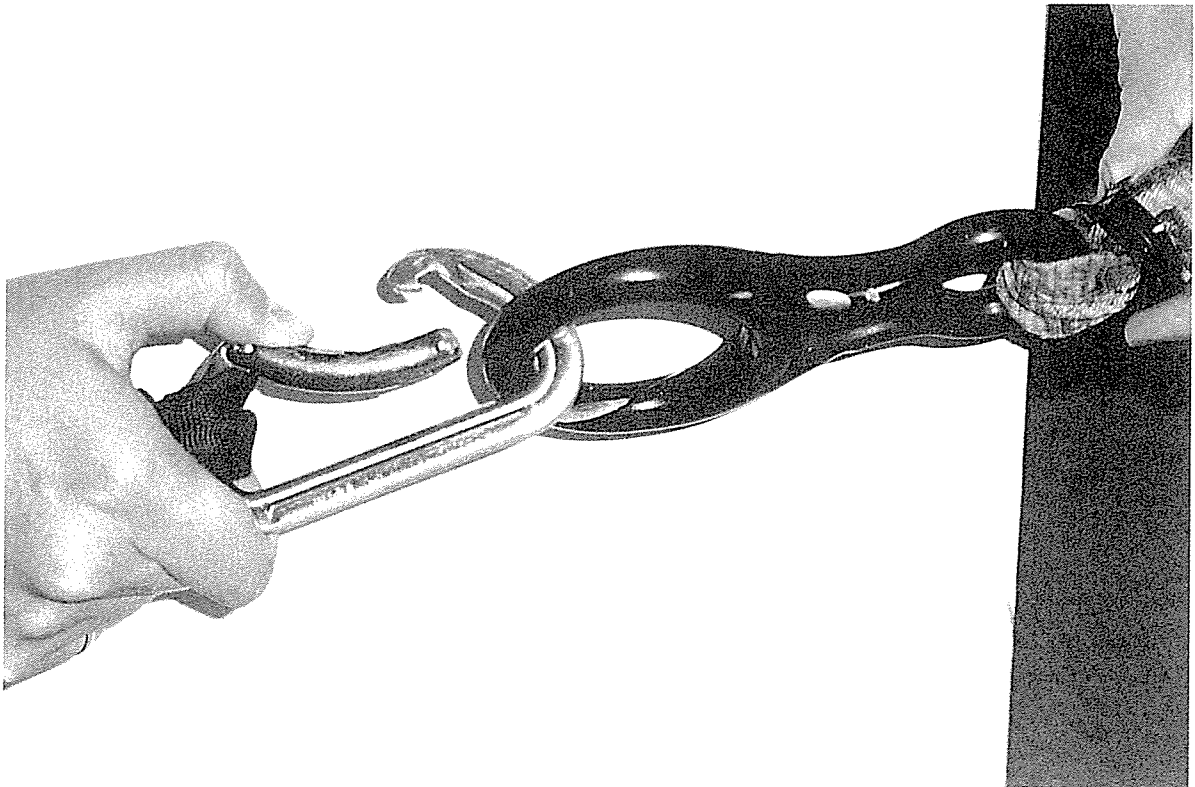
- 1.12 NZCAR C4, 3.1.1, required that "an approved safety belt or harness shall be installed for each seat of each aeroplane and rotorcraft".
- 1.13 The shooter's harness arrangement involved the use of a "bent-gate, snap-link" karabiner in place of the "lifting flap" buckle on the right portion of the seat's lap belt, and a metal "figure-of-eight" in place of the tongue on the left side of the seat's lap belt and diagonal harness. The length of the harness was fixed, such that it fitted loosely around the shooter's waist to allow him some freedom of movement. The "bent-gate" was spring loaded to the closed position but was not able to be locked in that position. (See figure 1)

Figure 1
Karabiner and "figure-of-eight"

1.21 With the karabiner type of harness arrangement utilised in ZK-HDD, potential exists for the “figure-of-eight” to twist back onto the “snap-link” and force it open, thereby allowing the “figure-of-eight” to slide out of the karabiner. ZK-HDD’s harness however did not permit this unless the “snap-link” was bent out of alignment by the “figure-of-eight”. The “snap-link”

- 1.22 Further testing of the karabiner did however show it was possible for the “snap-link” to be held in an open position by clothing or equipment, thereby allowing the “figure-of-eight” to release from the karabiner.
- 1.23 ZK-HDD had a terminating Certificate of Airworthiness which expired on 5 December 1995.
- 1.24 When the helicopter was issued with a Maintenance Release in September 1995 (valid until September 1996) the approved seat belts were fitted.
- 1.25 The pilot had qualified for a Commercial Pilot Licence (Helicopter) on 28 September 1995. He had a valid Class 1 Medical Certificate and a Robinson R22 aircraft type rating. At the time of the accident he had flown 203 hours on helicopters and 196 hours on the R22 type.

- 2.4 The “snap-link” on the harness’s karabiner was not able to be locked in the closed position, and potential therefore existed for it to be opened accidentally. It is probable that the “snap-link” was pushed open by the shooter’s equipment or clothing at some point during the accident flight, thereby allowing the “figure-of-eight” to release from the karabiner unbeknown to the shooter. Alternatively, the shooter may not have fastened the karabiner to the “figure-of-eight” correctly prior to the accident flight.

- 3.11 The harness's karabiner did not have any form of positive locking for its "snap-link", and potential existed for it to be held open by the shooter's equipment or clothing.

- 3.12 It is probable that the "snap-link" was held open by the shooter's clothing or equipment, unbeknown to the shooter, thereby allowing the "figure-of-eight" to disconnect from the karabiner.

Reconsider the issues involved in regard to the appropriate restraint of airborne deer shooters, with a view to ensuring that the equipment used for their restraint incorporates safety features guarding against inadvertent release. (005/96)
