No. 95-203

Wave-Piercing Catamaran *Condor 10*

Queen Charlotte Sound

16 April 1995

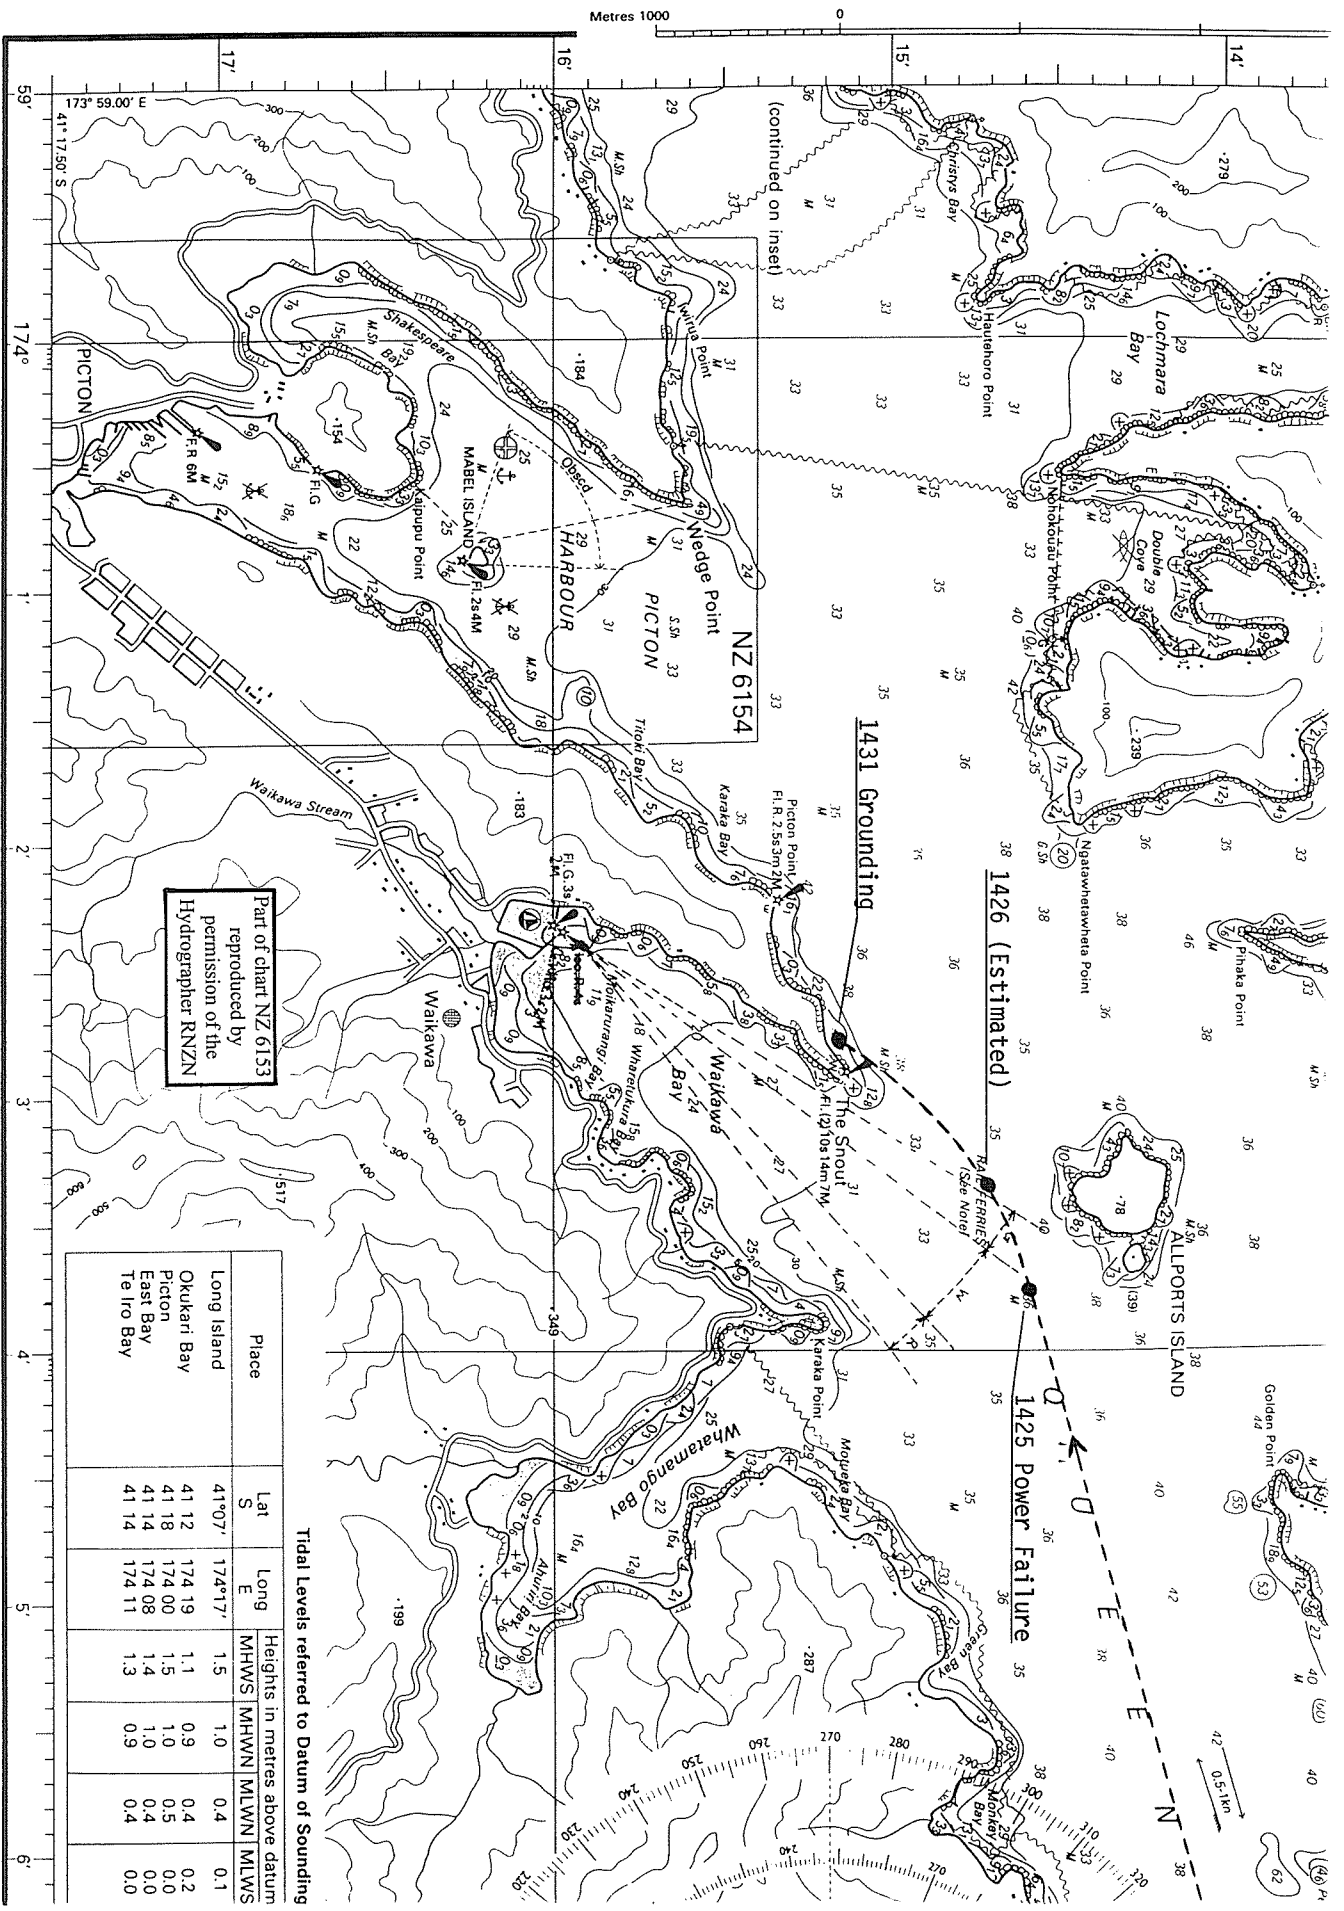
Part of chart NZ 6153 reproduced by permission of the Hydrographer RNZN

- 1.1.14 The First Engineer, having checked the port machinery room, reported to the Chief Engineer that there were no obvious abnormalities and proceeded across to the starboard machinery room where he found G3 and G4 also stopped. He went back to the port MSB room and reported this to the Chief Engineer. At this time, approximately five minutes after the loss of power, the Chief Engineer instructed the First Engineer to call the Master on the bridge and inform him that it was unlikely main power would be restored immediately. On hearing this the Master ordered that all propulsion engines be stopped using the fuel shut-off levers. This was done immediately. The vessel grounded shortly after on the north-west side of "The Snout" (see figure 2).

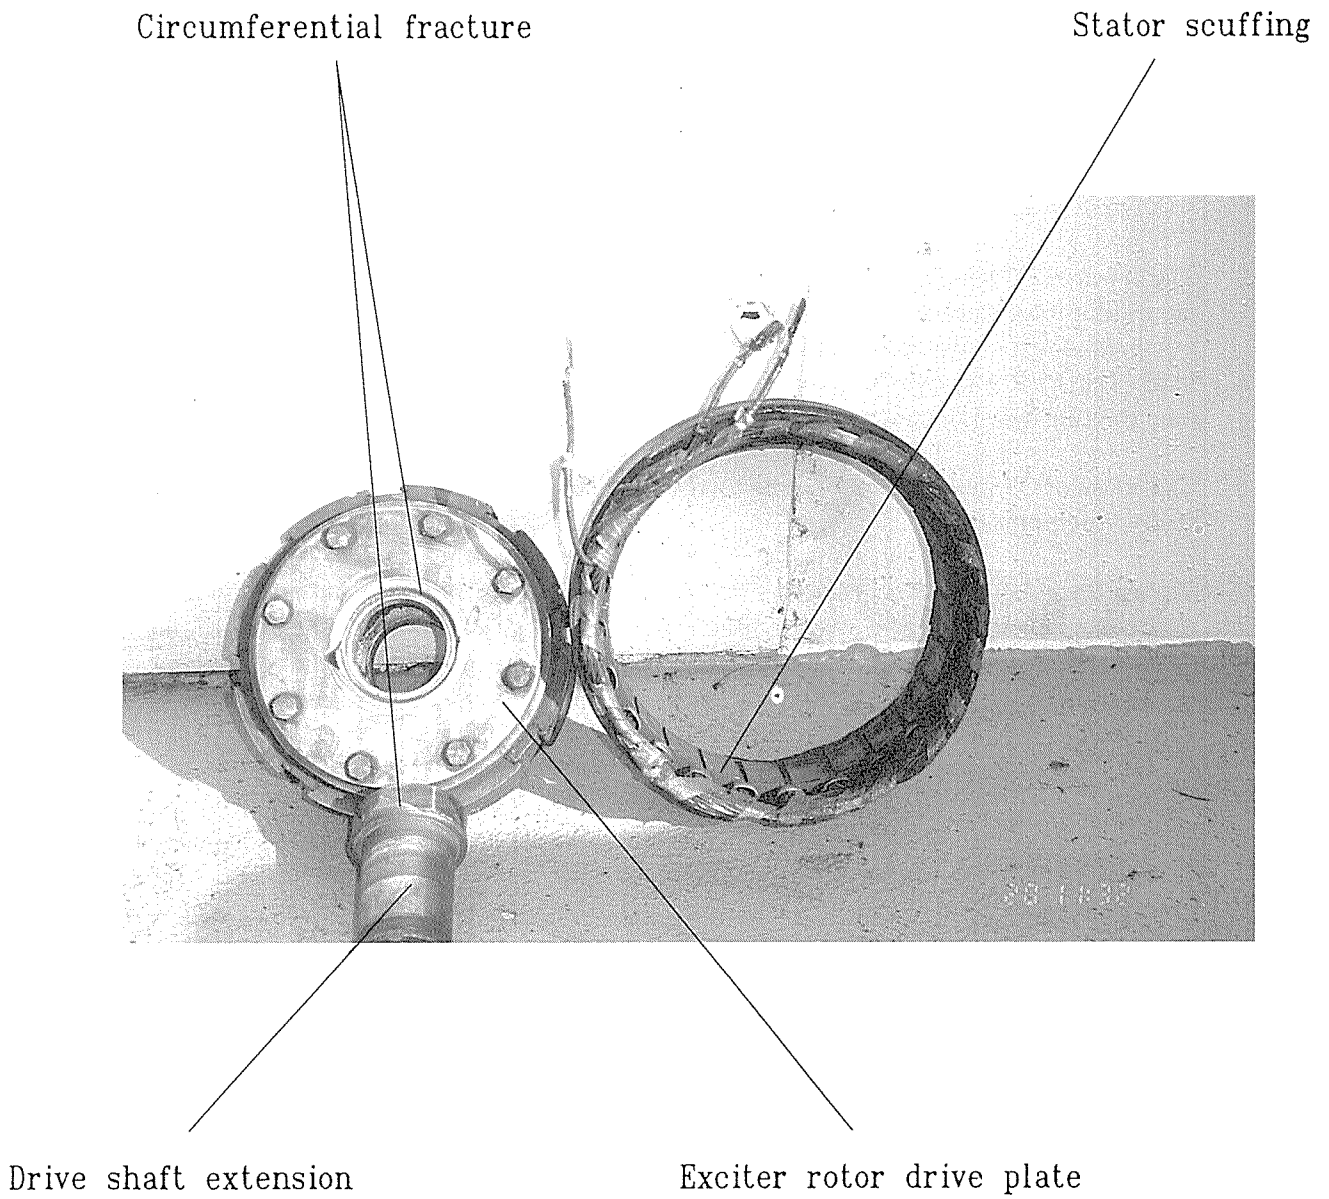
Figure 5

- 2.1.1 Subsequent inspection and tests carried out on *Condor 10*'s generating plant revealed that G1 had suffered a circumferential fracture where the permanent magnet exciter rotor drive plate was welded to the main drive shaft extension causing the laminated iron core to separate from the shaft. This caused the permanent magnet rotor to come in contact with its stator, pulling

- 2.1.2 The failure of the permanent magnet generator (PMG) on G1 caused the excitation field to collapse causing a complete and virtually instantaneous loss of generating power output on that generator.

- 2.1.3 The Generators installed on *Condor 10* were of the single bearing type. Inspection of the shaft bearing on G1 indicated that the bearing was worn and the outer race of the bearing had been fretting inside its housing. The wear in the bearing and its housing had been allowing the shaft to rotate off axis causing the PMG to scuff the inside of its stator (poling). The high speed uneven rotation of the PMG and associated vibration, together with the poling, is thought to have caused the PMG to fail in the manner that it did.

- 2.1.4 In spite of conducting the manufacturer's recommended periodic checks for bearing overheating or noise, wear in the bearing and its housing on G1 indicated that noise in the bearing assembly may have gone undetected for some time. The bearing and assembly on G3 was found in similar condition.

Photo Showing Failed Permanent Magnet Exciter From G1
