**No. 95-204**

**FV *Salania* 876105**

**South Island West Coast**

## Marine Accident Report No. 95-204

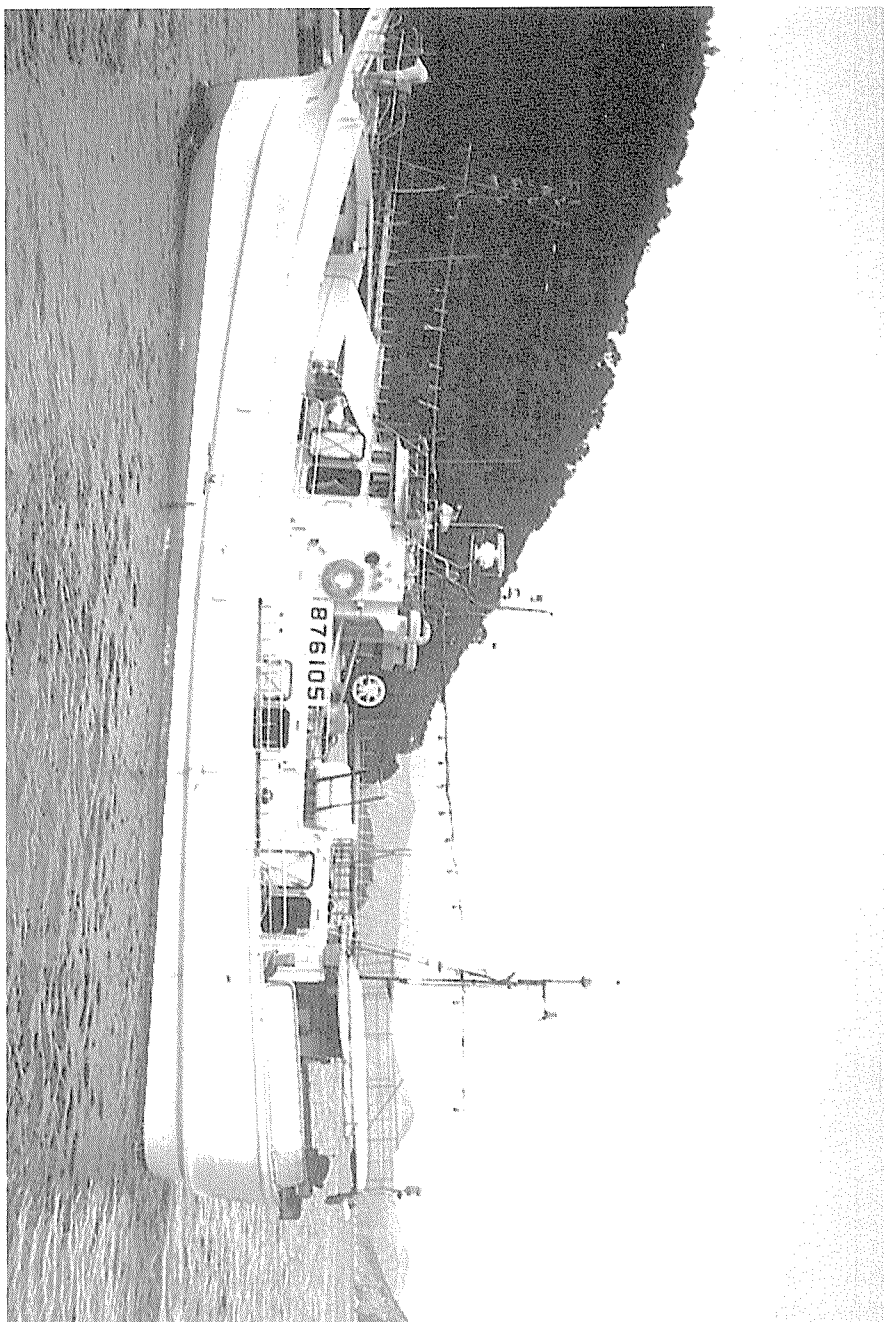
Figure 1

- 1.1.1 On Saturday, 1 July 1995 *Salania* (see figure 1) left Westport bound for the Southern Blue-fin Tuna grounds off Jackson Bay. On board was the Master, who was also the owner and three deck hands. The trip down took approximately 1.5 days. One “set” was made in that area without success. The *Salania* moved further south and made another “set” in the area off Cascade Point, and the next day further south between Milford Sound and Cascade Point. On Wednesday, 5 July the weather deteriorated becoming too rough to work the fishing gear so it was recovered and *Salania* proceeded into Milford Sound that night to seek shelter and a good night’s rest for the crew.

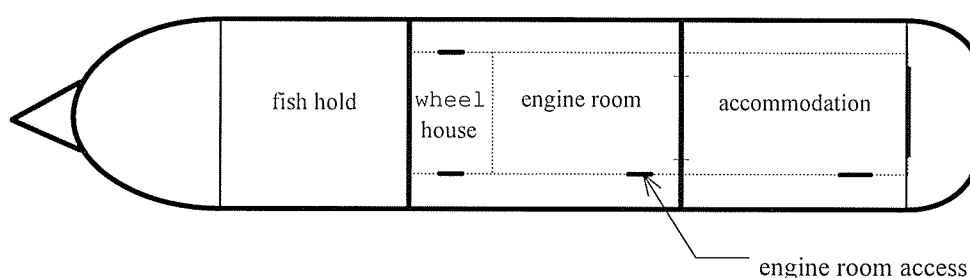
**Figure 2**  
***Salania* general arrangement (not to scale)**

1.2.2 The engine room was located amidships with the fish hold forward and accommodation aft of the engine room. The wheelhouse was located on top of the engine room at the forward end. Access to the engine room was via a watertight door on deck or through an internal sliding wooden partition separating the engine room from the accommodation. Access to the fish hold was from a hatch on the foredeck. (See figure 2)

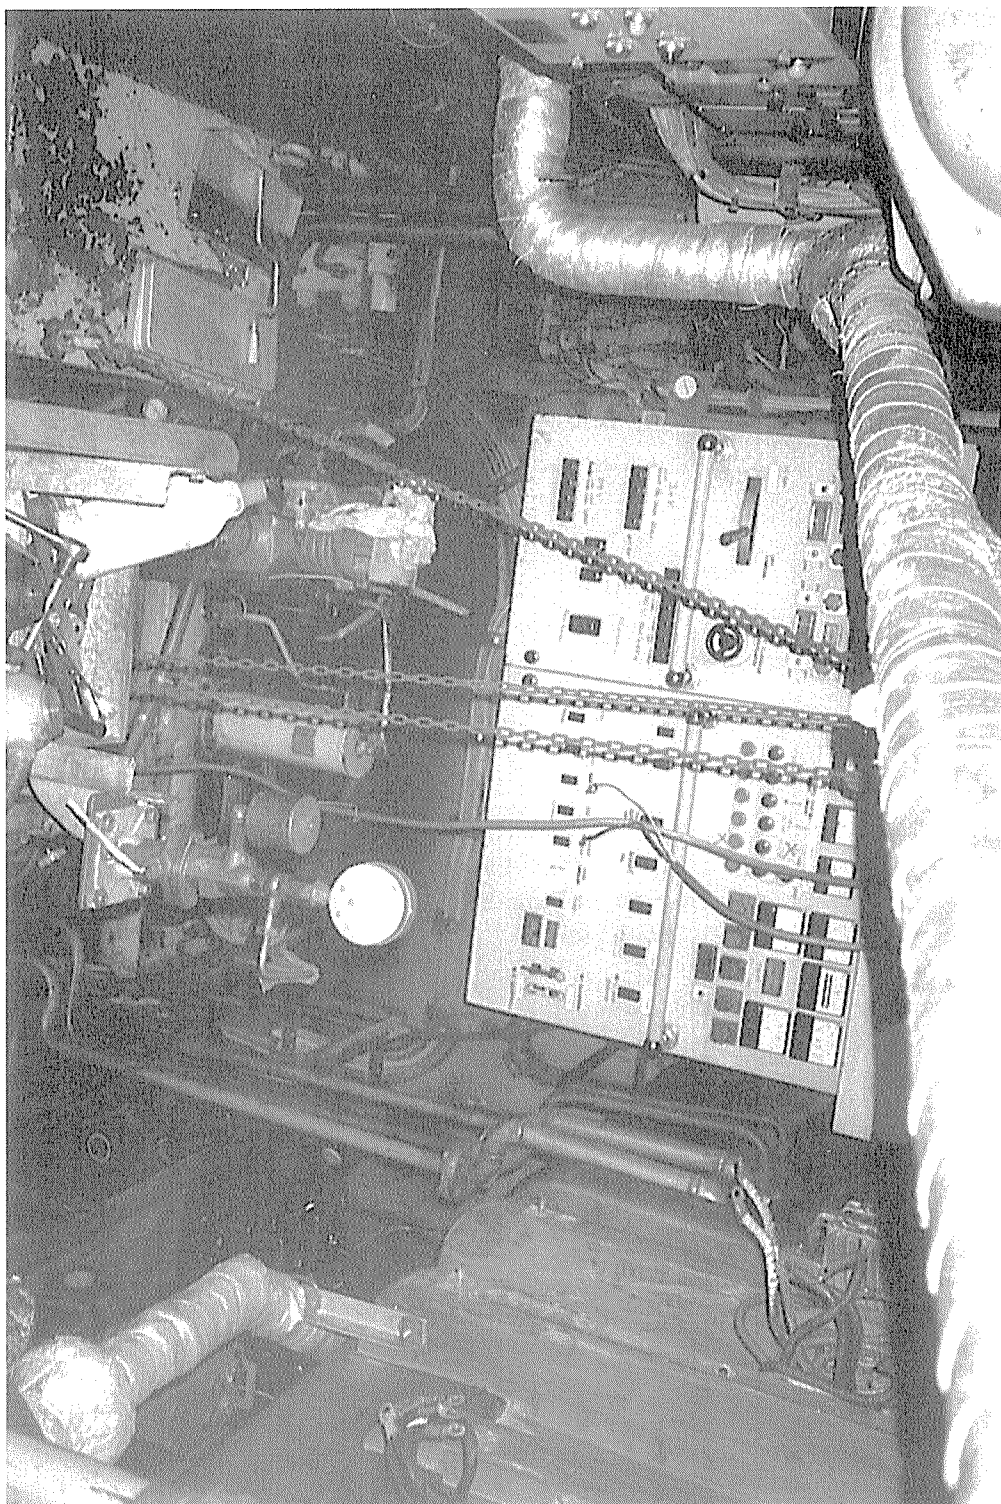
Figure 3

1.2.4 The *Salania* had a single 172 kW Yanmar diesel engine driving a single fixed pitch propeller giving a maximum speed of 11 knots and an economical speed of eight knots. Two Yanmar diesel driven AC generators provided 110V power for the vessel. The switchboard was so arranged to allow only one generator to supply power to the switchboard at one time (see figure 3).

1.2.8 The two generators were situated at the forward end of the engine room, one on each side, slightly elevated above the level of the main engine. The majority of the electric cabling from the generators to the switchboard and out to the various services ran through the bilge under the floorboards of the engine room.
