No. 95-206

White Water Rafting

Shotover River, Queenstown

Transport Accident Investigation Commission

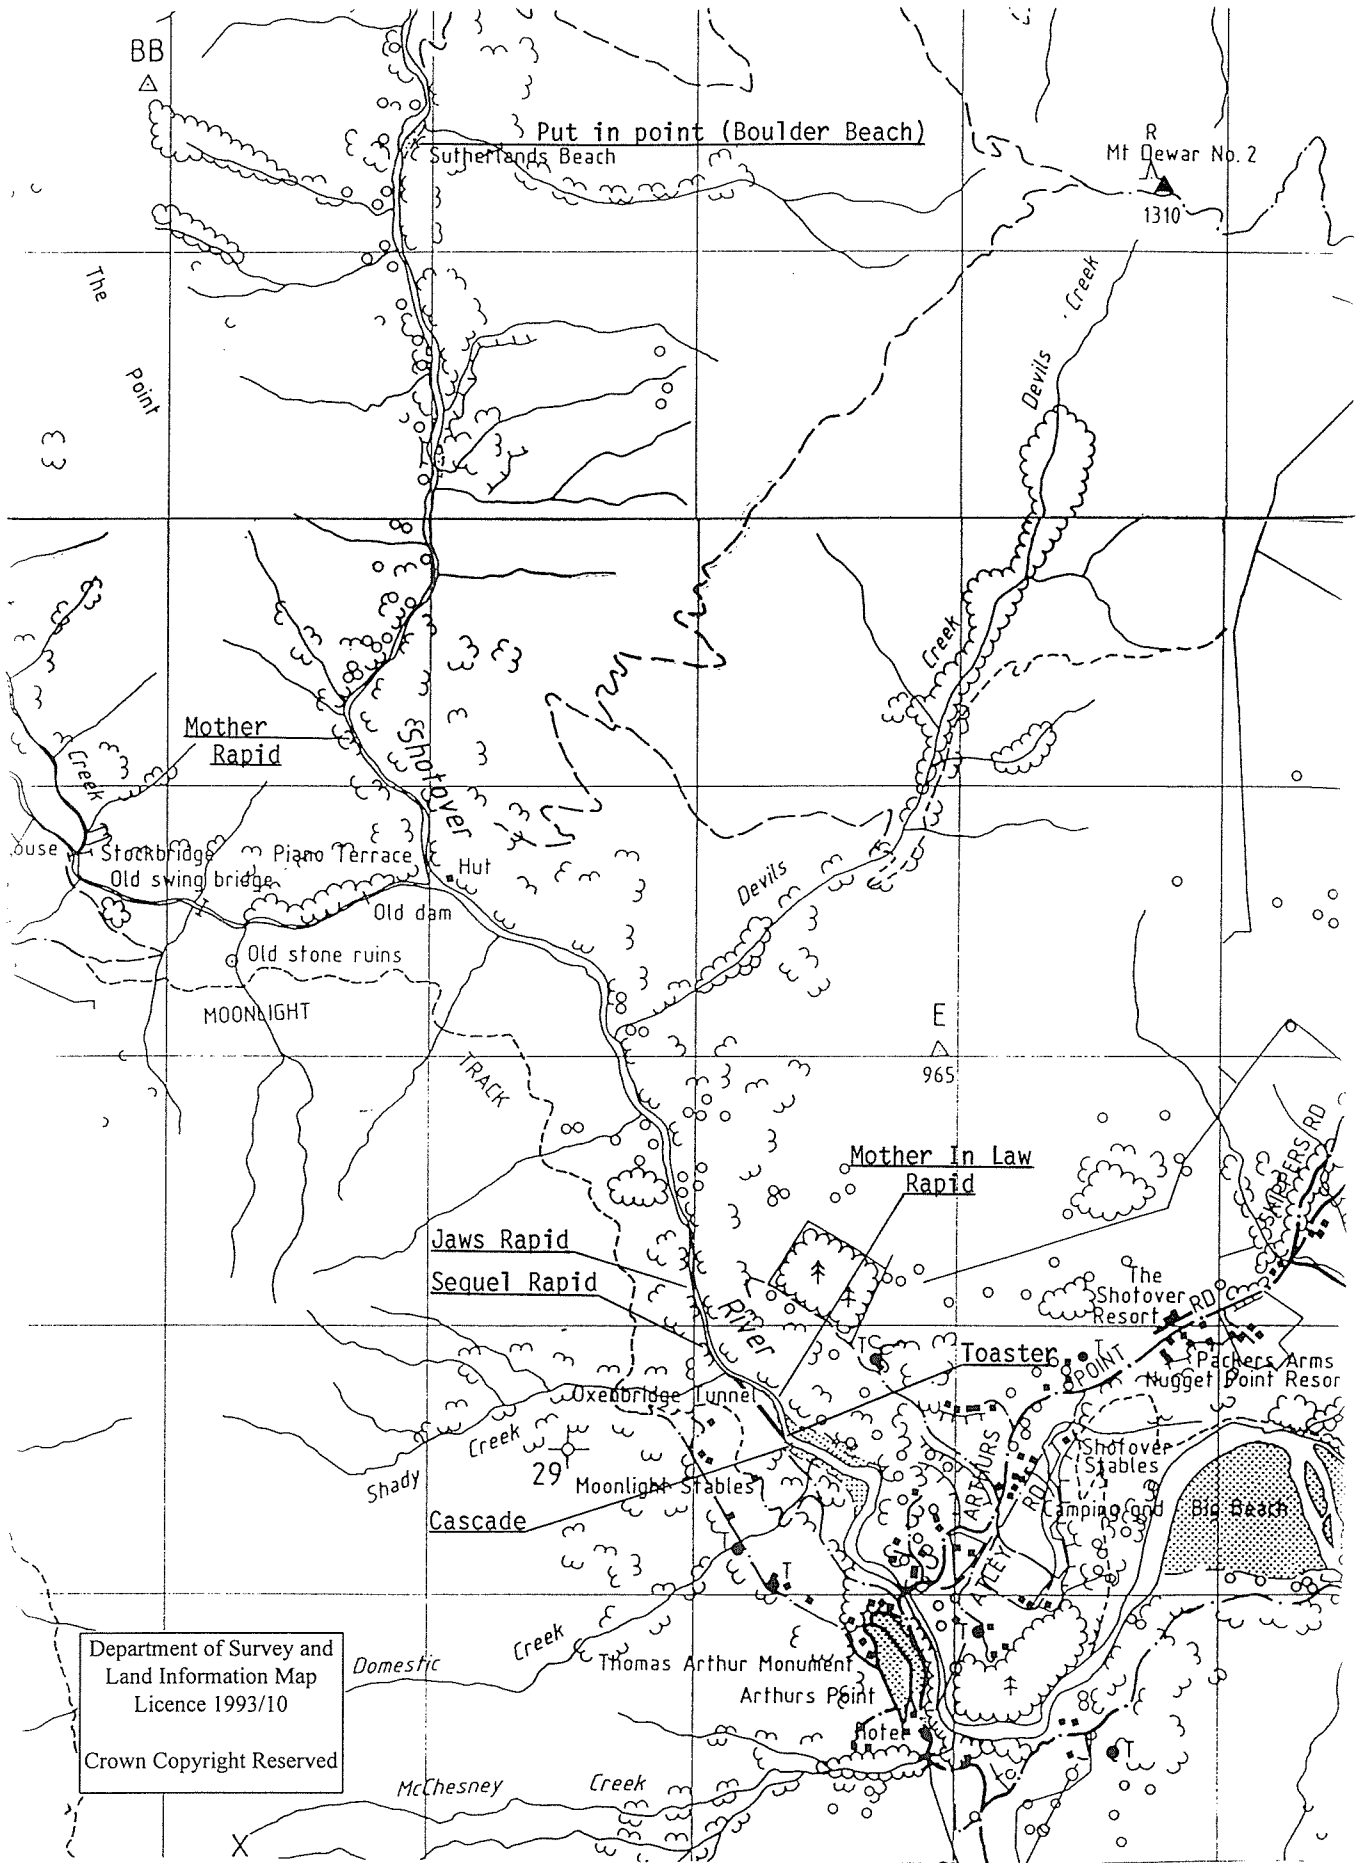
Figure 1

1.1.1 At about 1000 hours on Tuesday, 25 July 1995 eight tourists gathered at The Station booking office in Queenstown. They had booked and were about to embark on a multi-adventure sporting expedition known as “The Awesome Foursome”. This consisted of a helicopter flight to Deep Creek (Shotover River), followed by a jet boat ride up river to Skippers Bridge, a bungy jump off Skippers Bridge, return helicopter flight to Sutherlands Beach, and a 5.6 km white water rafting trip down river finishing at the Rafters Barn, Arthurs Point (See Figure 1).
