No. 95-208

MV Washington and MV Han Tao He

Port of Tauranga

Marine Accident Report No. 95-208

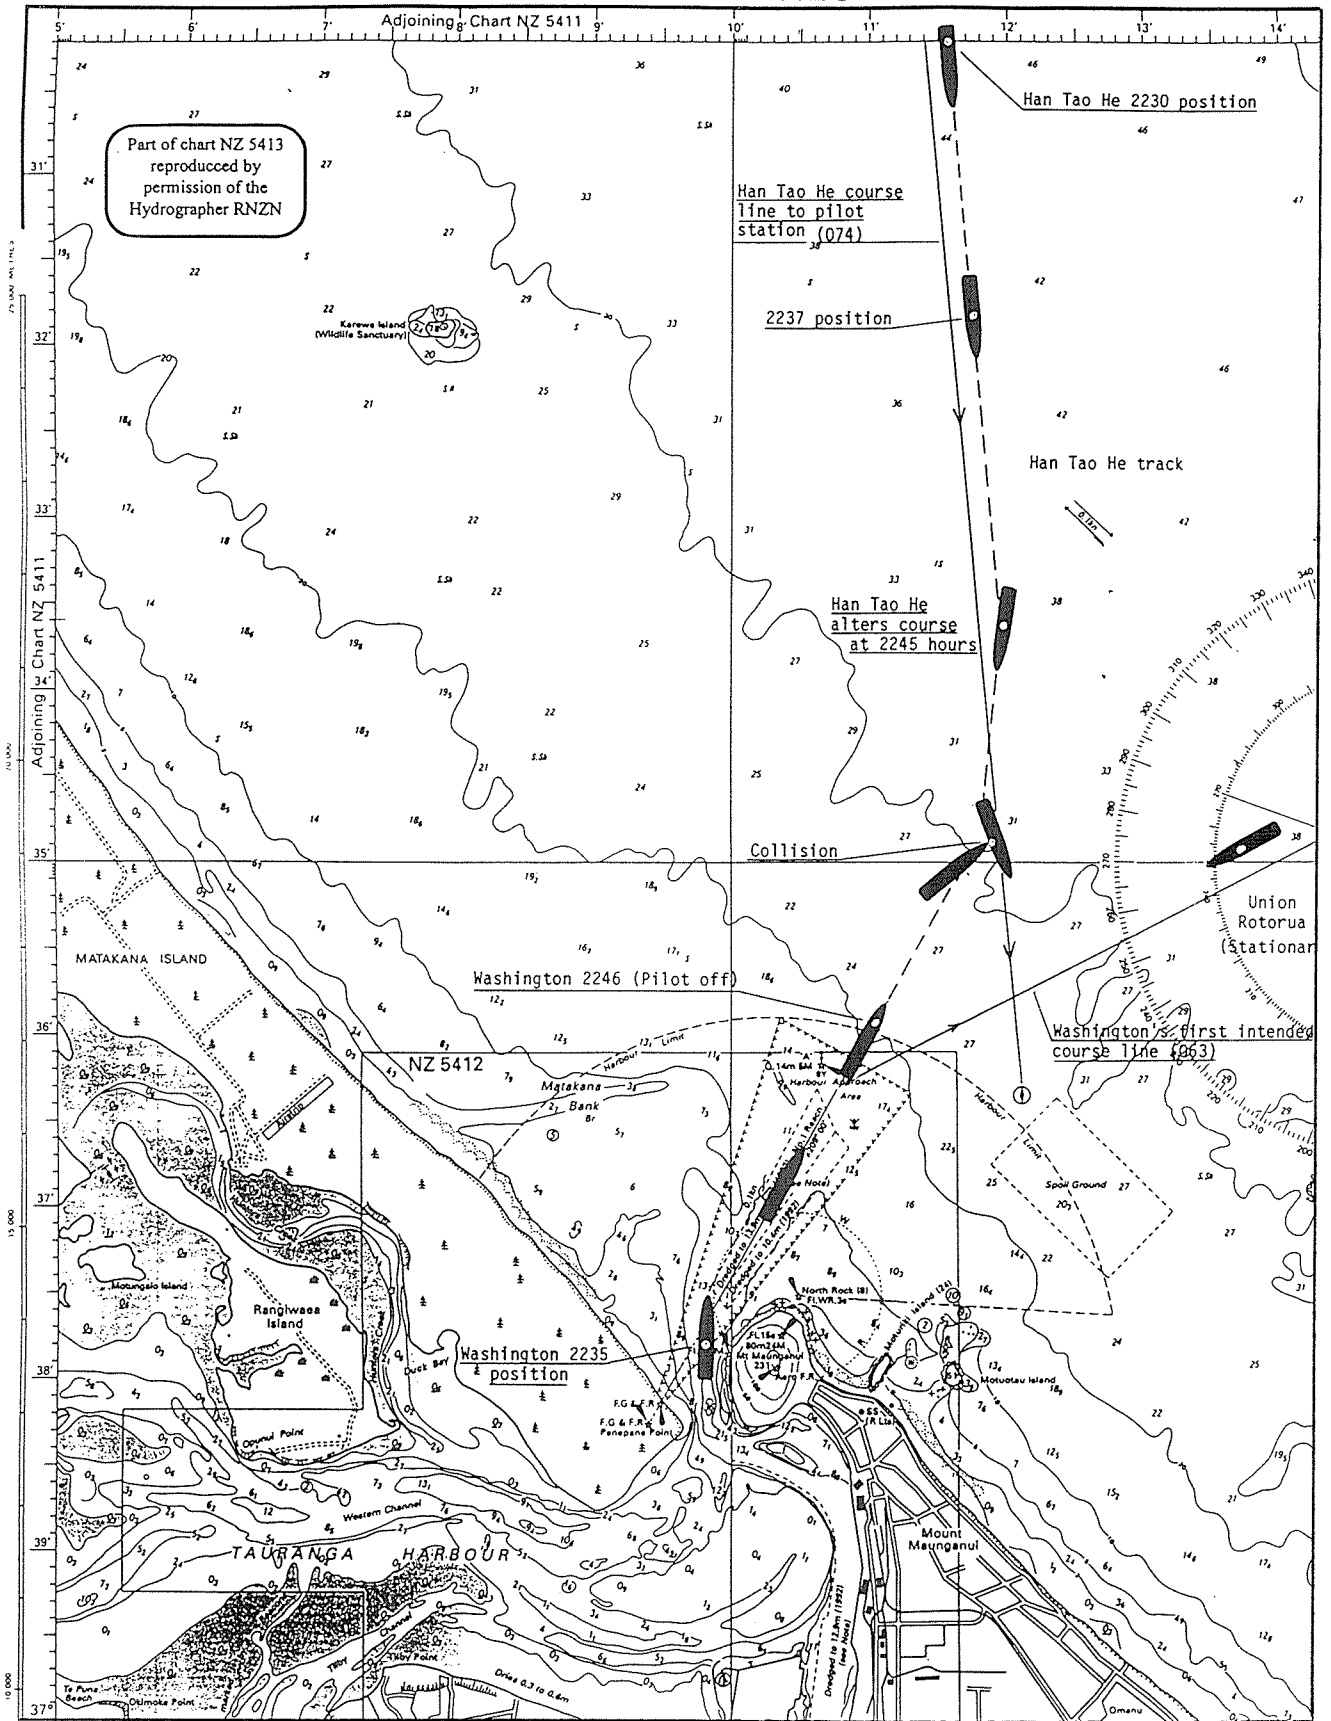
Figure 2

- 1.1.14 At 2244 hours after the *Washington* had passed “A” Beacon the pilot handed over the conduct of the vessel to the Master. He informed the Master that the engine was on “half ahead” and the course was 030 degrees gyro. He pointed out the *Union Rotorua* and told the Master that she was stopped in the water awaiting a pilot. He pointed out the *Han Tao He* and said that she was a Chinese vessel proceeding to the pilot station. The Master accepted the conduct and indicated to the pilot that he would continue on his present course and speed until clear of the *Union Rotorua* and then alter course to starboard to commence his sea passage on initial course of 063 degrees true. No instructions were given for avoiding the *Han Tao He* and none were asked for. The Master had the conduct of his vessel which was now outside the harbour limits where the “Shipping (Distress Signals and Prevention of Collision) Regulations” (referred to as The Collision Regulations) apply. (See figure 2)

- 1.1.20 At 2230 hours the Master of *Han Tao He* called the signal station and told them that he was 30 minutes away from the pilot station and asked what time the pilot would be boarding his vessel. The signal station replied that the pilot was on his way to board him now. The Master acknowledged this fact. At this time the vessel was still travelling near full sea speed (about 14 knots) and the *Han Tao He* was about 6.3 nautical miles from the pilot boarding ground. The Master was unaware that there would be an out bound ship and that the pilot would be transferring from that vessel to his vessel. (See figure 2)

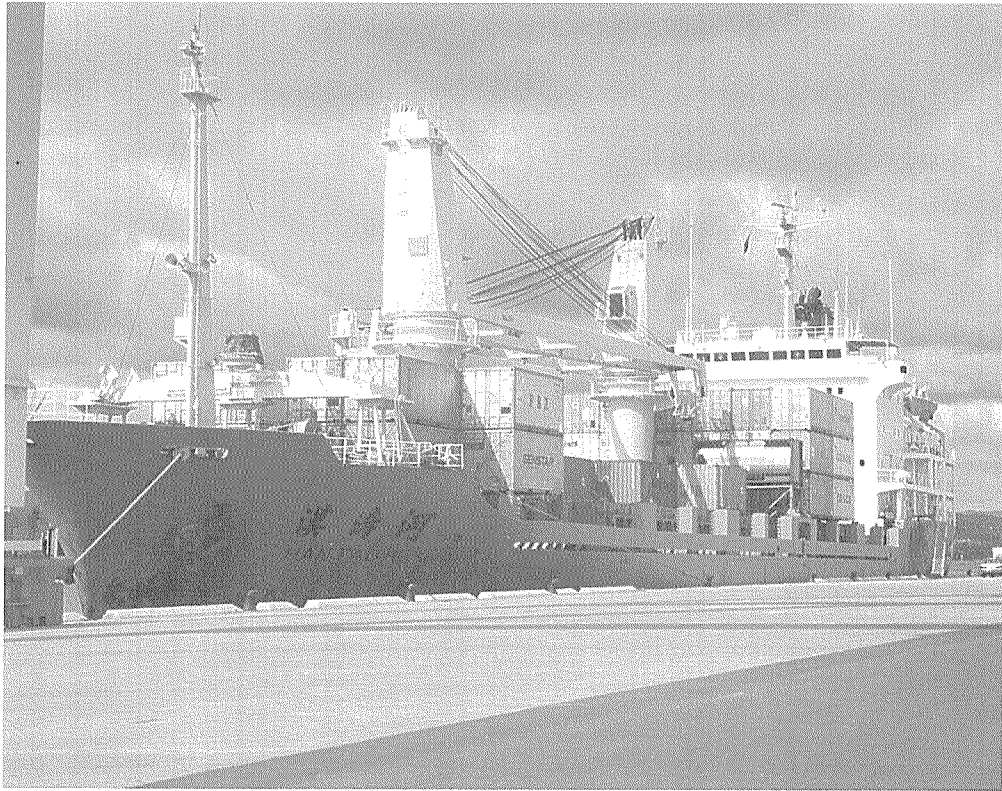
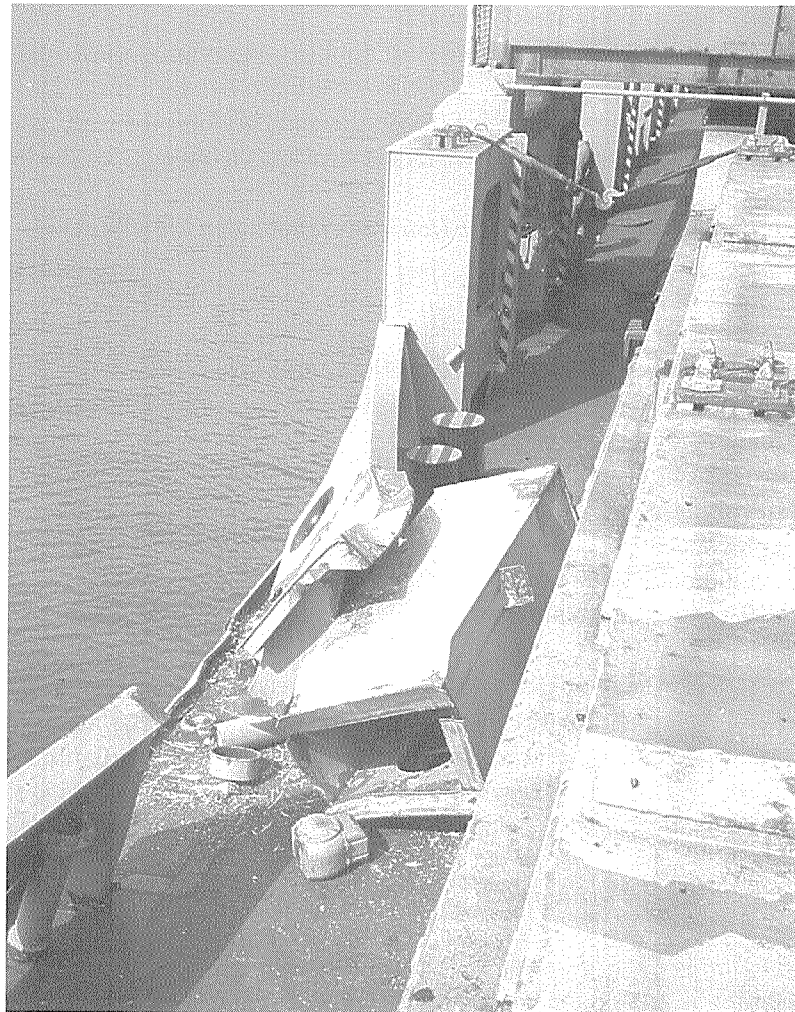
Figure 3
Han Tao He

- 1.5.2 Above the waterline the *Han Tao He* sustained slight buckling of the top of the sheerstrake and an eight metre section of the bulwarks was stove inwards shearing off a container pedestal and several tank vents.

- 1.5.3 Below the water line the *Han Tao He* suffered substantial damage. The *Washington*'s bulbous bow struck the solid bulkhead and tanktop separating No. 2 starboard wing water ballast tank, the starboard wing heeling tank and No. 2 starboard double bottom ballast tank. All three tanks were breached and the bulkhead and tanktop suffered crushing and buckling. (See figures 3 and 4)

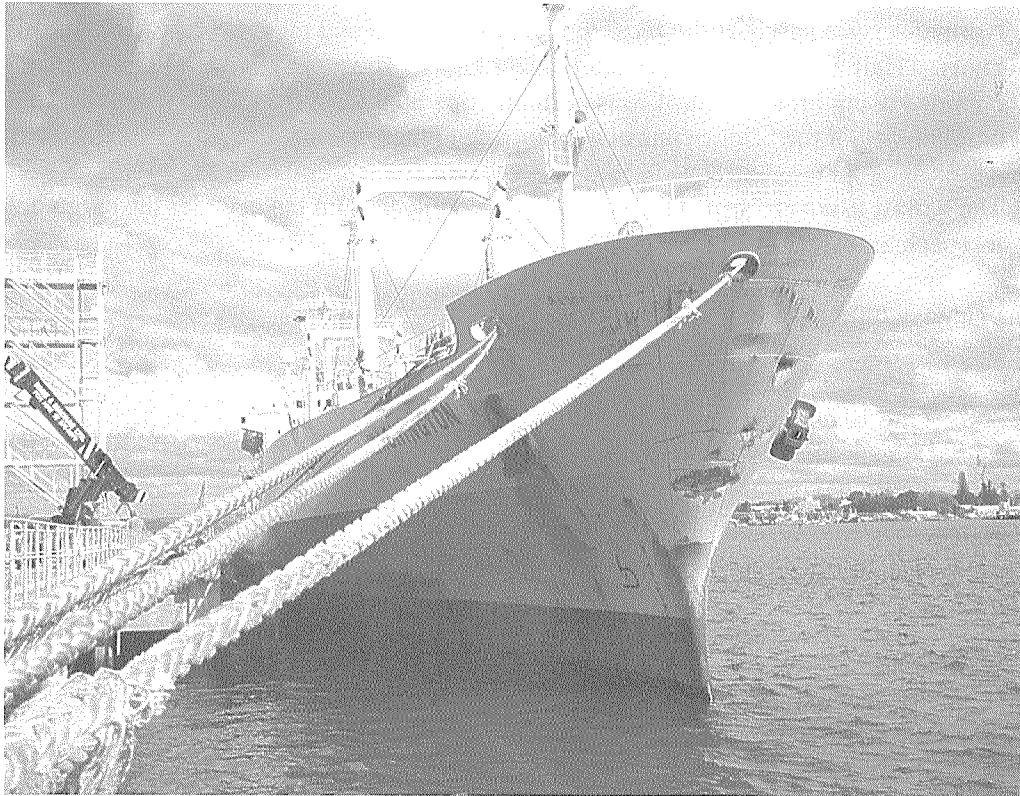
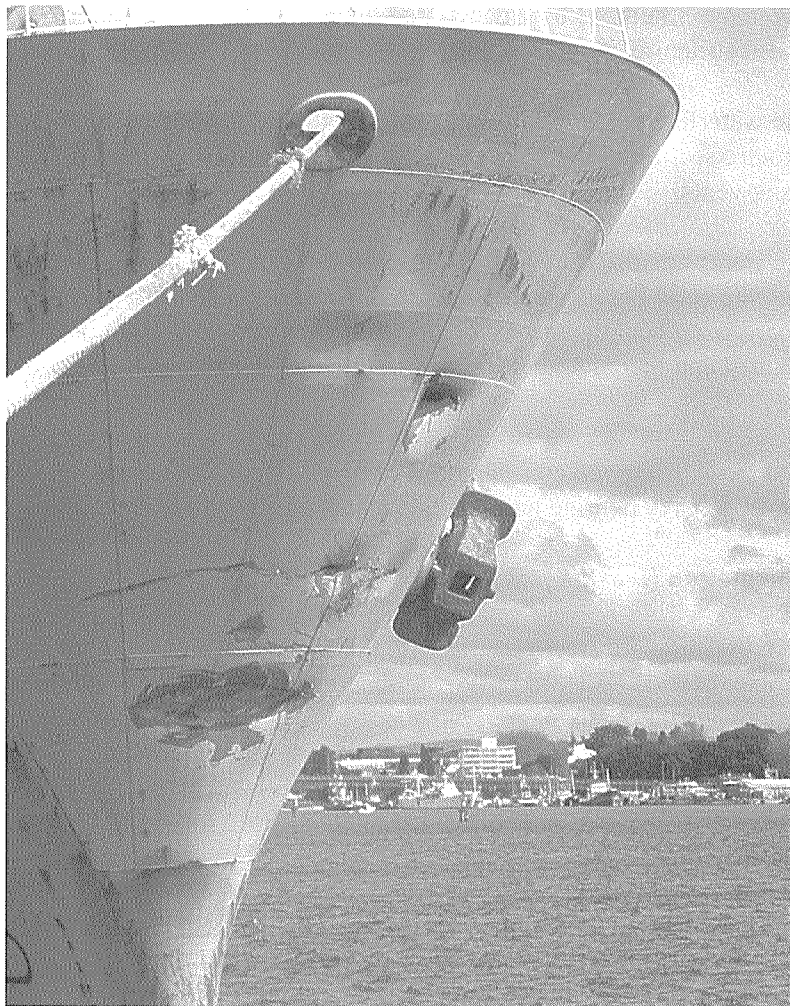
Figure 4
Washington

- 1.5.1 The *Washington*'s bulbous bow penetrated the *Han Tao He* amidships below the waterline and the soft nose structure of her bow rode up over the *Han Tao He*'s deck line.

- 1.5.4 Damage to the *Washington* consisted of buckling and penetration of the soft nose in way of the forecastle, and heavy denting and two holes in the bulbous bow breaching the forepeak tank.
