Report 96-117

Train 6210

Mis. 59 Irregularity

6 November 1996

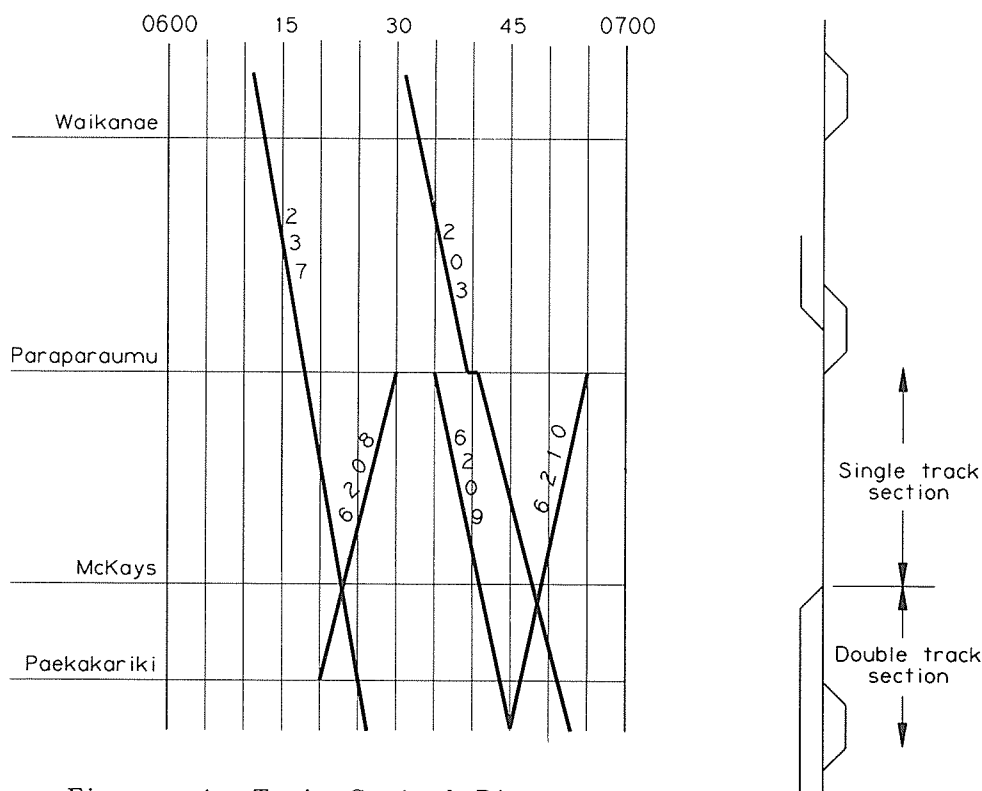
Figure 1 Train Control Diagram
Scheduled Services

1.6 The pre-printed schedule showed the northbound EMU (Train 6210) passing the southbound EMU (Train 6209) on the double track south of Paekakariki, and passing the southbound *Northerner* (Train 203) on the double track south of McKays before entering the single line section from McKays to Paraparaumu. The block section between Paraparaumu and McKays was signalled so that down² trains could follow one another through the section, separated and protected by appropriate intermediate signalling effectively breaking the block section into two separately controlled intermediate sections. Train 203 was following Train 6209 using this facility. Such following movements are common through this section to deal effectively with long haul and suburban services.

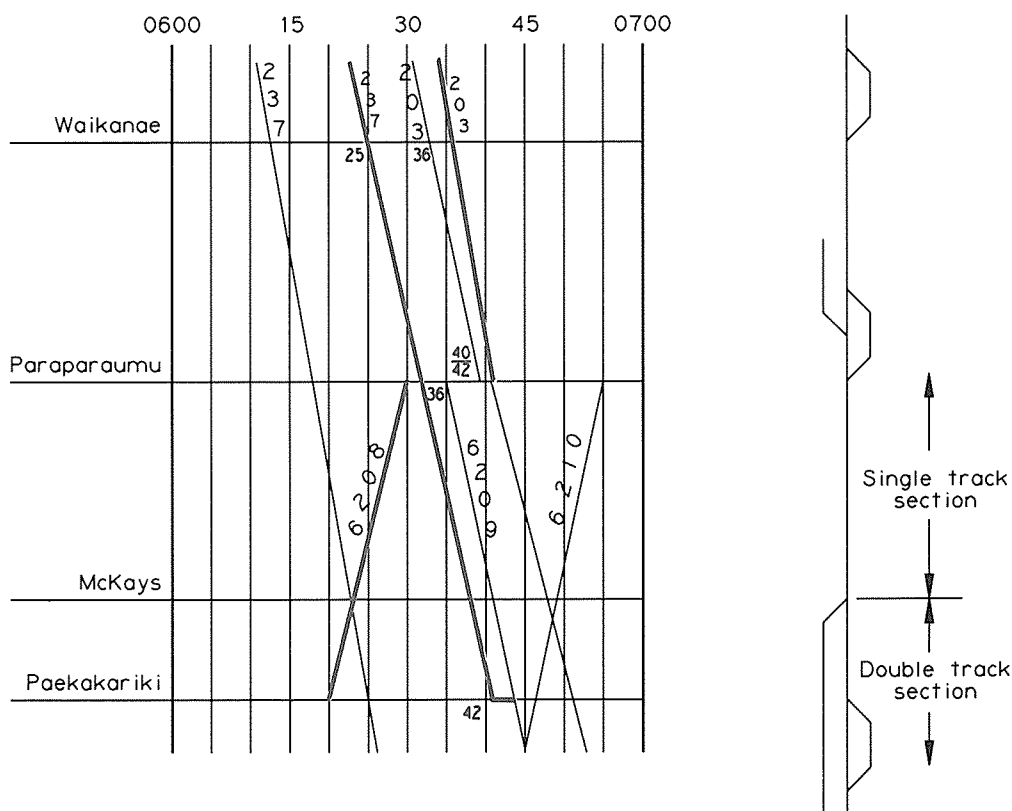
Figure 2 Train Control Diagram as marked up at approx 0644 hours

- 2.3 During this period the Train Control diagram on the desk in front of the TCO recorded the progress of the relevant trains as shown in Figure 2, and had he referred to the diagram it would have shown him the presence of Train 203 between Paraparaumu and McKays. The use of the Train Control diagram in this manner was standard and required practice, and the TCO's action in attempting to set up a signalled route for Train 6210 without such a check was the catalyst for the sequence of events which followed.

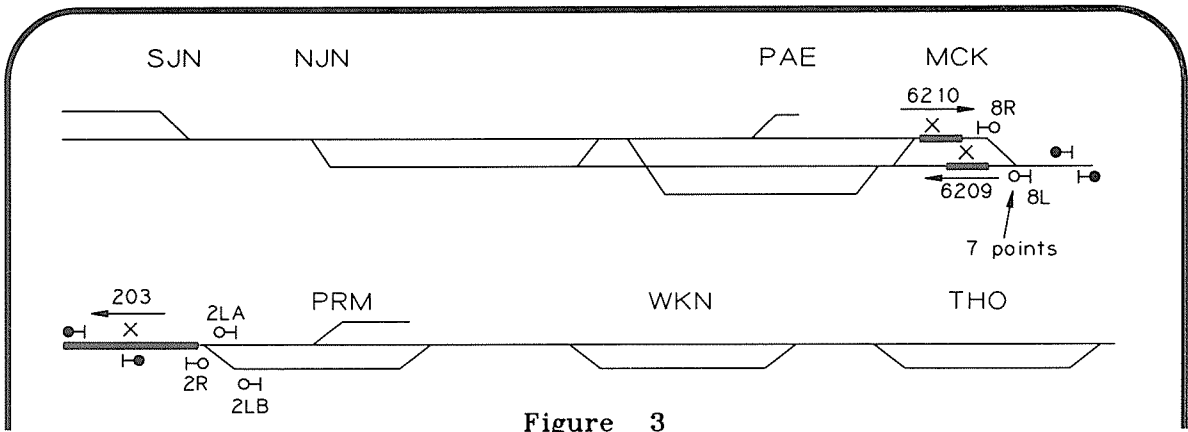
Figure 3

- 1.24 The TCO stated his misinterpretation was made possible because he looked only at activities near McKays on the right top level of his screen, without also looking at activities near Paraparamu at the left of the second level on his screen (refer Figure 3).

Screen display McKays - Paraparaumu as seen by TCO at 0644:31C
 TCO reverses 7 points at McKays for train 6210 and makes a first attempt to clear 8R signal

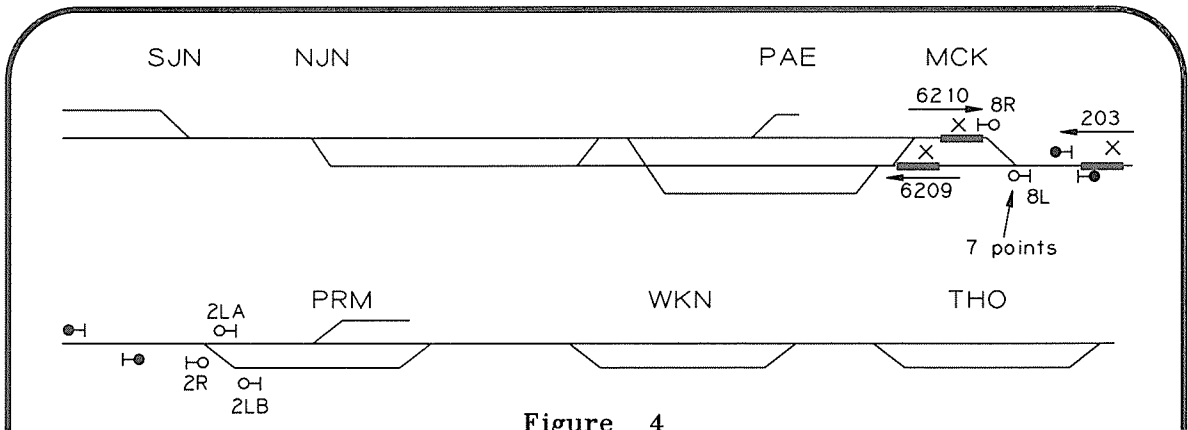
Figure 4

Screen display at 0645:38T
 Query from "A" box relating to the progress of train 203
 (and approximate timing of the second attempt to clear 8R signal)

- 2.9 At 0645:38 T, when the TCO referred to his Train Control diagram to answer the query from "A" box, the Train Control screen was as shown in Figure 4. Train 203 had passed the intermediate signal and then showed up over a small section at the right of McKays at the top of the screen.

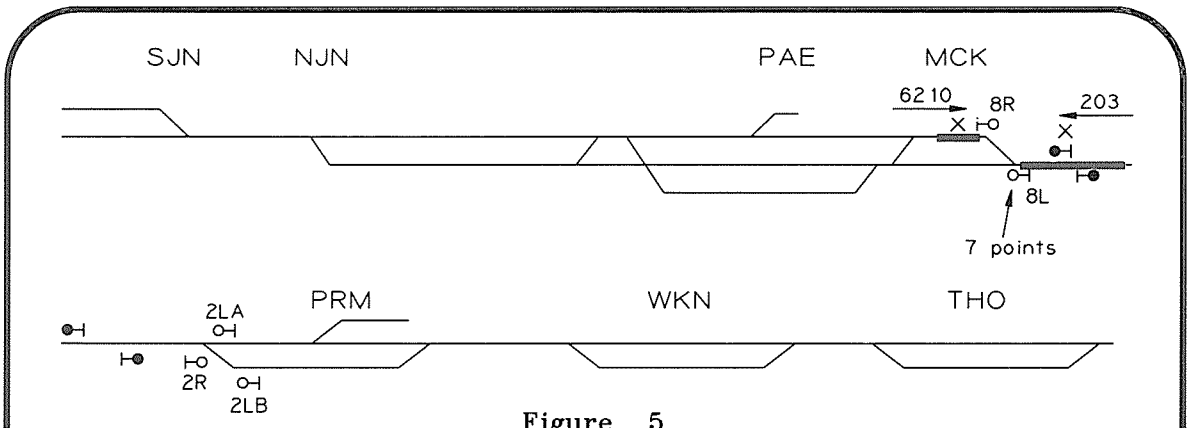
Figure 5

Screen display at 0646:25T (Train 6209 not shown)
 TCO advises LE he will issue a Mis 59

- 2.10 At 0646:25 T, when the TCO advised the LE he would issue a Mis. 59, the Train Control screen was as shown in Figure 5. The advance of Train 203 had been shown by an extended indication to the right of McKays, and this indication remained until Train 203 eventually cleared McKays.
