**Report 96-204**

**Mackcraft Jet Boat**

**Kawarau River, Queenstown**

## Marine Accident Report 96-204

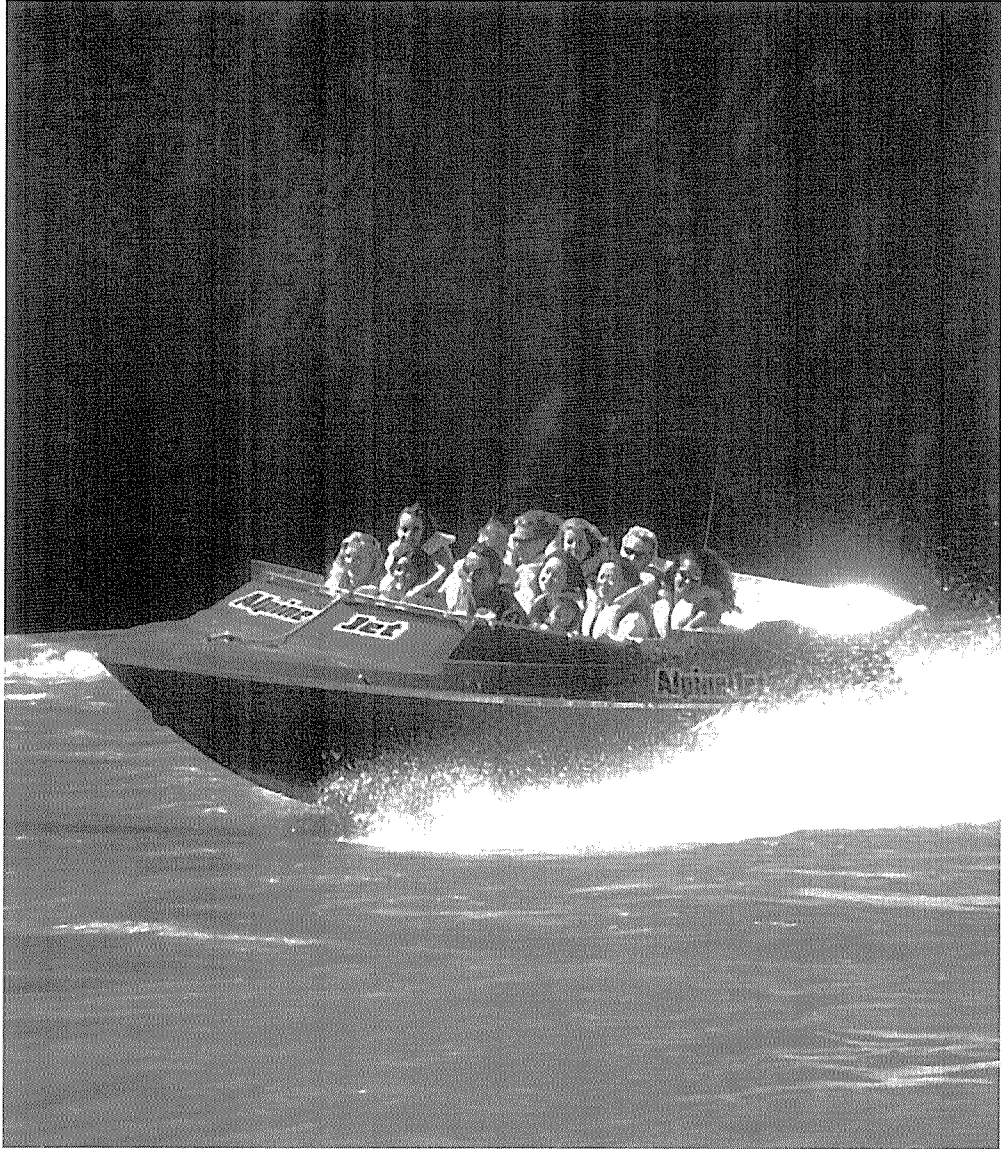
**Figure 1**  
**Typical Alpine Jet boat (Mackcraft)**

- 1.1.1 At approximately 1505 hours on Saturday, 4 May 1996, the jet boat (see Figure 1) departed from a jetty on the Frankton Arm of Lake Wakatipu, Queenstown. On board were the driver and four passengers. The passengers were all friends.

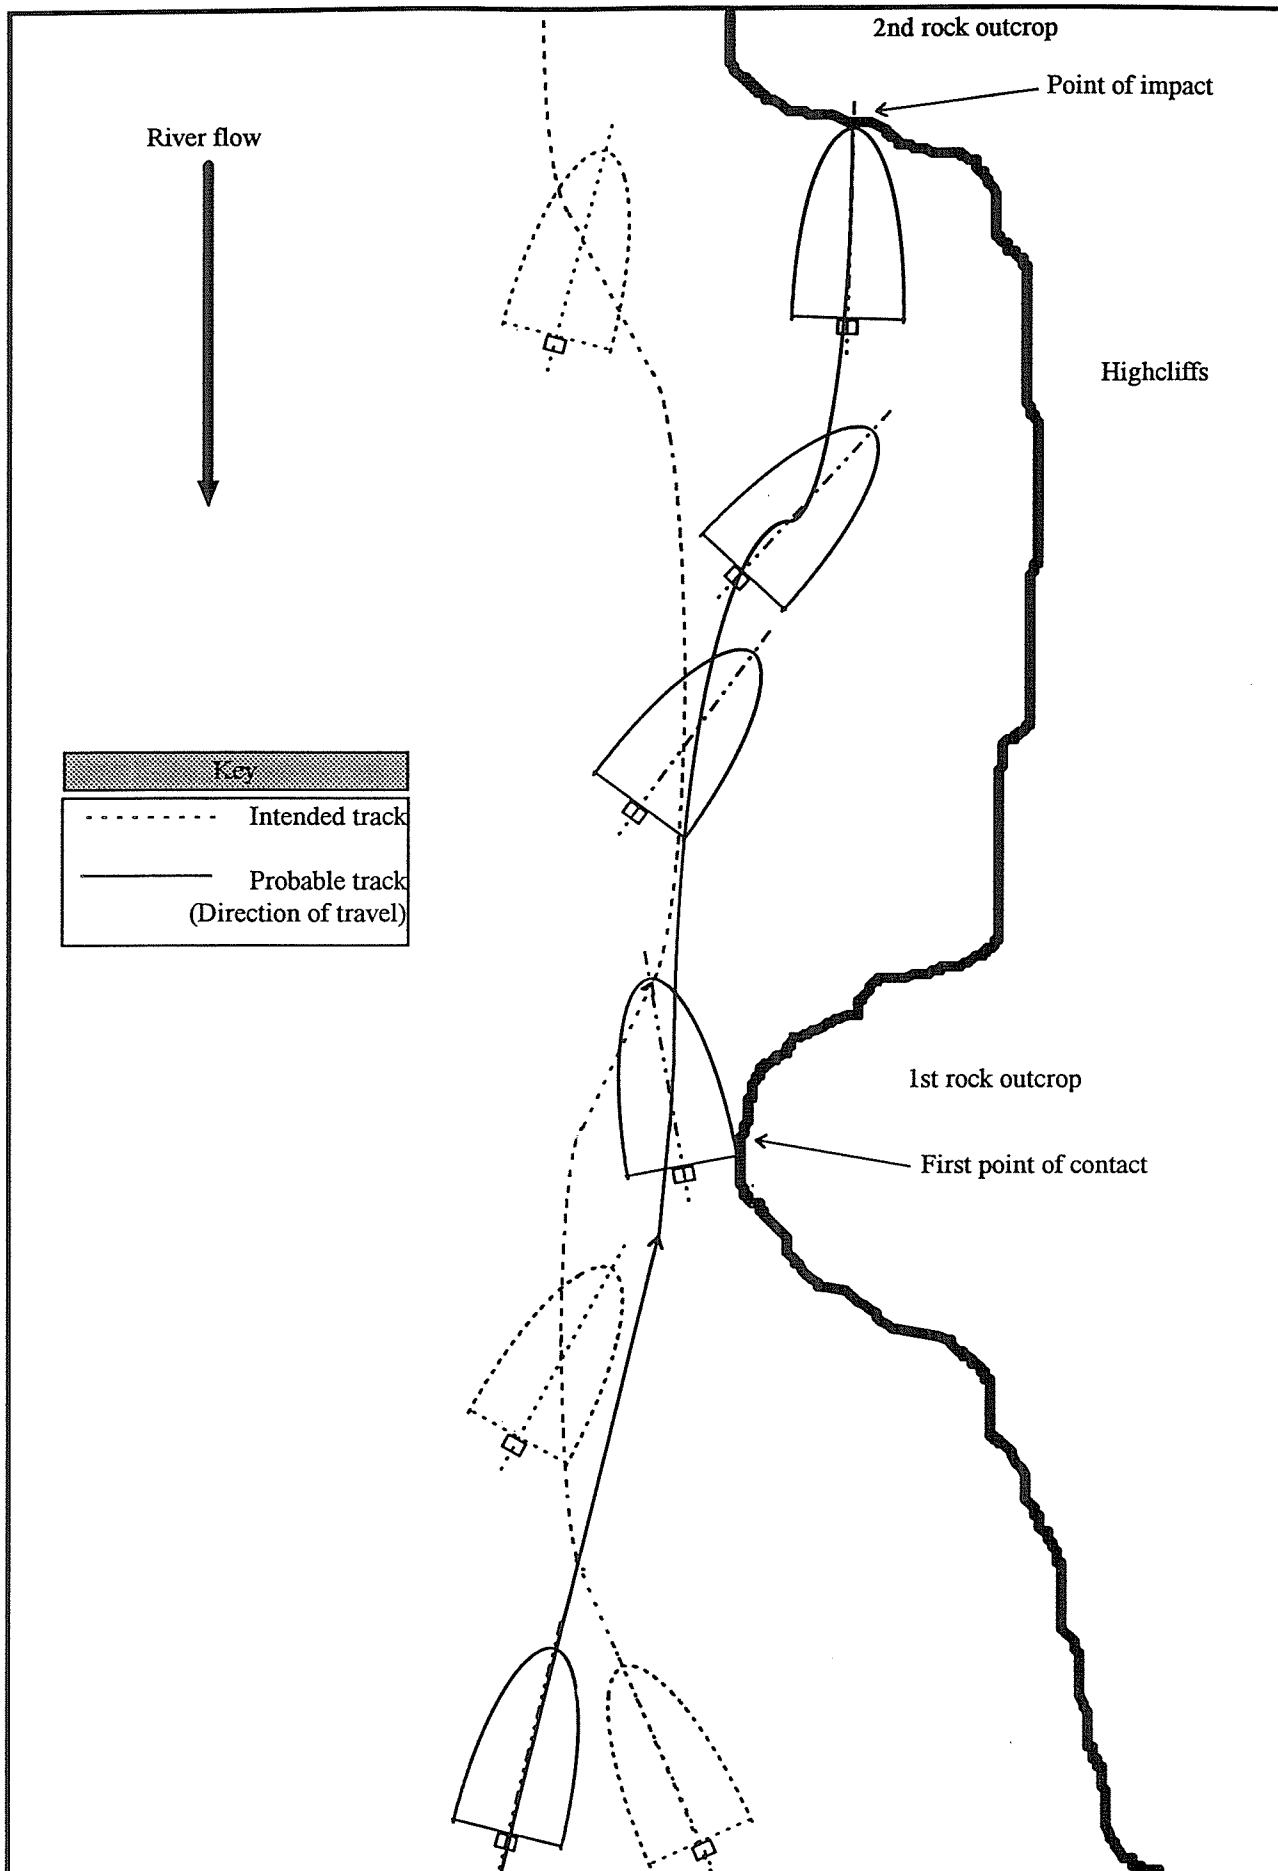
**Figure 2**  
**Diagram showing probable tracks and approximate heading of the jet boat**  
**(Not to scale)**

- 1.1.6 At approximately 1530 hours the driver applied full power and lined the boat up for the manoeuvre. As the boat was approaching the first rock outcrop on the plane, at approximately 40 km/h, the driver realised that he was off his intended approach line. He decided to abort the manoeuvre, and instead of turning into the outcrop, as would normally be done, he turned away. This action resulted in the boat's stern swinging toward the cliff face and its starboard rear corner striking the rock outcrop (see Figure 2). When he felt the stern of the boat glance off the rocks the driver throttled off instinctively.

- 1.1.7 The glancing blow deflected the stern causing the boat to veer towards the cliff face. The driver attempted to recover the situation by opening the throttle fully and applying maximum port helm. The boat recovered from the deflection, but too late to prevent it colliding with the second rock outcrop, head on. The distance between the rock outcrops was approximately 30 metres.

- 2.3 The driver had completed the manoeuvre successfully on numerous occasions in the past; however, on this occasion he approached the rock outcrops from further out in the river. Realising he was off his desired line, the driver tried to abort the manoeuvre and turn away from the cliff face in a planing turn to port. Had he delayed his turn by a few seconds, the stern of the boat would have swung into the bay between the two rock outcrops, avoiding the first contact.

- 2.4 The stern struck the rock causing the stern to spin out to port throwing the boat into a starboard planing turn, heading toward the rock face. The driver's instinctive reaction to throttle off would have resulted in the boat maintaining its direction of travel towards the cliff face. The driver's application of full throttle and hard port wheel prevented the boat from striking the cliff face, but was too late for him to avoid the second rock outcrop.

- 2.5 A better option would have been for the driver to apply full reverse thrust to reduce the force of, if not avoid, the collision.
- 2.6 A number of the passengers' injuries were sustained because they were unrestrained in their seats. While restraints may have reduced the type of injuries sustained in this case, they would have the potential to cause some occupants to drown under different circumstances should the boat over-turn.
