**Report 96-206**

**5.5 m Fyran dory, *Hunky Dory***

**off Whatuwhiwhi, Karikari Peninsula**

## Marine Accident Report 96-206

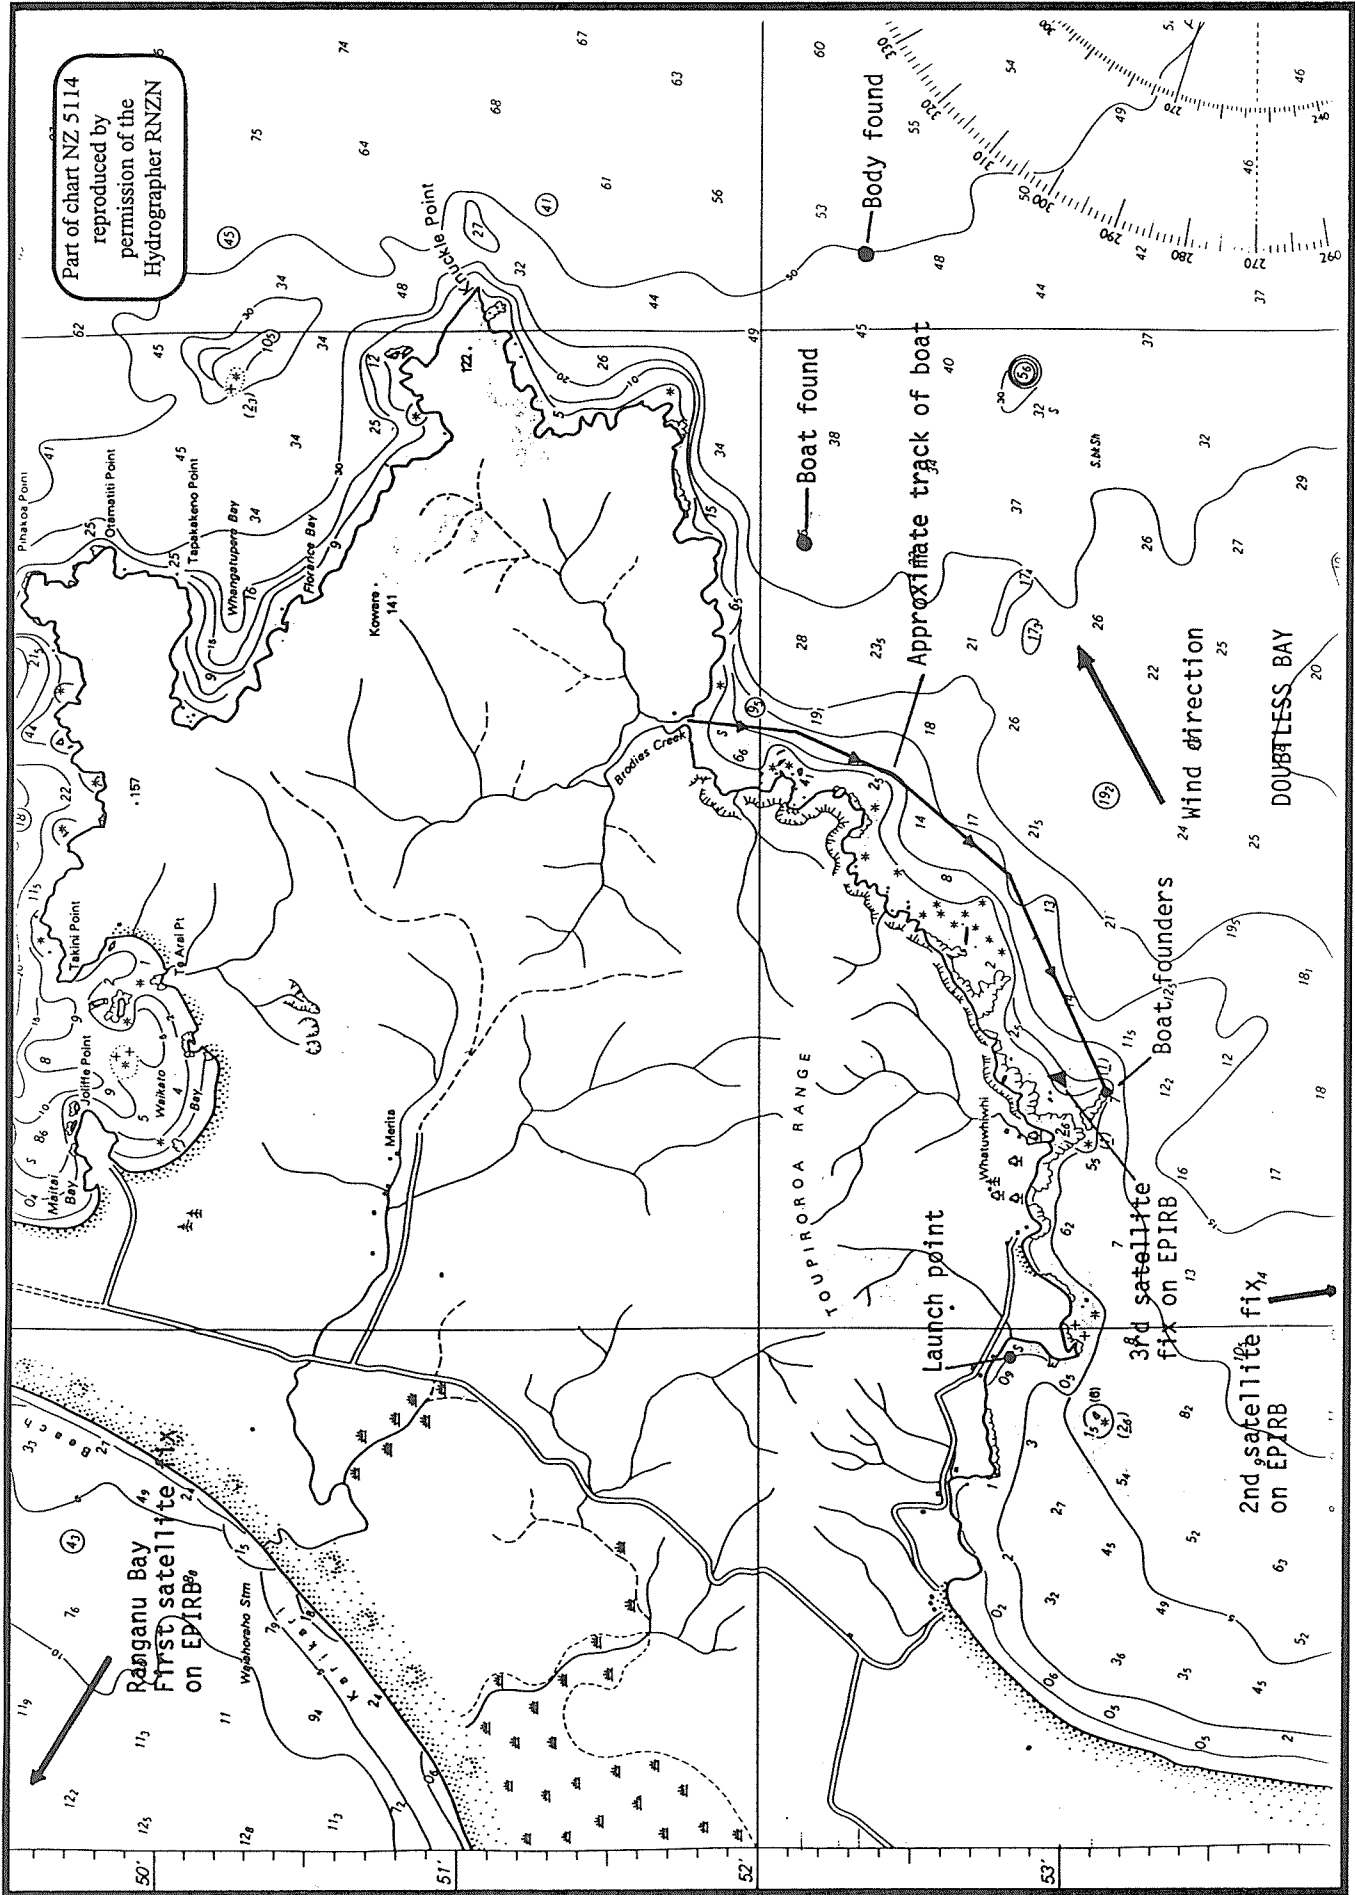
- 1.1.22 At 1854 another satellite pass gave the EPIRB’s position to be south of Karikari Peninsula in the middle of Doubtless Bay, approximately 3.5 miles from its true position. Far North Radio broadcast this new position and some of the rescue craft headed toward the area to commence a search. Searching vessels reported the weather conditions as south-west winds at 25 to 30 knots with rough seas off-shore. There was a two to three metre swell from the north-east running past Knuckle Point on the eastern tip of Cape Karikari.

Figure 1  
Part of Chart NZ5114, showing positions during Search and Rescue operation

- 1.1.25 At 2040 hours another satellite pass indicated the EPIRB was near the point where the *Hunky Dory* foundered, approximately 2.2 nautical miles from its true position.

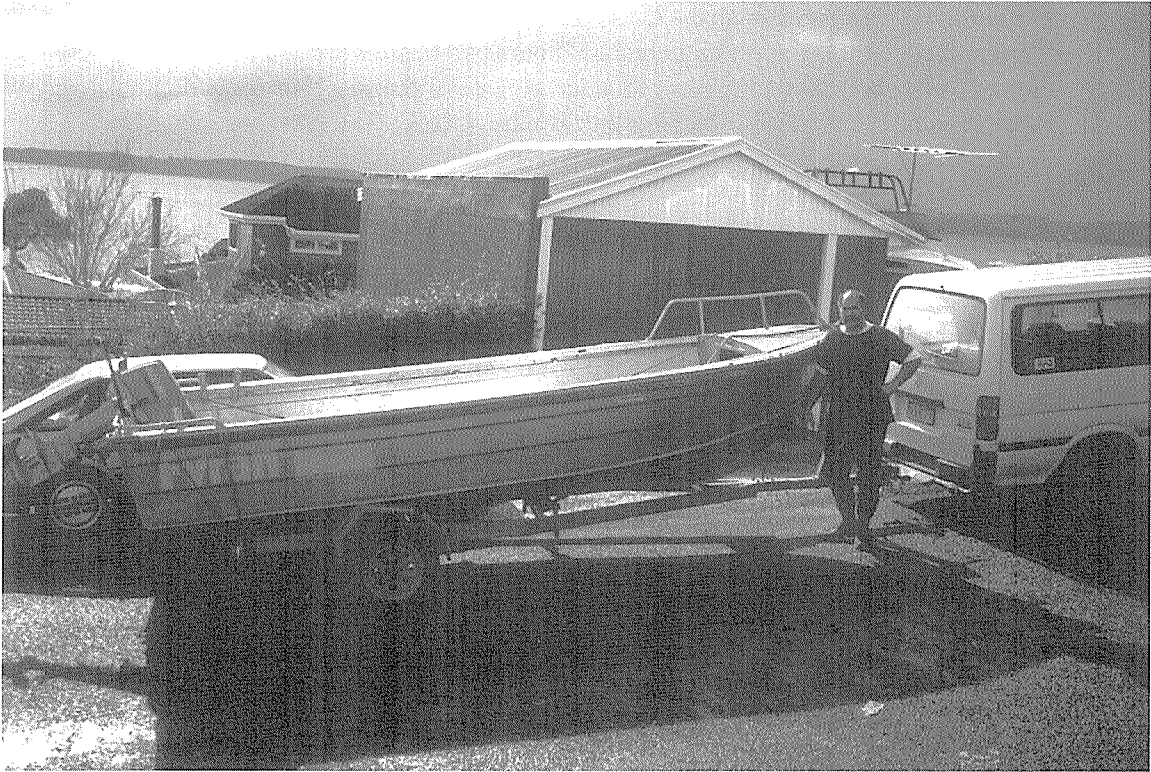
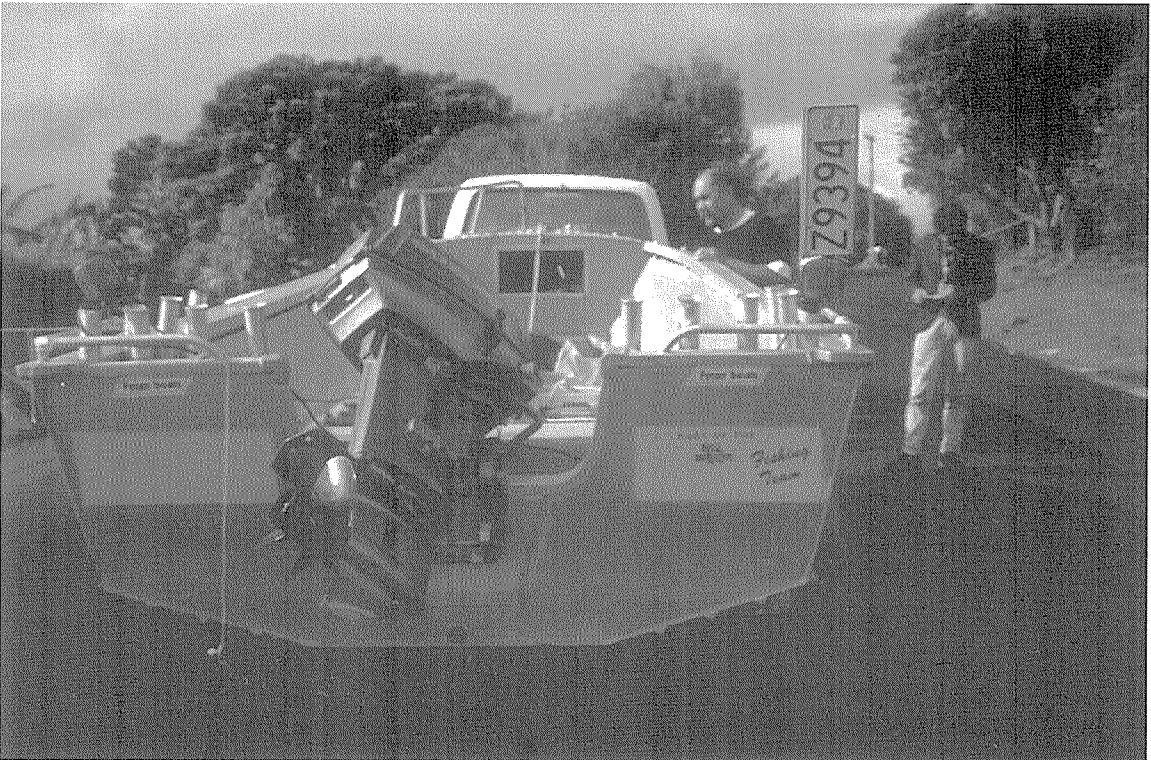
- 1.2.4 The boat's transom was cut away to accommodate the outboard motor. No outboard well was constructed to compensate for the resulting loss of freeboard in this area. (See Figure 2.)

**Figure 2**  
**The *Hunky Dory*, note the low transom**

- 2.3 With any boat, the design and operating concept should be to prevent water entering the boat at a rate faster than that at which it can be removed. The freeboard of a boat such as the *Hunky Dory* is determined by its lowest point. The cut away section of the *Hunky Dory*'s transom, with no compensating "outboard well", rendered the boat susceptible to flooding by the stern under adverse conditions. The polystyrene flotation did not contribute to the buoyancy of the boat until it became submerged. The polystyrene blocks under the floor frames were probably responsible for the vessel capsizing as it foundered. Once a small boat capsizes it seldom offers any significant support or protection for its occupants.

- 3.4 The *Hunky Dory* was overwhelmed by the sea and foundered.
- 3.5 The design of the *Hunky Dory*'s transom rendered the boat susceptible to flooding by the stern.
