**Report 96-207**

**Fishing Vessel *Avenger***

**Te Waewae Bay, Foveaux Strait**

## Marine Accident Report 96-207

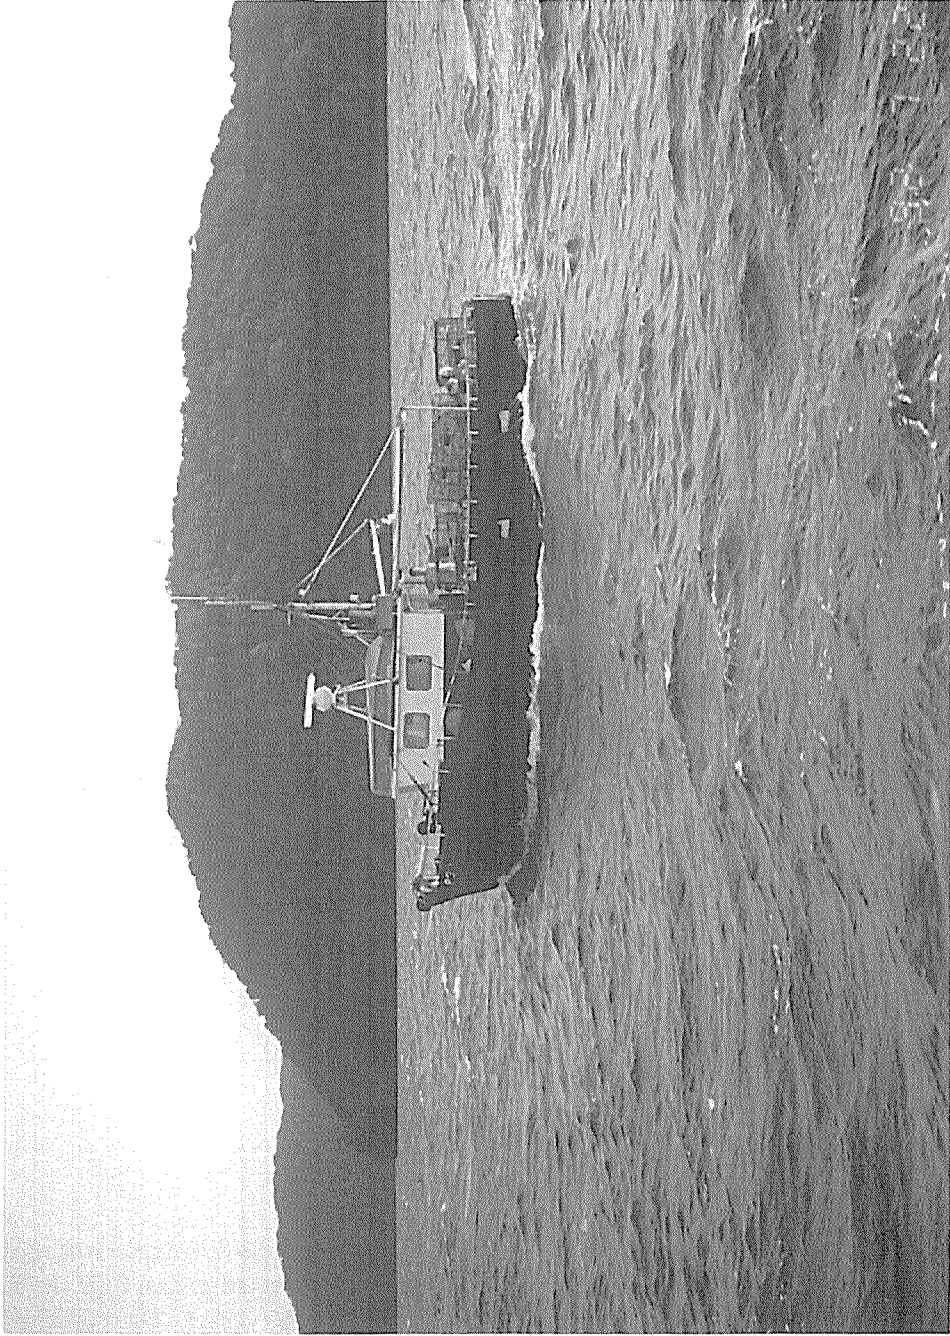
*The Avenger in 1992*

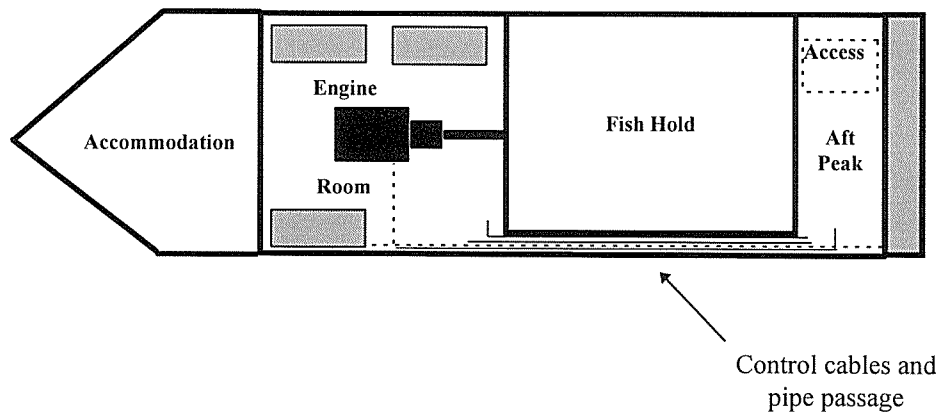
**Figure 2**  
**Under-deck plan of *Avenger***  
**(Diagram not to scale)**

- 1.2.4 In 1995 the *Avenger's* original engine was replaced with a second-hand diesel of the same make and model.
- 1.2.5 The *Avenger's* engine room was located slightly forward of midships, with the fish hold aft and the accommodation forward of the engine room. The wheelhouse, which was located on top of the engine room, had a rear-facing door opening onto the aft deck. Access to the accommodation and the engine room was from inside the wheelhouse (see Figure 2).

- 1.2.6 The *Avenger's* hull, superstructure, coamings, bulwarks and hatch covers (except that on the fish hold) were constructed from steel. The fish hold was offset approximately 30 cm to starboard, leaving an under-deck space on the port side for control cables and pipes to pass through to the aft peak, which was located aft of the fish hold. Access to the aft peak was through a hatch on deck near the stern. The fish hold was fitted with removable pond boards to prevent the catch from shifting, and an aluminium hatch cover.

- 2.5 If the aft peak became flooded, water would have flowed from there, past the fish hold and into the engine room. As the bilge pump was not operational, the water level in the engine room would have risen until either the vessel lost stability, the engine stopped, or a combination of both. If water did enter the engine room, and this was detected by the crew, they would have had to stop the engine to pump out the bilge, and risk losing control of the vessel in relatively rough seas. This option would be available to them only if the batteries were still operative.
