Report 96-209

Longline Fishing Vessel *Warlock*

20 August 1996

Marine Accident Report 96-209

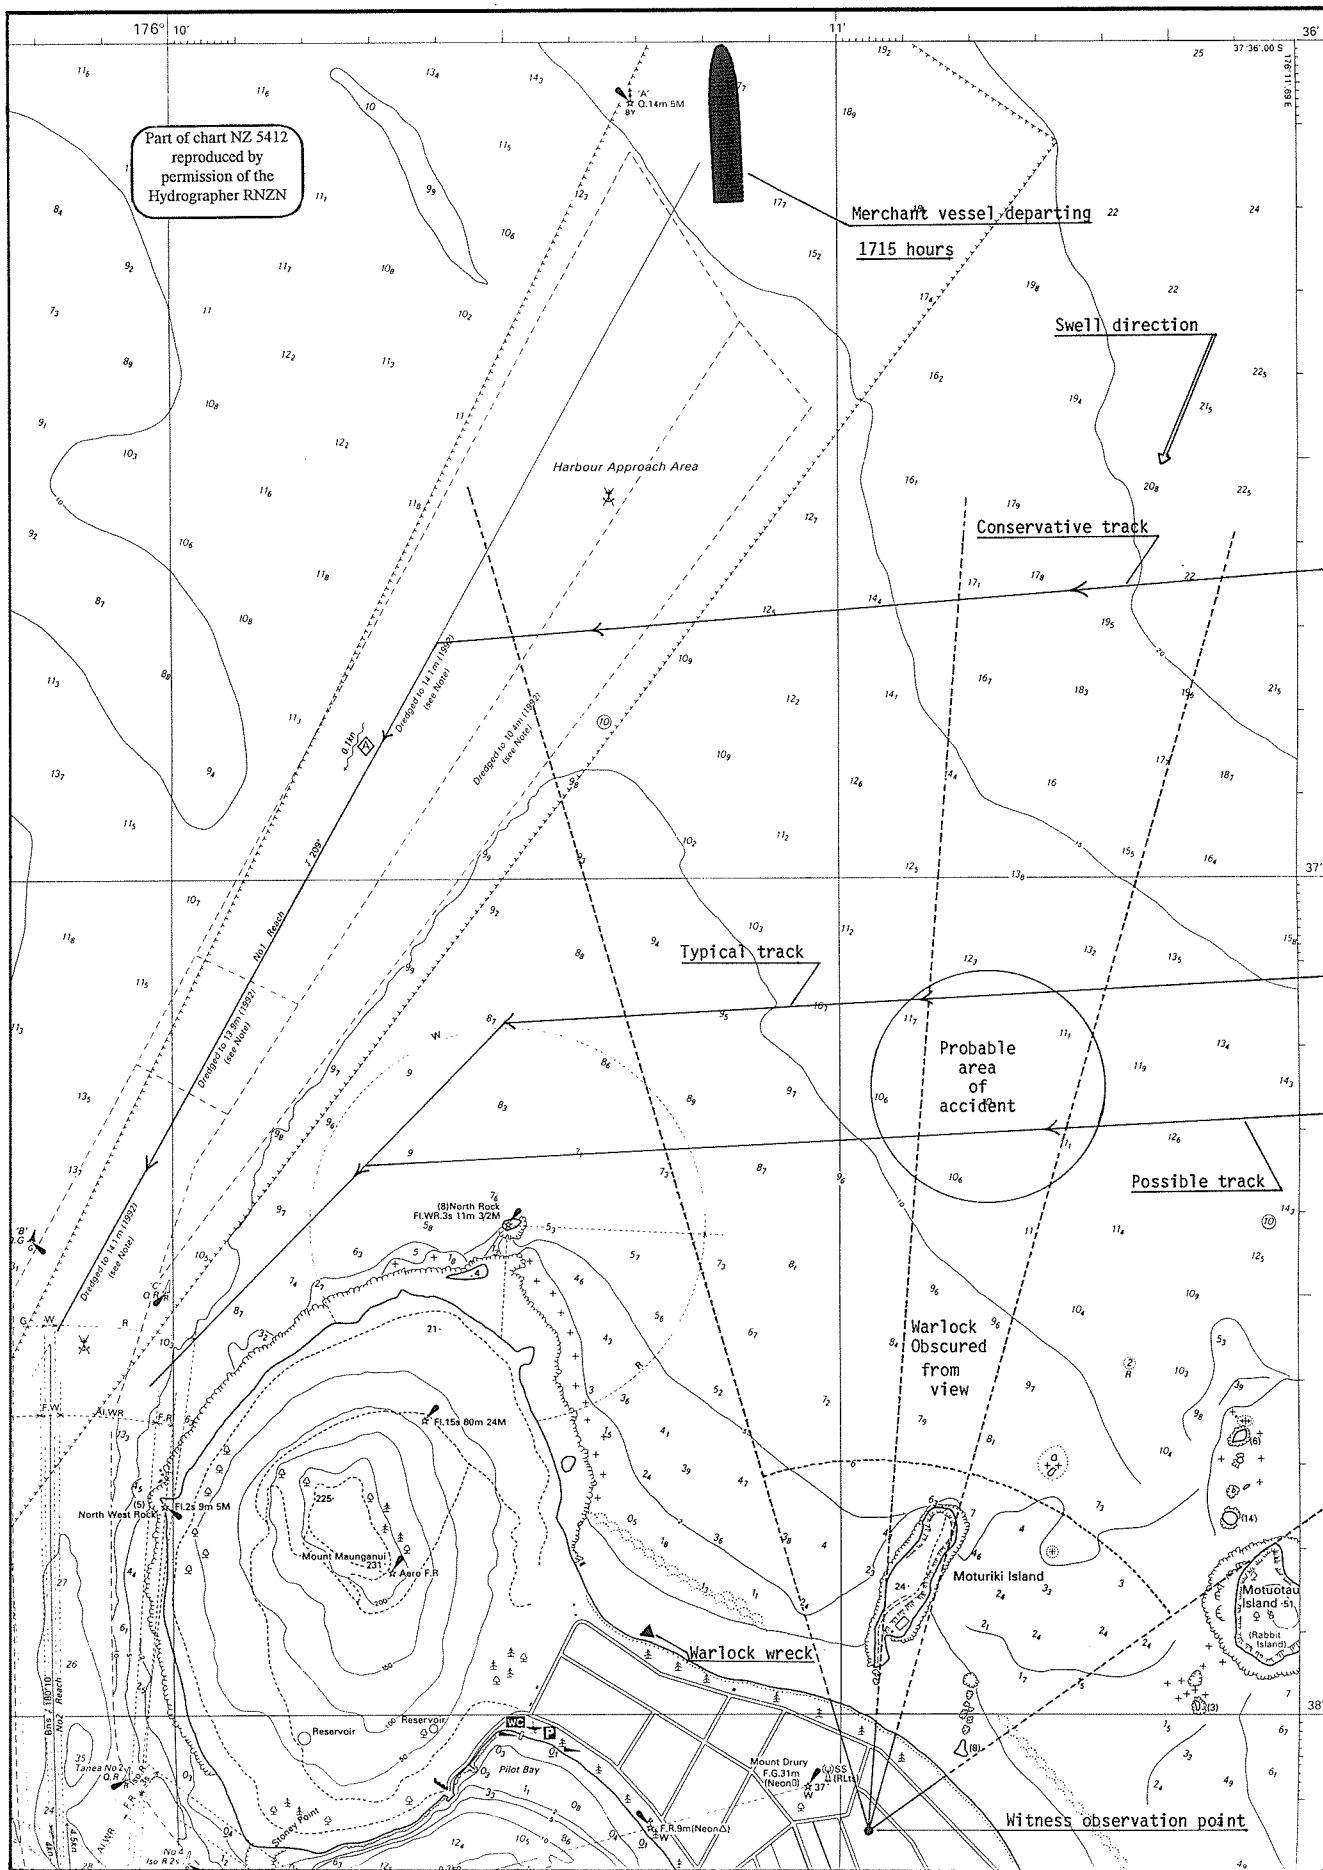
Figure 1
Approximate track and positions of note

- 2.6 The timing of the *Warlock's* disappearance behind Moturiki Island, the Master's telephone call to his father (stating that he was one mile off his waypoint), and the location of the wreck (see Figure 1.), provide a basis for determining a reasonably accurate position at which the initial event occurred.

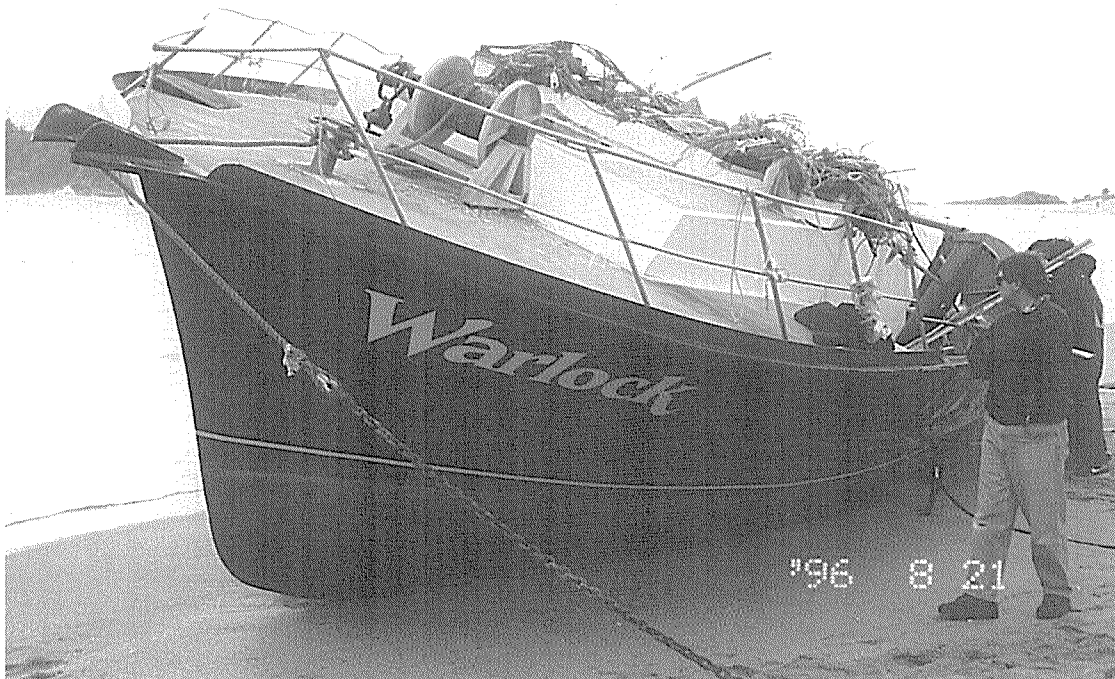
- 1.5.1 The *Warlock* was registered as under 12 m and therefore did not require to be issued with a Certificate of Survey.
- 1.5.2 The *Warlock* had spent some time in heavy surf before coming to rest upside down on the beach. As a result, the deck equipment and fittings suffered extensive damage. The roof of the wheelhouse was separated from the main structure and was found near where the *Warlock* came to rest. The bulwark door on the starboard side of the aft deck was not secured and had been bent at the hinges. The hull suffered superficial damage only. (See Figure 3.)
- 1.5.3 The rudder was set up approximately four centimetres. The steering-gear hydraulic ram was bent where it had been forced past its normal limits and contacted the steel bulkhead on which it was secured.

Figure 3
Warlock on the beach, after righting
