## **Report 96-211**

### **Restricted-Limit Charter Launch *Toroa***

**collision with exposed rock**

**11 November 1996**

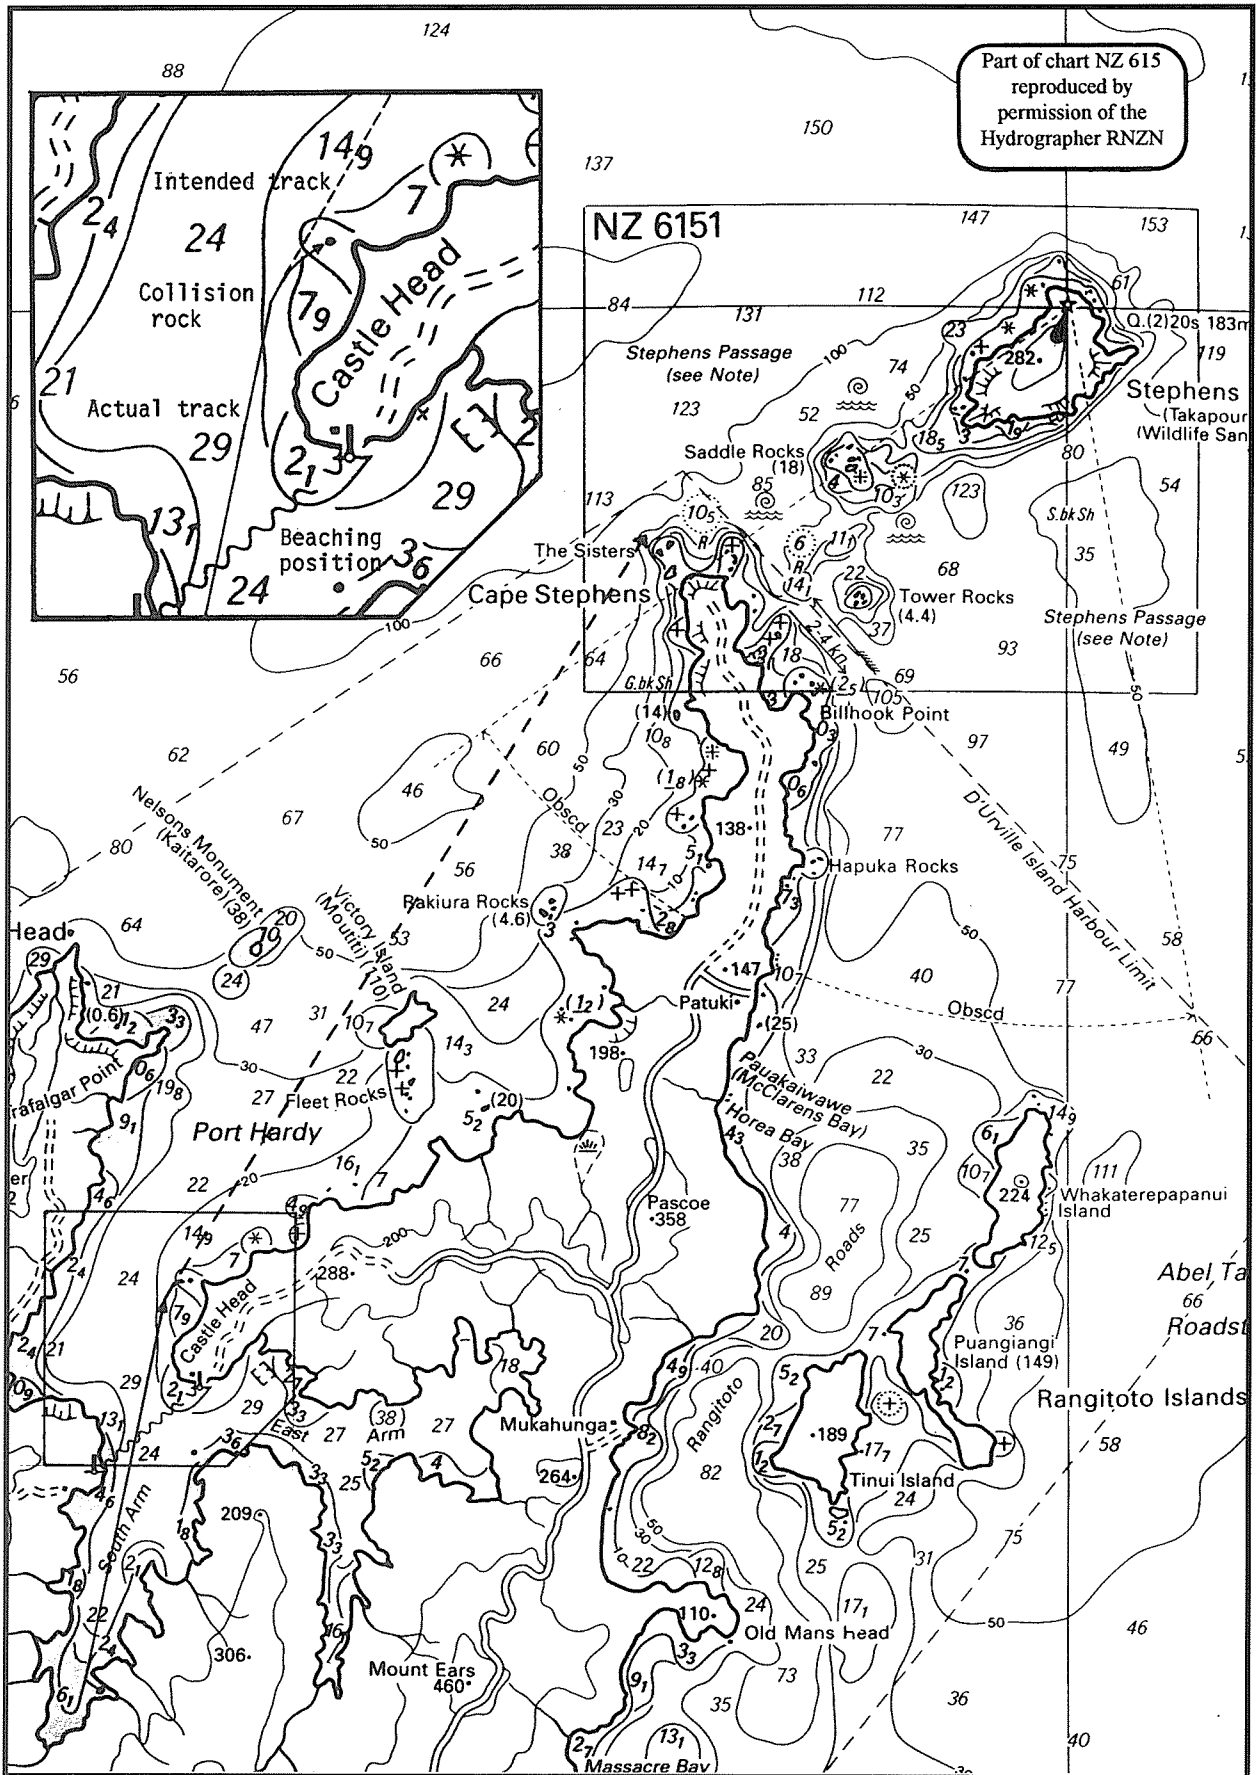
**Figure 1**  
Part of Chart NZ615, showing approximate track of *Toroa*

- 1.1.6 On Sunday night the *Toroa* sat on a mooring in South Arm of Port Hardy. The next day it was planned to return to Havelock via Stephens Passage arriving in the early afternoon so that the group would have time to drive back to Christchurch that day. (See Figure 1.)

- 1.1.12 At about 0818 hours the skipper's friend handed him a plate of breakfast. The skipper checked to see that the *Toroa* was on track and keeping its course. He estimated that the pinnacle of rock (un-named) off the north-west point on Castle Head was about 200 m ahead of the *Toroa*, and that their track would clear the rock by about 80 m.
