Report 96-212

Restricted-Limit Fishing Charter Boat *Lambo*

foundering

26 November 1996

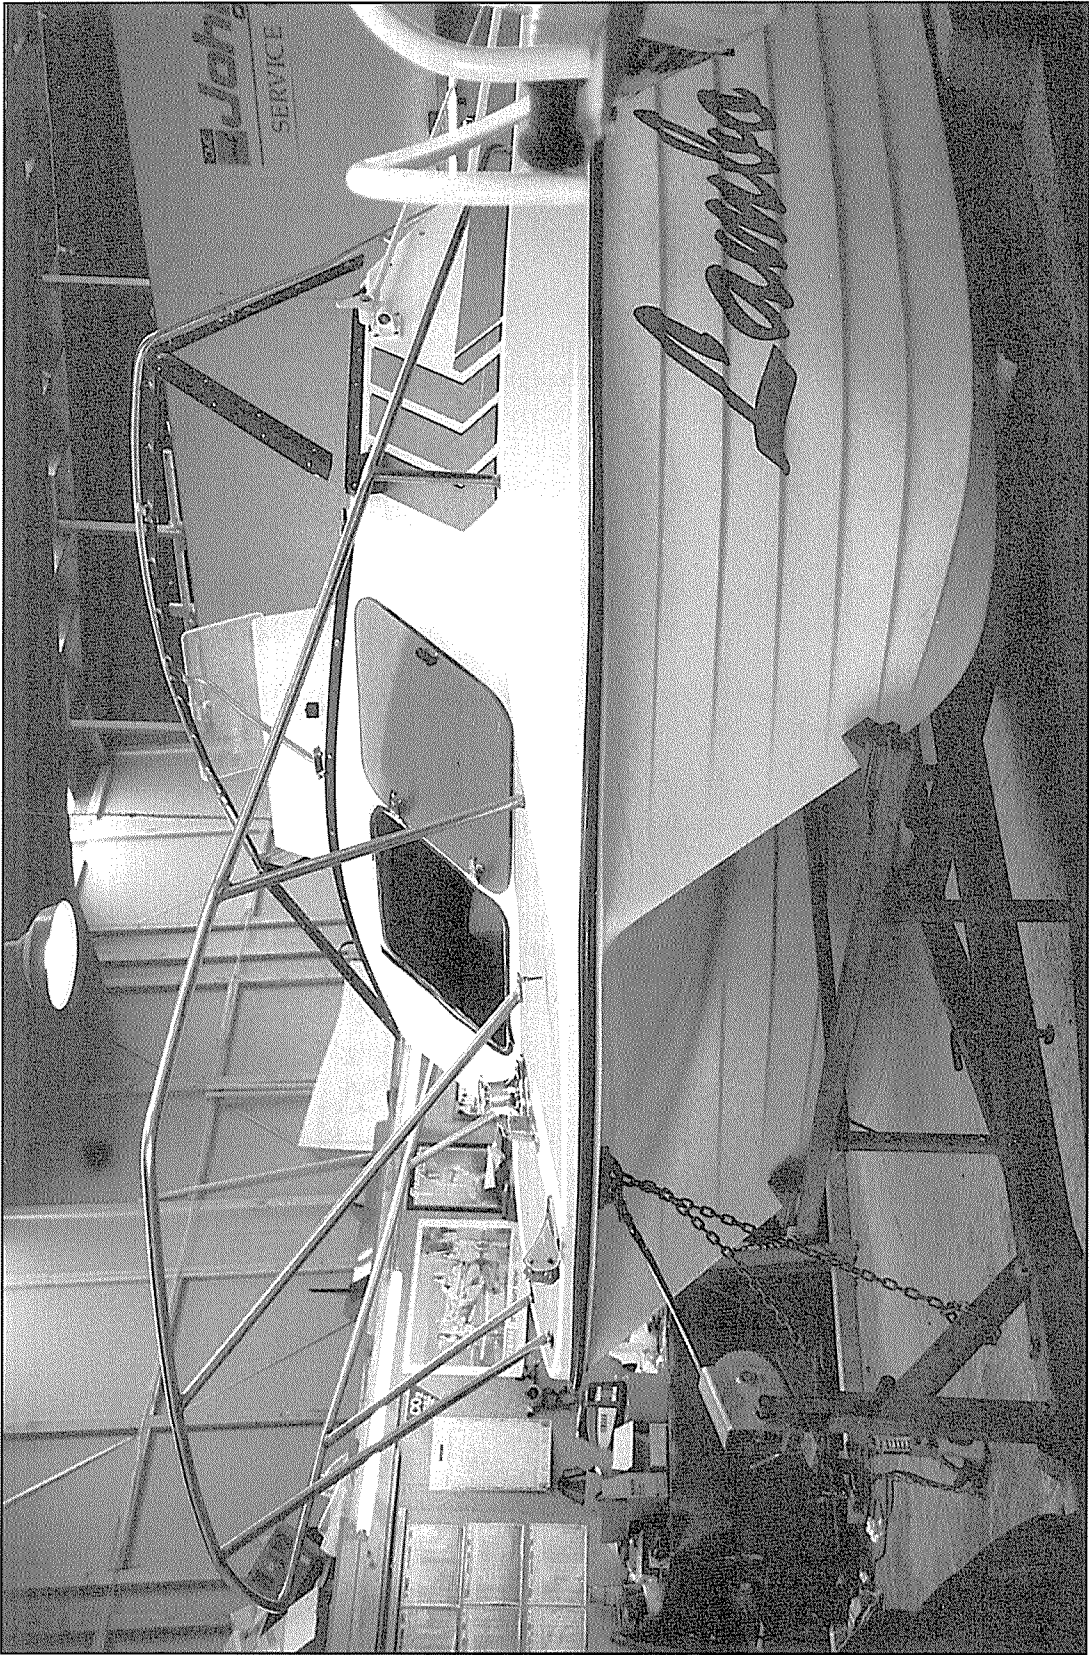
Lambo

- 1.2.1 The *Lambo* was a 5.6 m Shark Cat catamaran constructed in GRP. A large cockpit and small forward cabin sat atop the twin hulls. The forward cabin could be accessed from the cockpit and a hatch with a 10 mm thick perspex cover gave access to the foredeck from within the cabin. The hatch cover, which was normally secured from inside the cabin by one window-latch, opened outwards and sideways to the port side of the boat.

- 1.2.2 The single window latch was the original type fitted by the boat builder during the construction of *Lambo*. The boat builder now fits a designated marine hatch with a four point securing system to each of his boats.

- 3.6 The hatch cover on the foredeck of the *Lambo* was not secure when the skipper started into the wind and sea towards the shore; the wind probably blew the hatch cover open.

- 3.7 The skipper, by suddenly reducing power when the *Lambo* was on the plane, caused the boat to settle in the water, trim forward and ship two consecutive waves through the open hatch.

- 4.1 Since the accident the *Lambo* has been fitted with a hatch cover with a four-point securing system, and with two new 90 hp outboard motors with long shafts to raise the level of the engines above the waterline.
- 4.2 Metservice now includes a brief mention of any gale warning in force for the parent sea area in the recreational marine area forecasts placed on Metphone.
