**Report 96-213**

**Collision between**

**Fast Passenger Launch *Mack Attack***

**at Paihia, Bay of Islands**

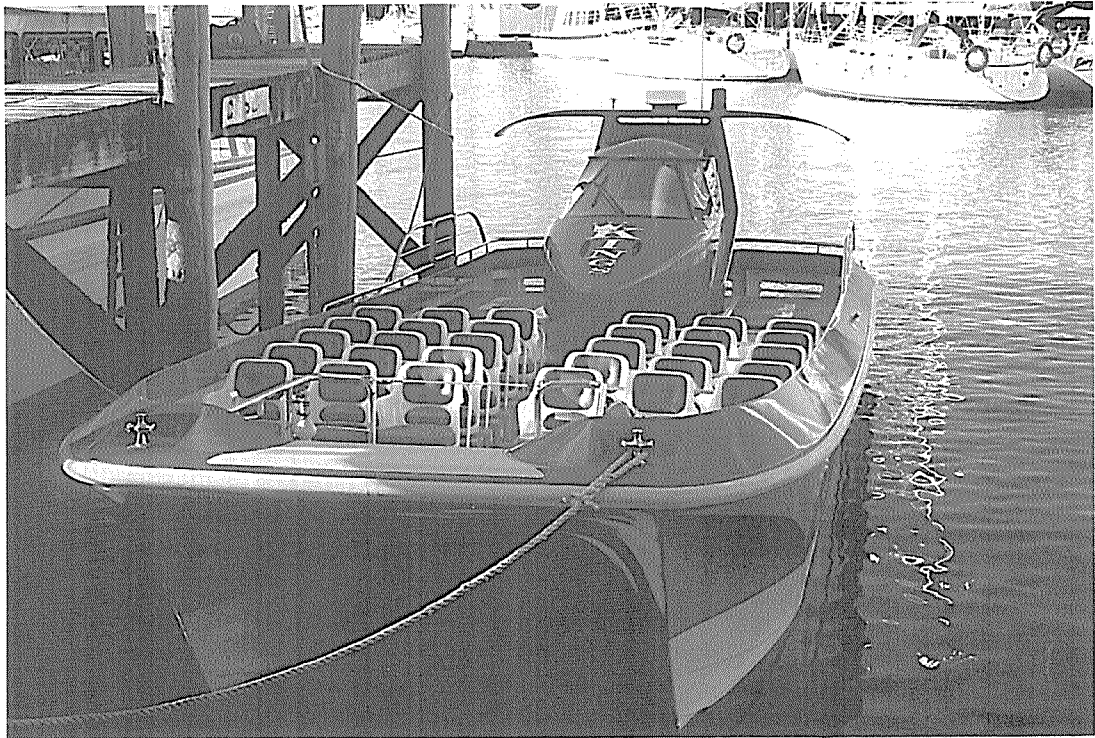
**Figure 1**  
*Mack Attack*

- The mullions of the cockpit windscreen on both sides are approx. 50 mm wide and cause some loss of view to port and starboard unless the skipper makes a point of moving his head sufficiently to see around them.

- The only apparent damage was scratching and chipping of the gelcoat on the outside and inside of the stem of the port hull vertically over a length of 900 mm above the stationary waterline.

2.2.1 There were some limitations on the field of view from the skipper's seat in the cockpit of *Mack Attack* imposed by the design of the craft. They may have contributed to his failure to observe the dinghy. These limitations were caused by:

- The width of the mullions in the cockpit windscreen
- The lack of height of eye above the deck forward, over a horizontal arc of about 5° on either side of the fore and aft line
- The lack of height of eye above the passengers on the port and starboard bows over a further horizontal arc of approx. 10° each side of the foredeck limiting arc.

2.2.2 The total limited field of view at the time of the accident was approximately 30°, being 15° on each side of the fore and aft line, with the 5° - 15° on either side of the fore and aft line being the more severely restricted.

- 2.2.4 Visibility from the cockpit when ‘on the plane’ is considered to be satisfactory although it could be improved by raising the skipper’s seat (which would also involve an increase in the height of the cockpit structure); and by modifications to the windscreen, removing or substantially reducing the size of the mullions.

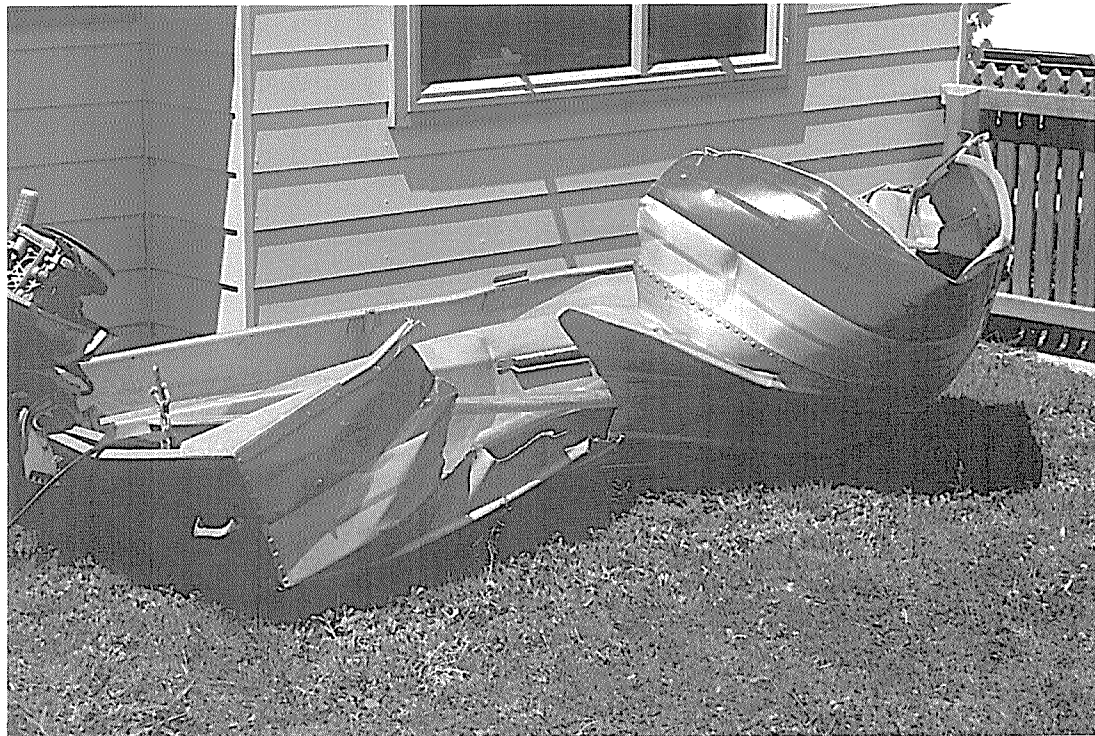
**Figure 2**  
*The dinghy*

1.3.8 The three metre aluminium dinghy was fitted with one thwart (seat) and with buoyancy tanks forward and along both sides, providing additional seats. It was suitable for up to four people in calm waters and, at the time of the accident, was fitted with a Johnson 6.5 h.p. outboard motor. The dinghy had an orange stripe painted above the waterline along the full length of its topside.

- The damage was extensive and constituted virtual destruction of the dinghy. There was evidence of an impact on the starboard quarter which tore that side apart from the keel to the gunwale, removed the centre thwart, demolished the starboard buoyancy tank and substantially bent the dagger plate housing.
